Wilson, K.J. Power, W.L., Nishimura, Y., 'Atelea Kautoke, R., Vaiomo'unga, R., Mori, H., Pongi, 'A., Fifita, M., Vaoahi, M., Teukava, S. 2009. Post-tsunami survey of Niuatoputapu Island, Tonga, following the 30<sup>th</sup> September 2009, South Pacific tsunami, *GNS Science Report 2009/71*. 28 p.

## **ABSTRACT**

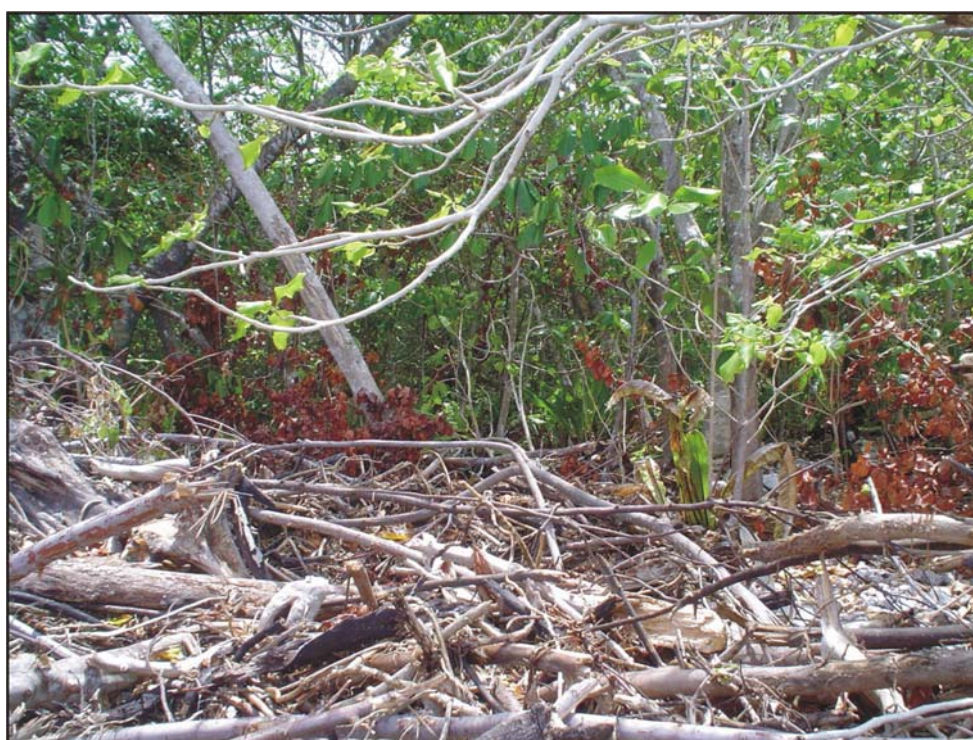
The inundation distance is the maximum inland distance reached by the tsunami flow (Fig. 2), which was typically recognised in the field by the boundary between dead or damaged vegetation, and healthy vegetation (Fig. 3). Dispersal of debris and damage to buildings could also be used as a guide to inundation extent, along with eyewitness observations. Where the surveying method allowed, the runup elevation was also measured, this being the height above mean sea level that the tsunami flow reached at its maximum inland extent.

Figure 3. Example of the distinguishing features of the tsunami inundation limit. Note the stark contrast between the dead vegetation and the healthy vegetation. Photo taken at the southeastern corner of Niuatoputapu, grid reference 844081E, 8230634N (UTM Zone 1 South coordinates).

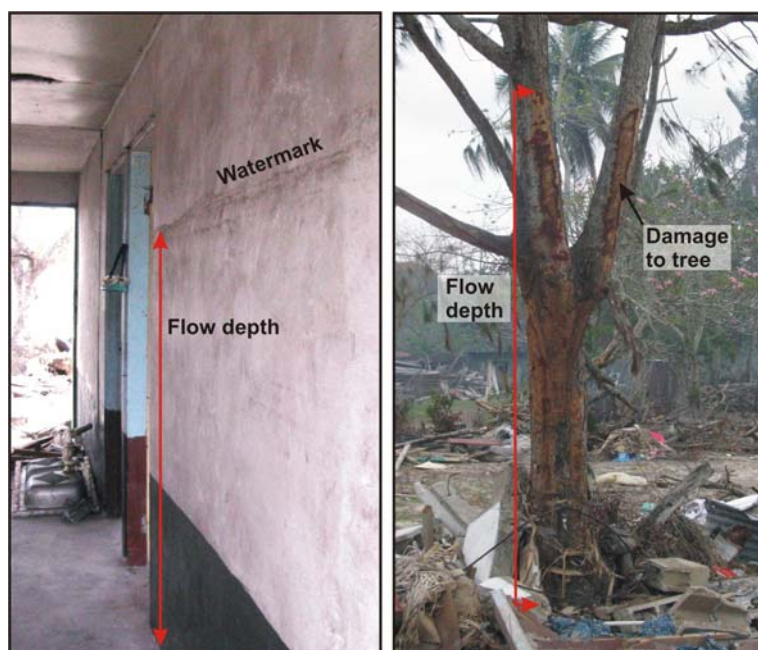
Figure 4. Examples of flow depths indicators. Left photo shows a watermark within a house at Hihifo. Right photo shows gouge marks and bark stripped from a tree trunk in Hihifo village.

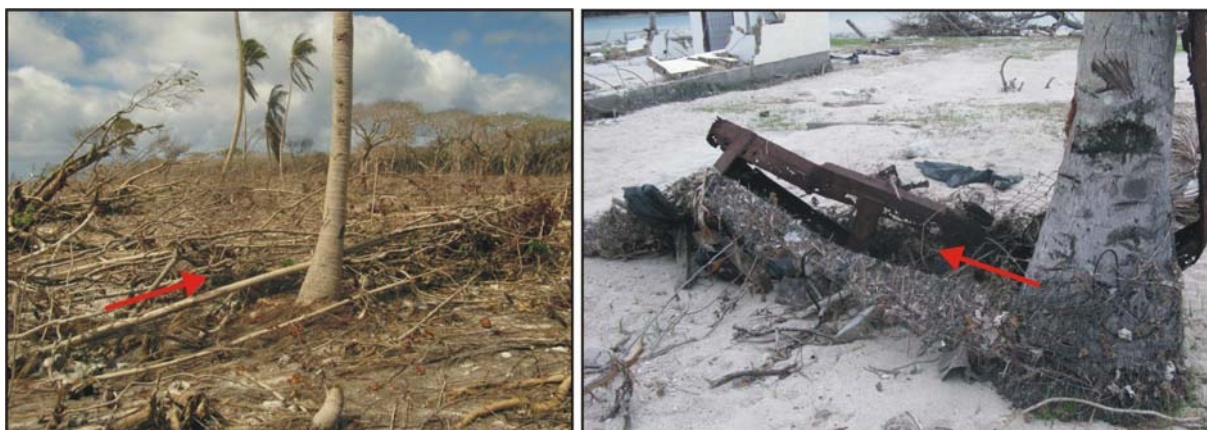
Figure 5. Examples of flow direction indicators, red arrows indicate the alignment of debris. Left photo the alignment of fallen trees, this photo was taken at Toma on the eastern coast of Niuatoputapu (grid reference 845358E, 8231327N). The right photo shows wire fencing and other debris caught around a coconut tree trunk in Hihifo village, the direction of the wire fencing shows the flow direction.

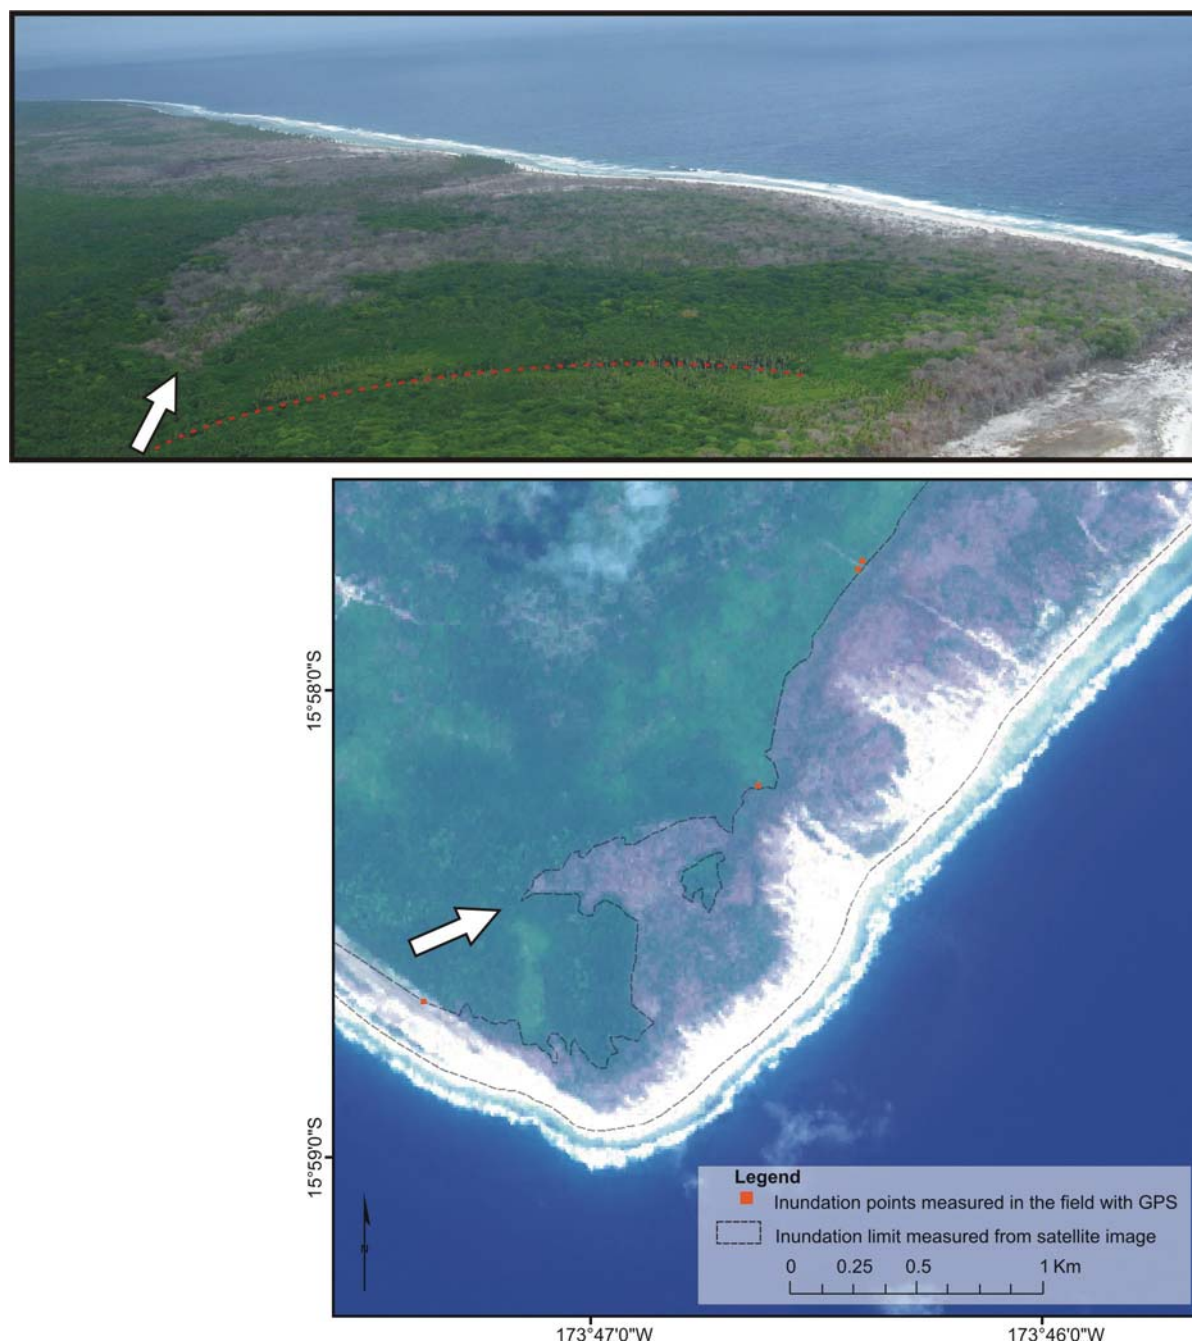
Figure 8. A comparison between an oblique aerial photograph of the zone of tsunami inundation and the satellite image of tsunami inundation. Both images are of the southwestern corner of Nuatoputapu. The white arrows point out the comparable features in each image. The dashed red line in the top image shows a road that was checked in the field for tsunami inundation and where none was found, confirming that inundation probably did not extend beyond the region of dead trees.

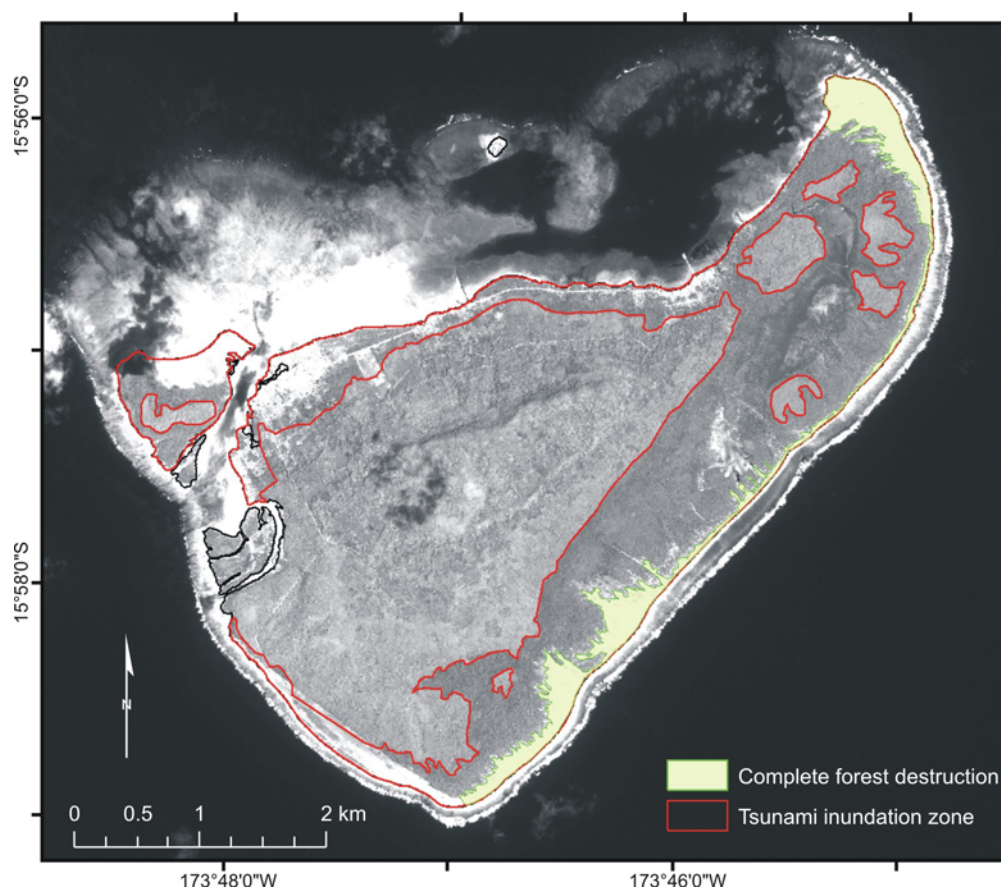
Large swathes of forest on Niuatoputapu were destroyed by the tsunami (Fig. 16 and 17). Forested areas were affected in Samoa and American Samoa, but typically the damage was moderate – such as bent trees, trees with snapped branches, and small shrubs uprooted. In contrast, in parts of Niuatoputapu (shaded green areas on Fig. 16) all the trees were uprooted or snapped at the base. All the forest undergrowth was removed and only rare large trees and occasional coconut trees remained standing (Fig. 17). Using satellite images to map the zones of complete forest destruction (confirmed by field visits to most areas, Fig. 16) we calculate that  $\sim 0.89 \text{ km}^2$  of forest was destroyed, that is 6% of the total land area of Niuatoputapu. In forested areas of the tsunami inundation zone where there was not complete forest removal, damage was still severe to moderate. In some areas, the forest was still standing but all trees and undergrowth plants were dead, in other areas, particularly near the inland limits of inundation, only small undergrowth plants had been killed by the salt water inundation but larger plants and trees still appeared to be healthy. In the time available we did not gather information on the plant species that were particularly resilient or particularly vulnerable to the tsunami inundation but this may be an interesting topic for future study.

Figure 16. Areas of complete forest destruction on Niuatoputapu Island.

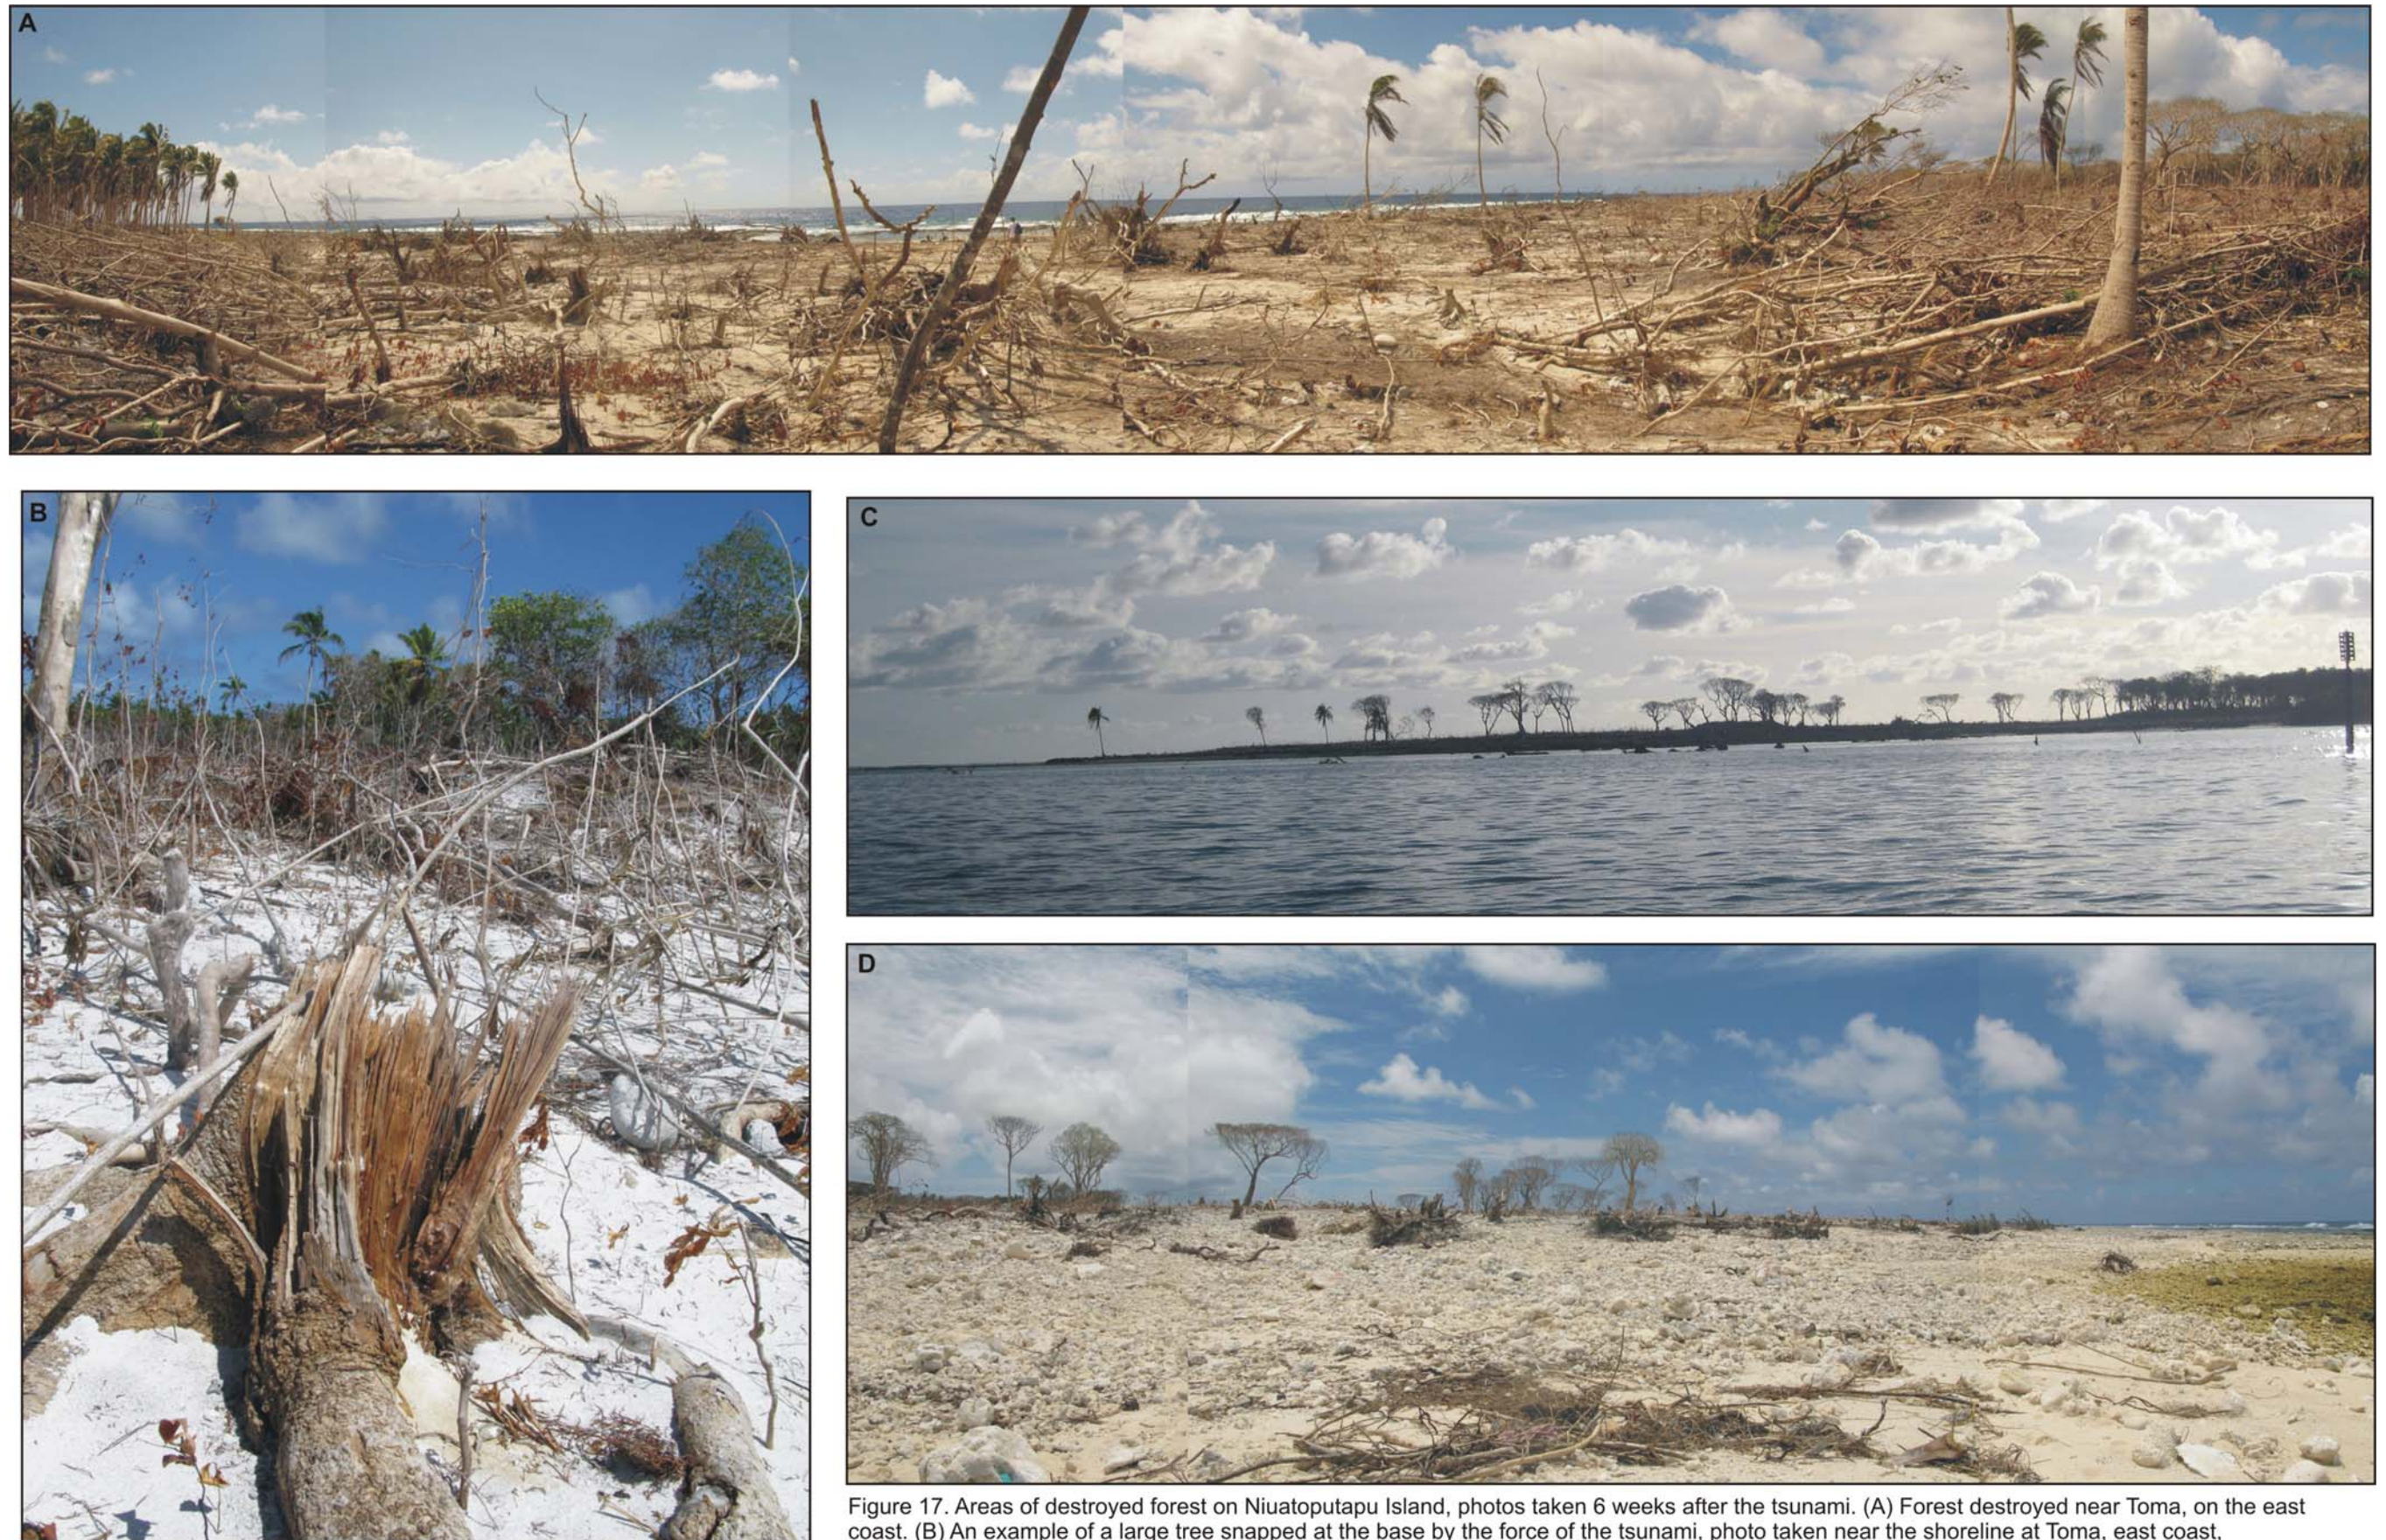
Figure 17. Areas of destroyed forest on Niuatoputapu Island, photos taken 6 weeks after the tsunami. (A) Forest destroyed near Toma, on the east coast. (B) An example of a large tree snapped at the base by the force of the tsunami, photo taken near the shoreline at Toma, east coast, Niuatoputapu. (C) The northern tip of Niuatoputapu, the whole peninsula had been previously forested, now only sparse large trees remain. (D) Photos taken looking across the northern tip of Niuatoputapu from the eastern shoreline.

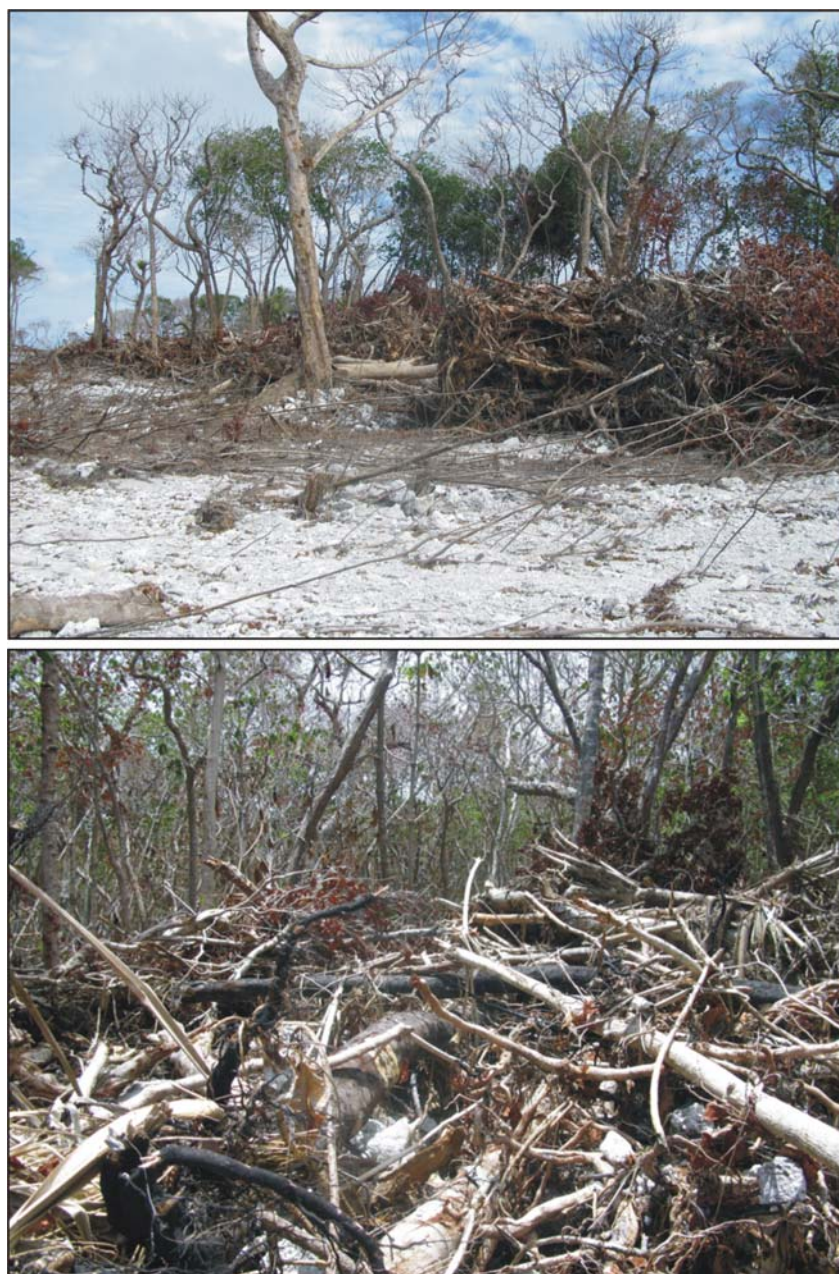
At the periphery of the zones of complete forest destruction there were typically large debris piles. These debris piles were formed of dead vegetation, often including large trees and packed with small shrubs. The debris piles were up to 4 metres high and are likely to take several months to years to break down naturally. Also observed were significant accumulations of debris within the lagoon on the northwestern side of the island (Fig. 19). This debris will also naturally break down but may linger as a hazard for boating within the lagoon for some time and will probably be remobilised during cyclones.

Figure 18. Debris piles at Niuatoputapu. The upper photo is from the northern point of Niuatoputapu at the southern margin of the zone of forest destruction. The lower photo is from Toma, on the east coast of Niuatoputapu, also at the margins of a zone of forest destruction.

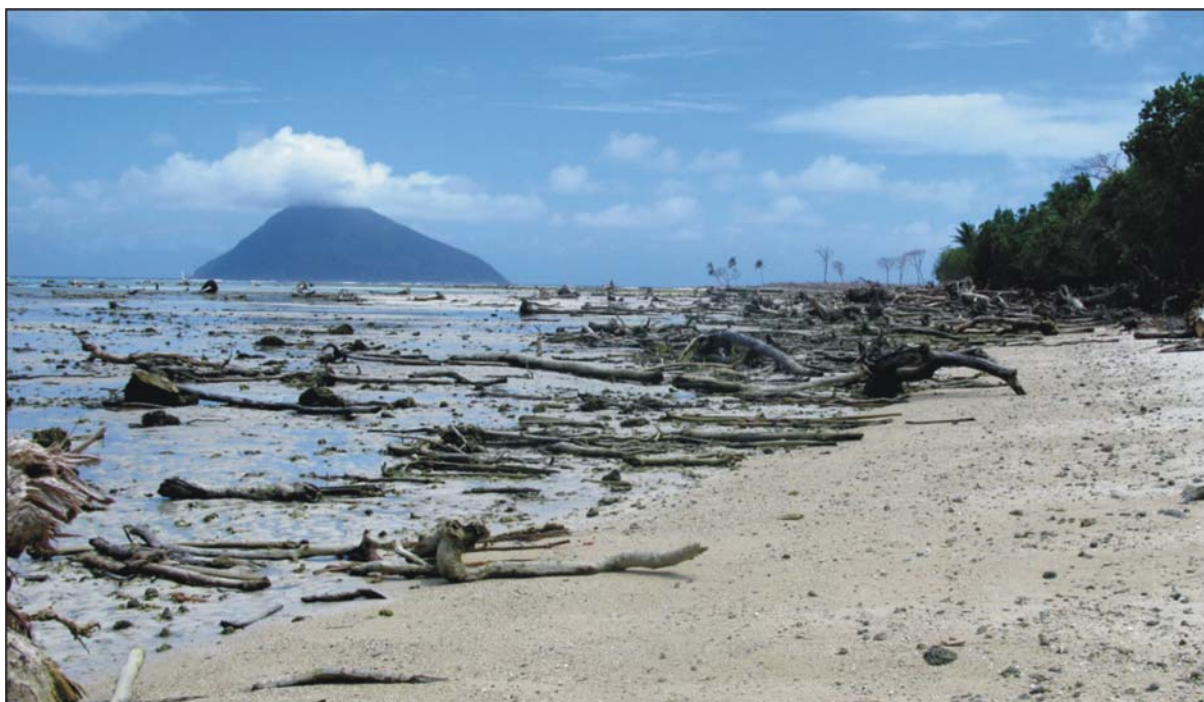
Figure 19. Debris in the lagoon on the northwestern coastline of Niuauputapu.

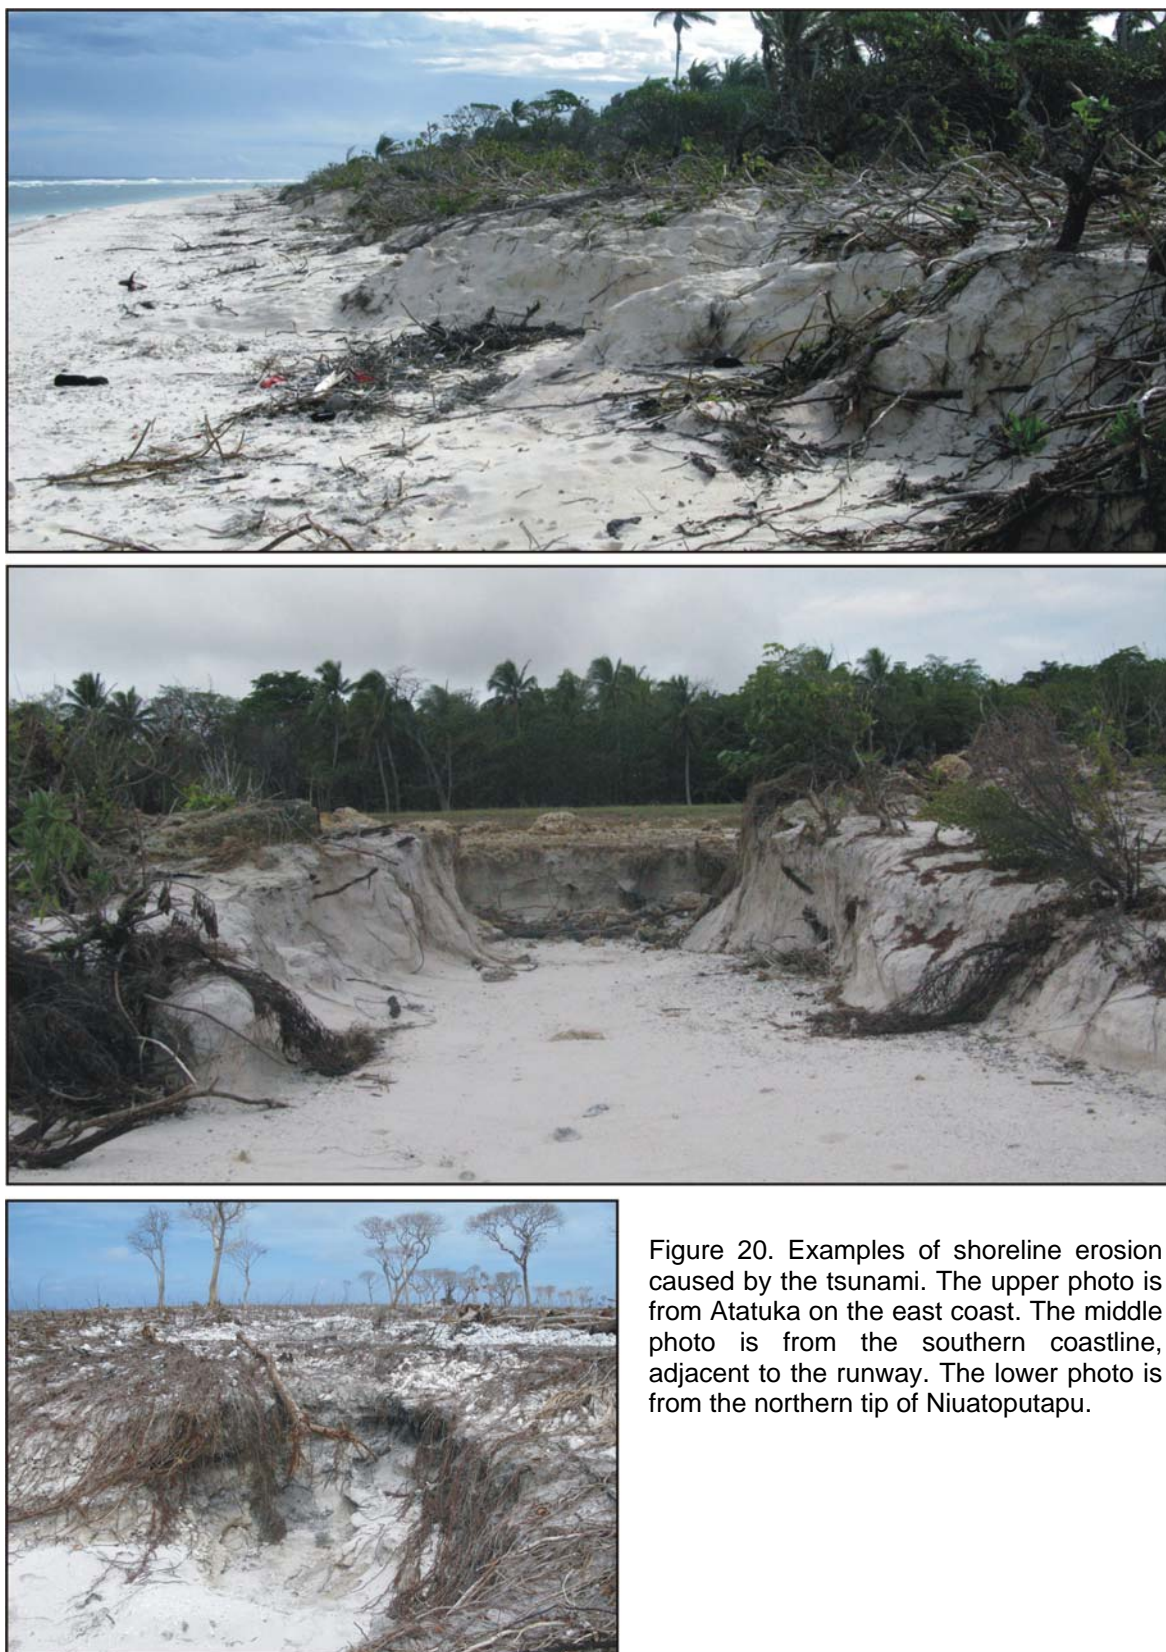
The shoreline of Niuauputapu was scoured and eroded by the tsunami along the northern, eastern and southern coastlines (Fig. 20). Scoured indentations into the sand foredunes typically extended 1 – 4 m inland, and most of the vegetation was stripped from the foredune. The shoreline erosion probably would have been worse if there had not been a fringing coral reef offshore; however, the stripping of vegetation means the shoreline is now more vulnerable to further erosion during the cyclone season. Along the western coastline of Niuauputapu the shoreline is not as steep and no significant erosion was noticed, however, much of the vegetation was removed or damaged therefore the shoreline is now more vulnerable to erosion (Fig. 21).

Figure 20. Examples of shoreline erosion caused by the tsunami. The upper photo is from Atatuka on the east coast. The middle photo is from the southern coastline, adjacent to the runway. The lower photo is from the northern tip of Niuatoputapu.

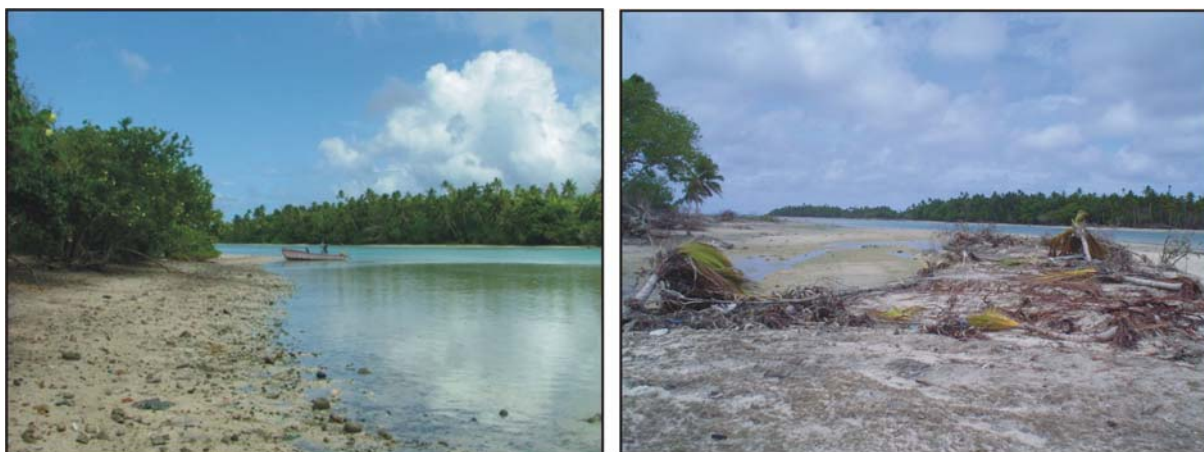
Figure 21. Before and after photos of the Hihifo shoreline demonstrating the extent to which vegetation was stripped from the shoreline, enhancing the areas vulnerability to coastal erosion (Hungahunga Island in the background). Photo on the left is from Google Earth, from Panoramio users Andrey and Irina Popovich (<http://www.panoramio.com/user/2347807>).

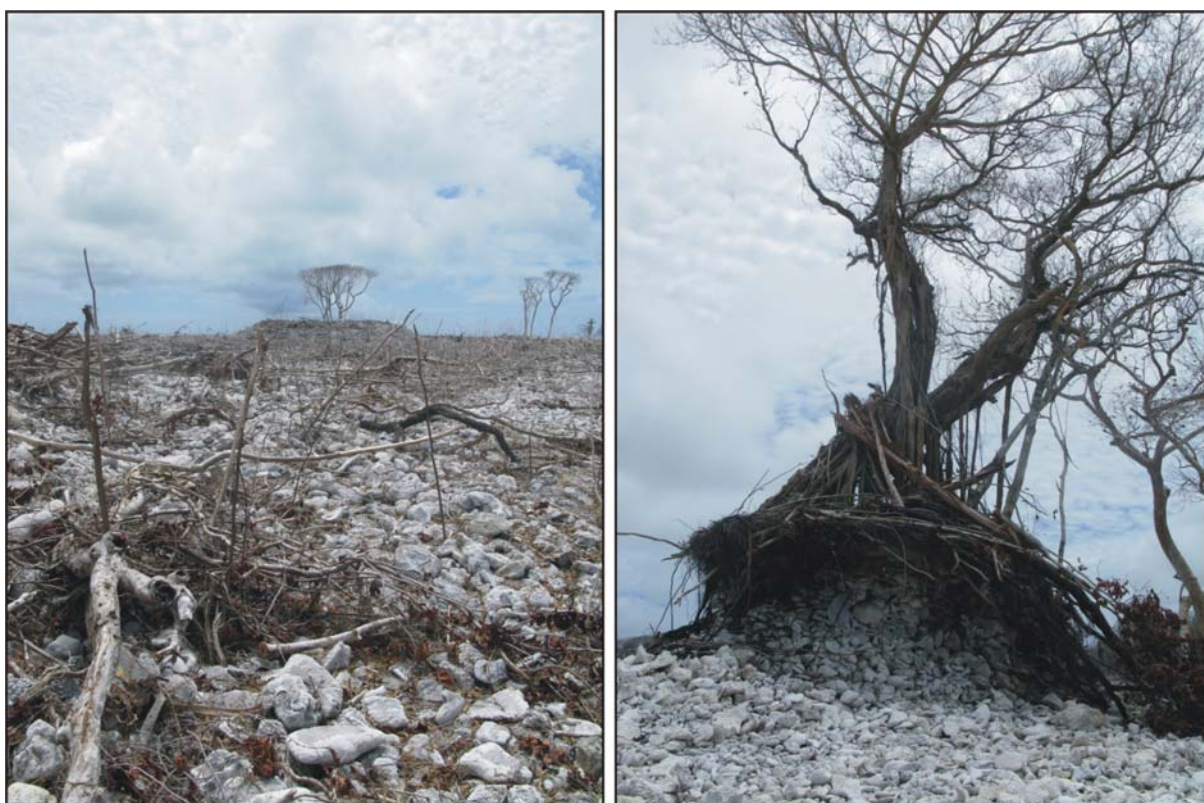
In places where the forest was completely destroyed by the tsunami (Fig. 16) the land surface was also eroded by the tsunami. All soil was removed and the land surface is now bare coral cobbles and boulders or sand (Fig. 22). At the northern tip of Niuauputapu, where coral rubble was exposed, it will likely take many years to decades before the forest will recover.

Figure 22. Photos showing the extent of land surface erosion at the northern tip of Niuatoputapu. Photo on the left shows how all soil and organic matter layers were stripped from the surface and bare coral rubble and coral boulders have been exposed. Photo on the right shows a tree formerly rooted on a small hummock of coral boulders. The land all around the hummock has been scoured and eroded by the tsunami.
