THE 28TH SEPTEMBER 2018 PALU EARTHQUAKE AND TSUNAMI

ITST, 07-11 November 2018

POST TSUNAMI FIELD SURVEY REPORT (SHORT)

November 23, 2018

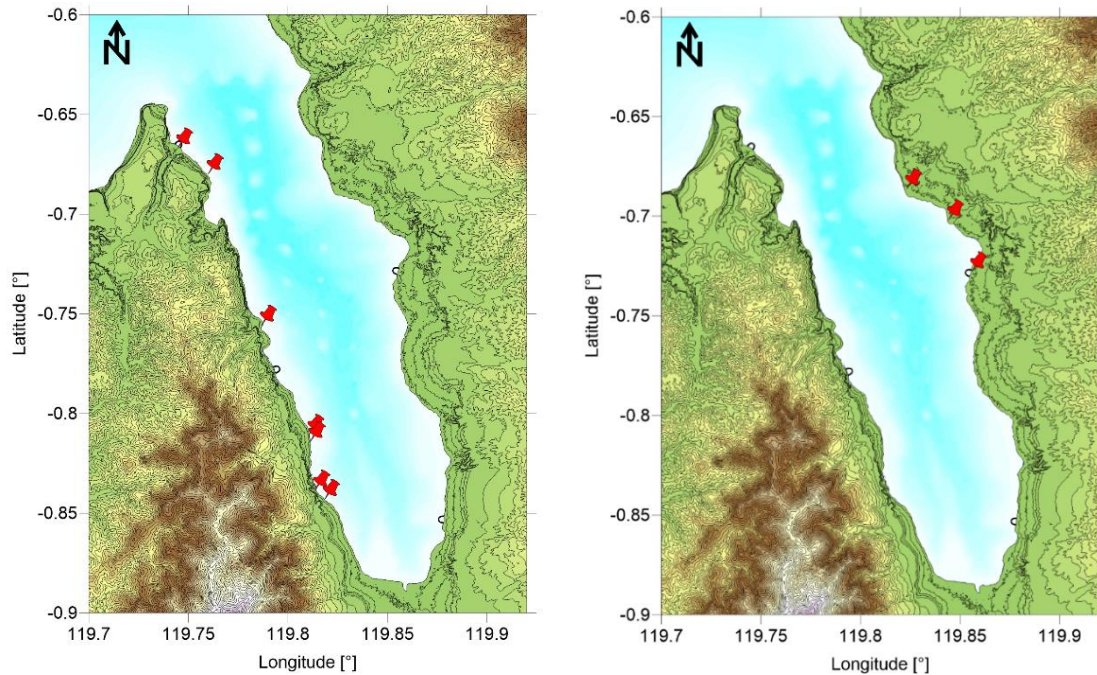
Figure 3.1. Coastal collapses/landslides observed along the Western and Eastern coast of Palu Bay

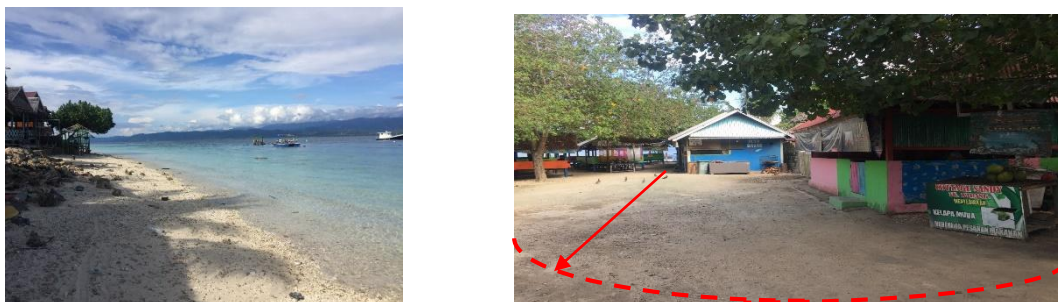
W-01.2 Eastern tip of Tanjung Karang

Figure 3.3. Flat area that the waves reached according to eyewitnesses at W-01.2 survey location

Taking in consideration the eyewitnesses description, the survey team measured a runup height of 0.2m (after detiding) and an inundation distance of 49m at this location. The wave direction is reported as either from Wani or Palu (110° from North) indicating the waves coming from inside of the bay.

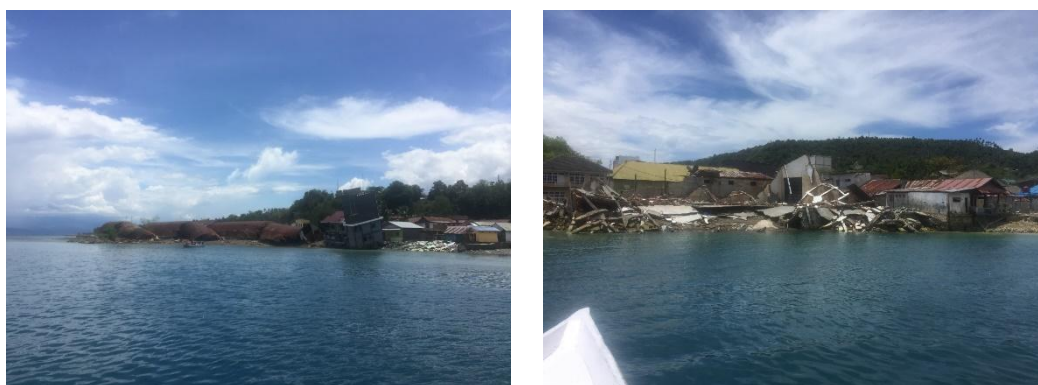
Point: W-02 Donggala

Figure 3.4. Damaged structures due to coastal collapse/landslide at W-02 Donggala

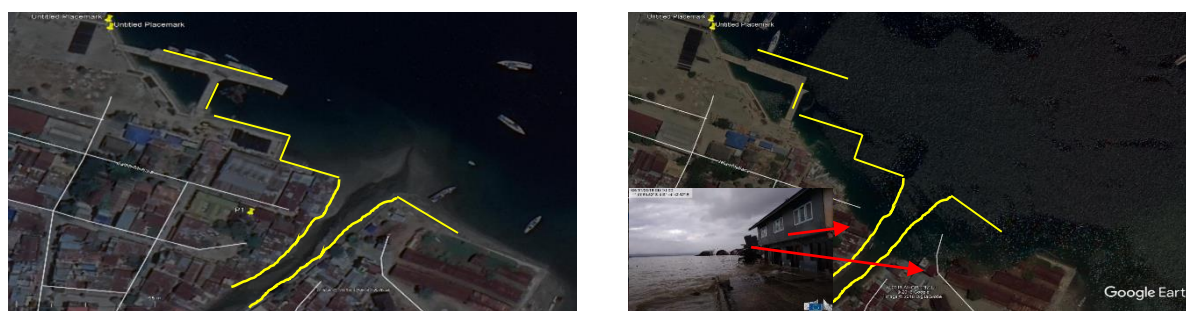
Figure 3.5. Satellite image before (left) and after (right) the event showing Port of Donggala and the river mouth (survey location W-02)

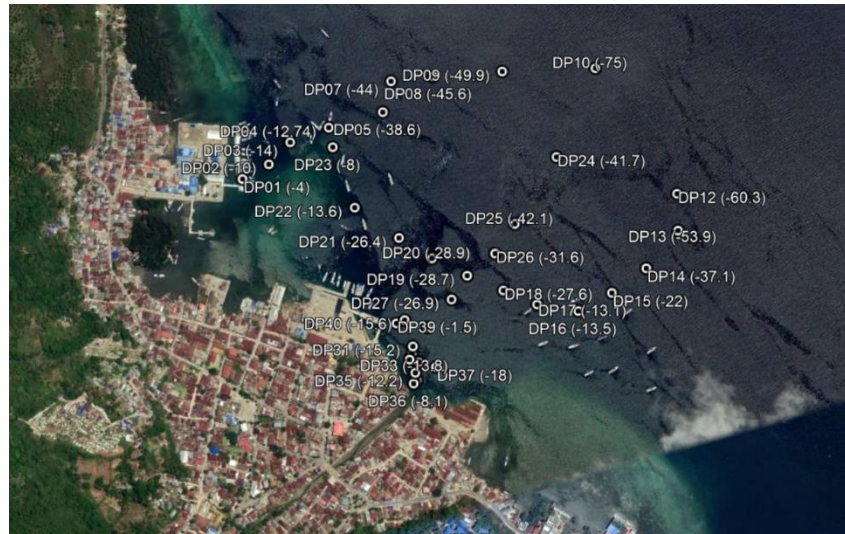
On the 3rd day of the survey, the team performed a bathymetric survey by sonar measurements at several points in this region (Port of Donggala) to investigate the size of the landslide/coastal collapse and obtain the nearshore bathymetry of the area.

Figure 3.6. Bathymetric survey measurements at Port of Donggala region

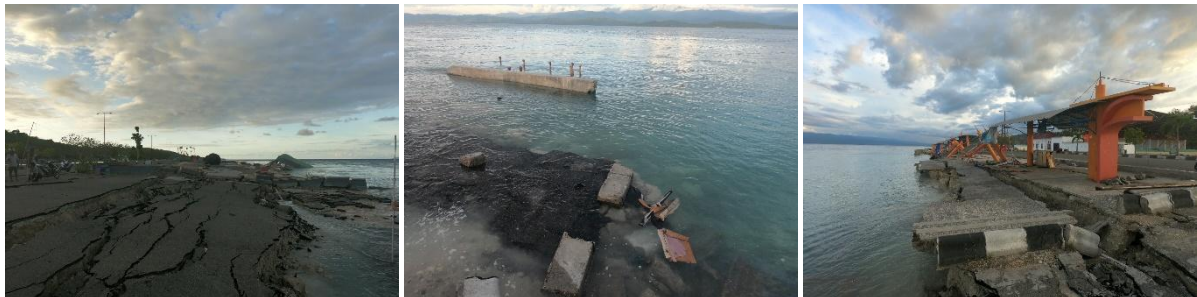
Point: W-03.1 Donggala Kota Wisata, Ujung

This survey point is another landslide/coastal collapse region where some part of the coastal structure at Donggala Kota Wisata (0.67972S 119.75997E) went down to the sea and the small seawall was damaged by the tsunami according to eyewitnesses

Figure 3.7. Damage on the coastal structures at Donggala Kota Wisata (W-03.1)

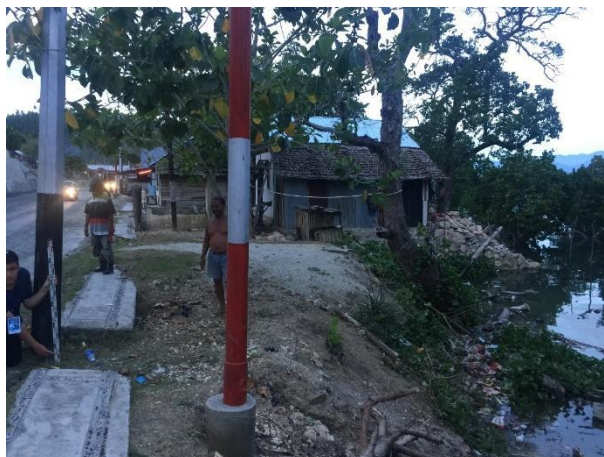
Point: W-03.2 Nambo

This survey point is located in a mangrove coast region (0.69457S 119.75741E) and eyewitnesses showed the location, where small waves reached at the road along the shore.

Figure 3.8. Runup measurement according to eyewitness reports at Nambo (W-03.2)

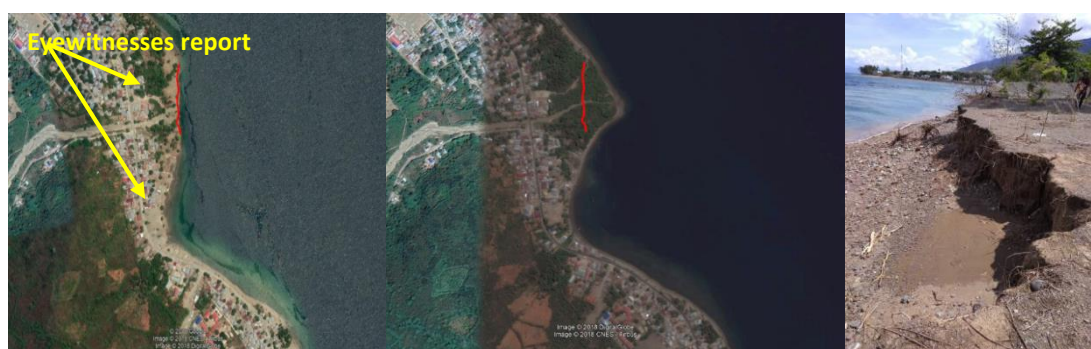
This survey point (0.75837S 119.78547E) revealed the presence of a potential landslide/coastal collapse, for which a GPS tracking of the rim of the head-scarp was performed (Figure 3.9)

Figure 3.9. GPS track showing the landslide/coastal collapse at Lolidondo (W-06) (the red segment outlines the edge of the collapsed/sliding coast (0.755728S 119.786732E))

Eyewitnesses from both sides of the landslide area mentioned hearing, after the earthquake shaking, a kind of explosion coming from the collapse location. They also observed the sea retreating before escaping towards the hill. A small wave arrived first after ~1min then followed by a largest and destructive one.

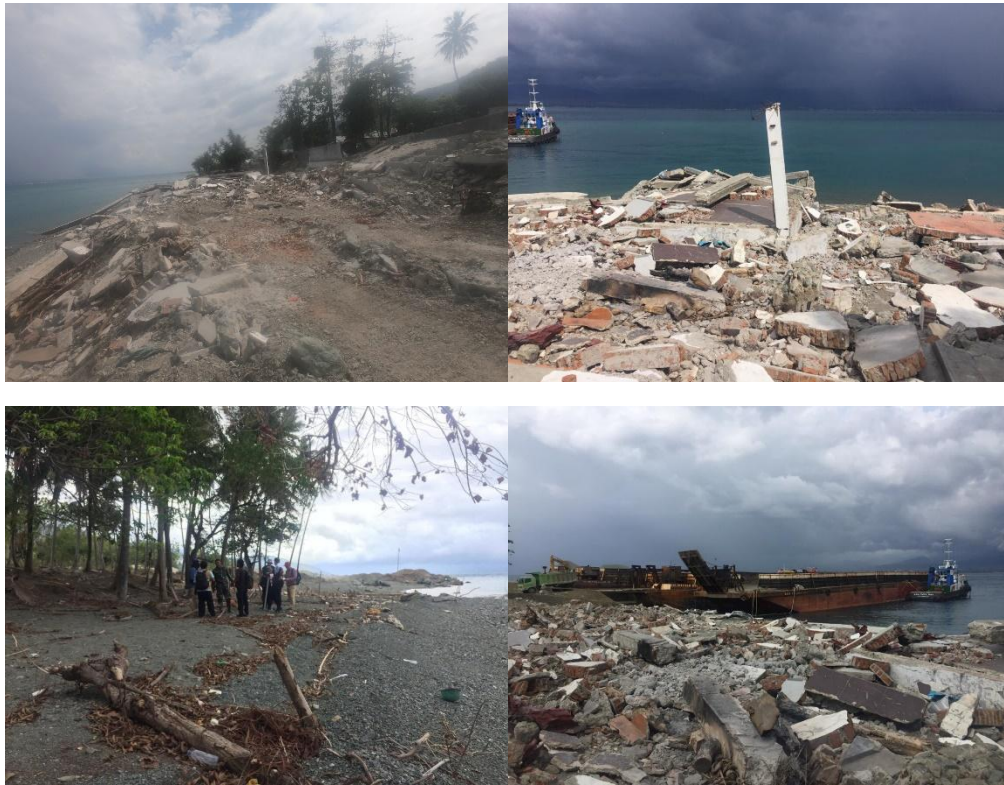
Point: W-08 Tamunggu

At this survey point (0.80948S 119.80981E) the team has identified another landslide/coastal collapse and performed a GPS tracking of its headscarp rim as shown in Figure 3.10. The measured runup is 6.2m according to both observations and eyewitness reports. The inundation distance is 75m.

Figure 3.10. Observed coastal damage at Tamunggu (W-08)

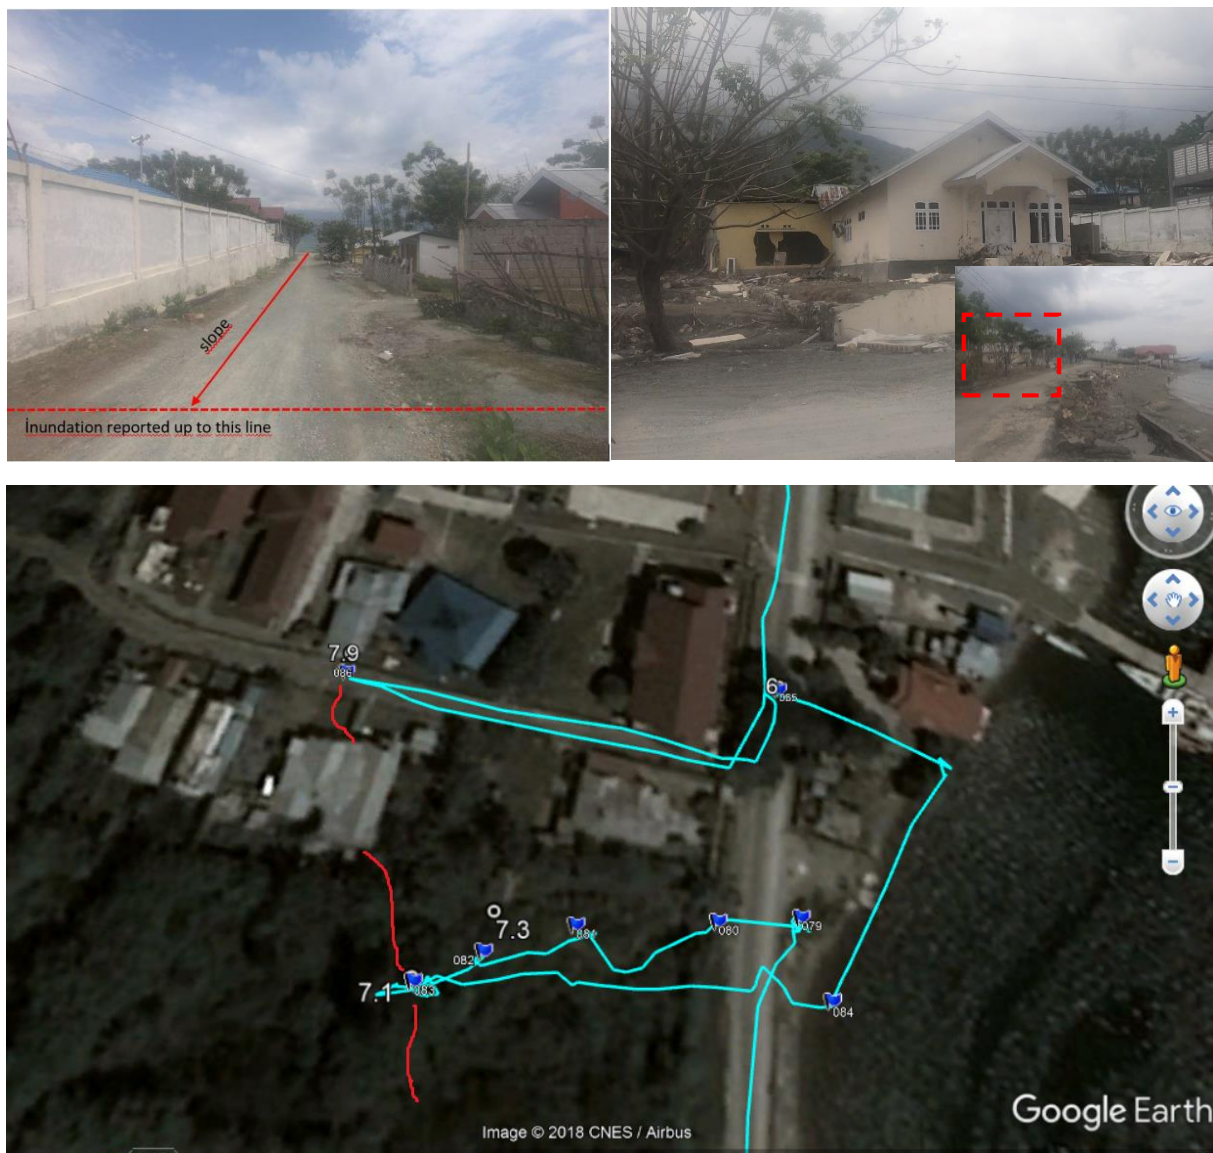
Point: W-09 Watusampu

This survey point is nearby region of the Naval Base at Watusampu (0.82207S 119.81024E). Several measurements were performed in this region since the damage was high, the inundation was high and the runup height is measured as 6.3m (after detiding). The inundation distance is measured as 74m at one of the measurement points according to eyewitness (householders) reports (Figure 3.11).

Figure 3.11. Tsunami inundation according to eyewitnesses at Watusampu (W-09)

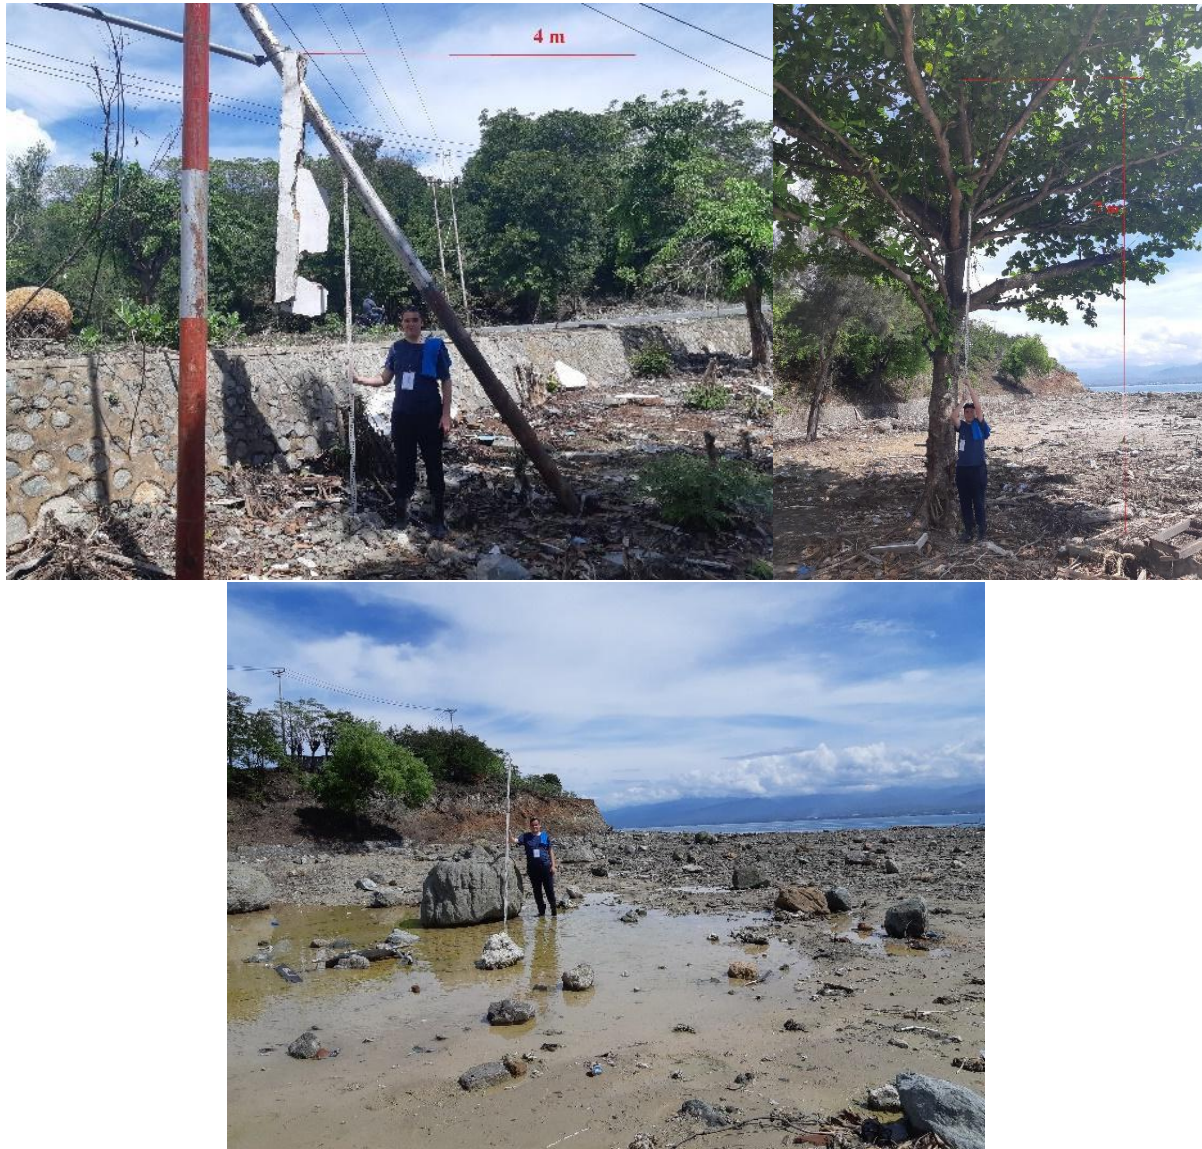
Point: W-10 North Benteng

At this survey point a highly tsunami impacted area between Benteng and Watusampu (0.83772S 119.81371E) was observed but no eyewitnesses could be found there. The measurements were performed according to the traces and signs. The summary of the measurements and the observed damage are given in Figure 3.12.

Figure 3.12. Summary of the measurements and impacted coasts at North Benteng (W-10)

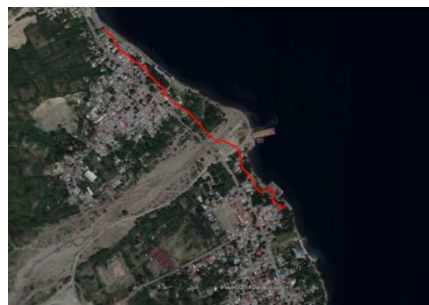
Point: W-11 Benteng

At this survey point a large landslide/coastal collapse area nearby a river mouth at Benteng (0.84591S 119.82061E) was identified by the team that performed a GPS tracking of its head-scarp rim (Figure 3.13).

Figure 3.13. GPS track showing the landslide/coastal collapse at Benteng (W-11)

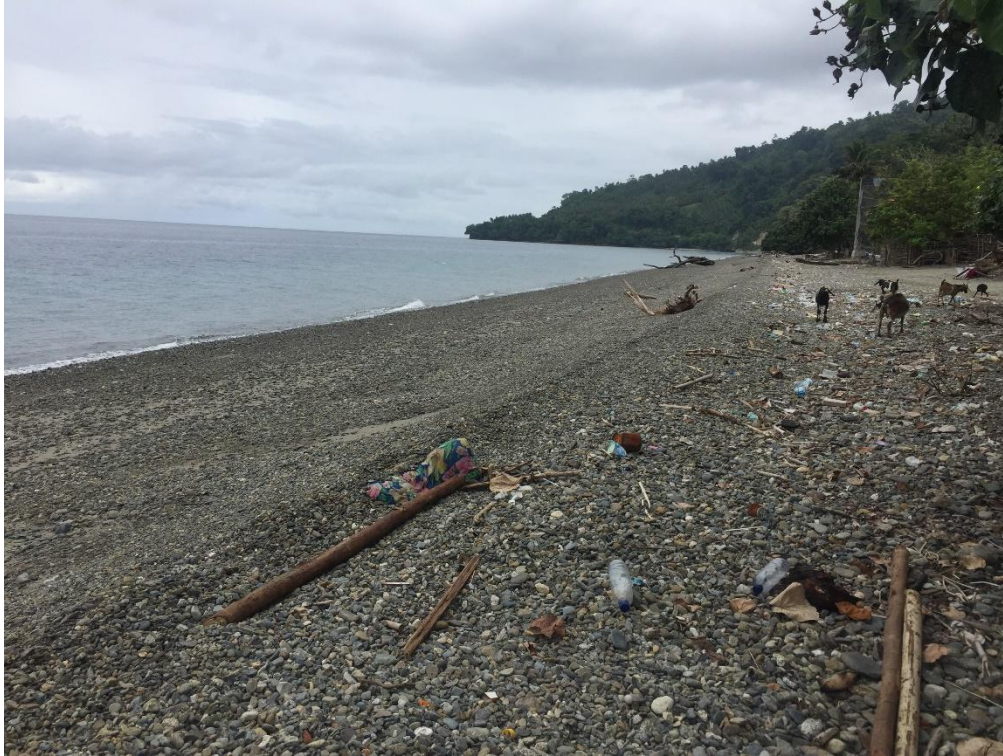
Point: E-04 Bulu Sigalari

The eyewitnesses in this location (0.5415S 119.7798E) stated that they saw large waves offshore (in the bay) but they were moving to Palu direction. According to the observations and eyewitnesses' interviews, there has been small subsidence as the shore slope inclined at this location (Figure 3.17).

Figure 3.17. Surveyed coast at Bulu Sigalari region (E-04)

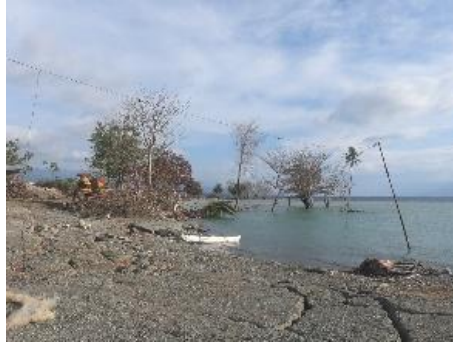
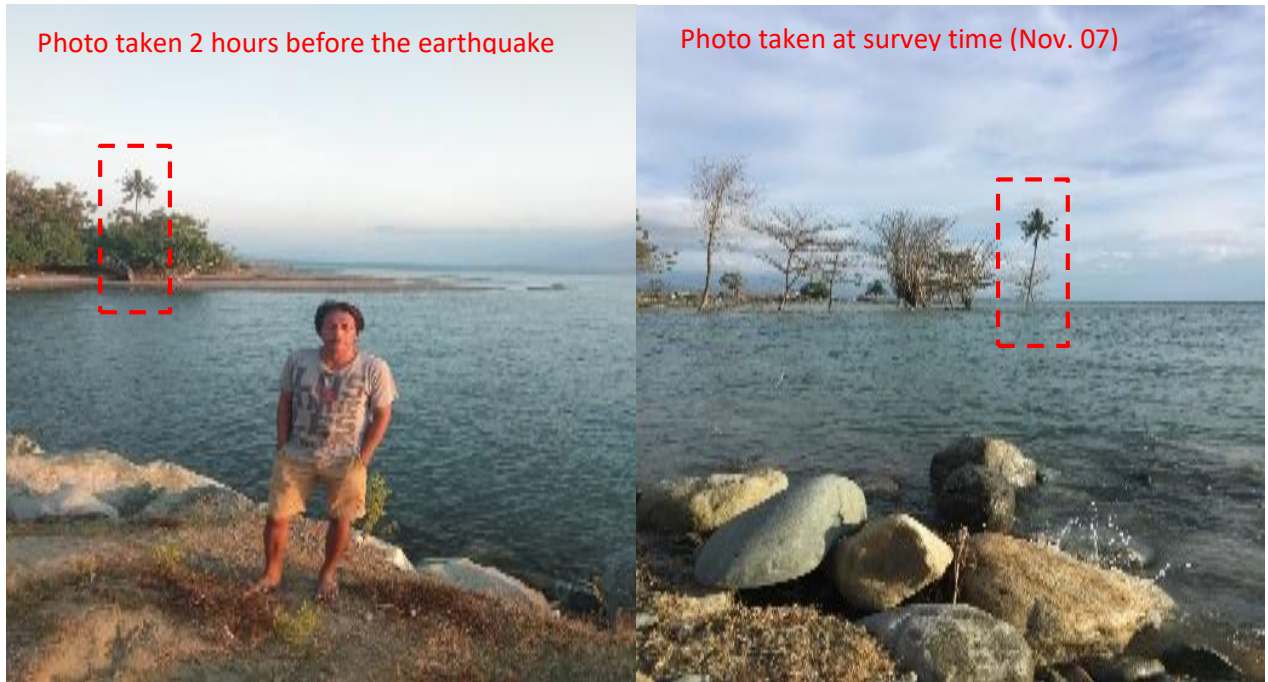
Point: E-07 Labuan

This survey point is at a river mouth in Labuan region (0.6885S 119.8247) where there has been coastal collapse/landslide as shown in Figure 3.19. The eyewitnesses observed a first negative (leading depression) wave.

Figure 3.19. Observed coastal collapse/landslide phenomenon at Labuan region (E-07). The person on the left picture is Mr. Andi. The picture on left was taken by Mr. Renaldi. The picture on right was taken by team member Gozde Guney Dogan.

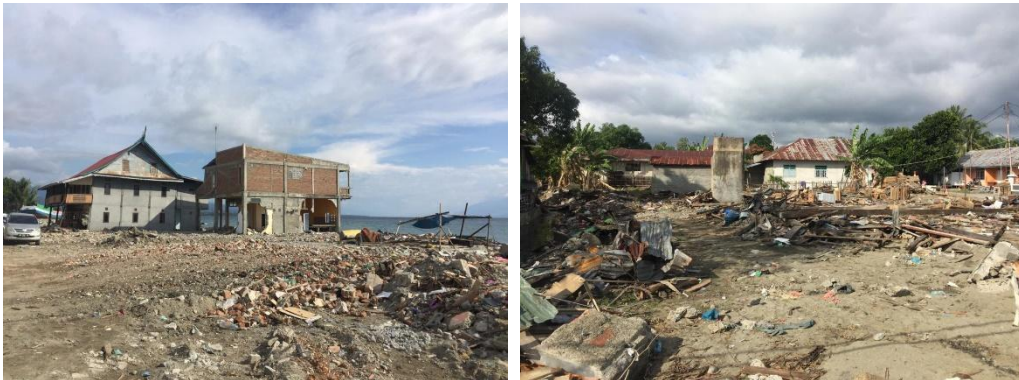
Point: E-08 North Ngapa

Eyewitnesses reported waves coming from two different directions (one from southern side and one from western side) at this survey point in North Ngapa (0.69341S 119.83815E).

Figure 3.20. Observed damage at North Ngapa (Point E-08)

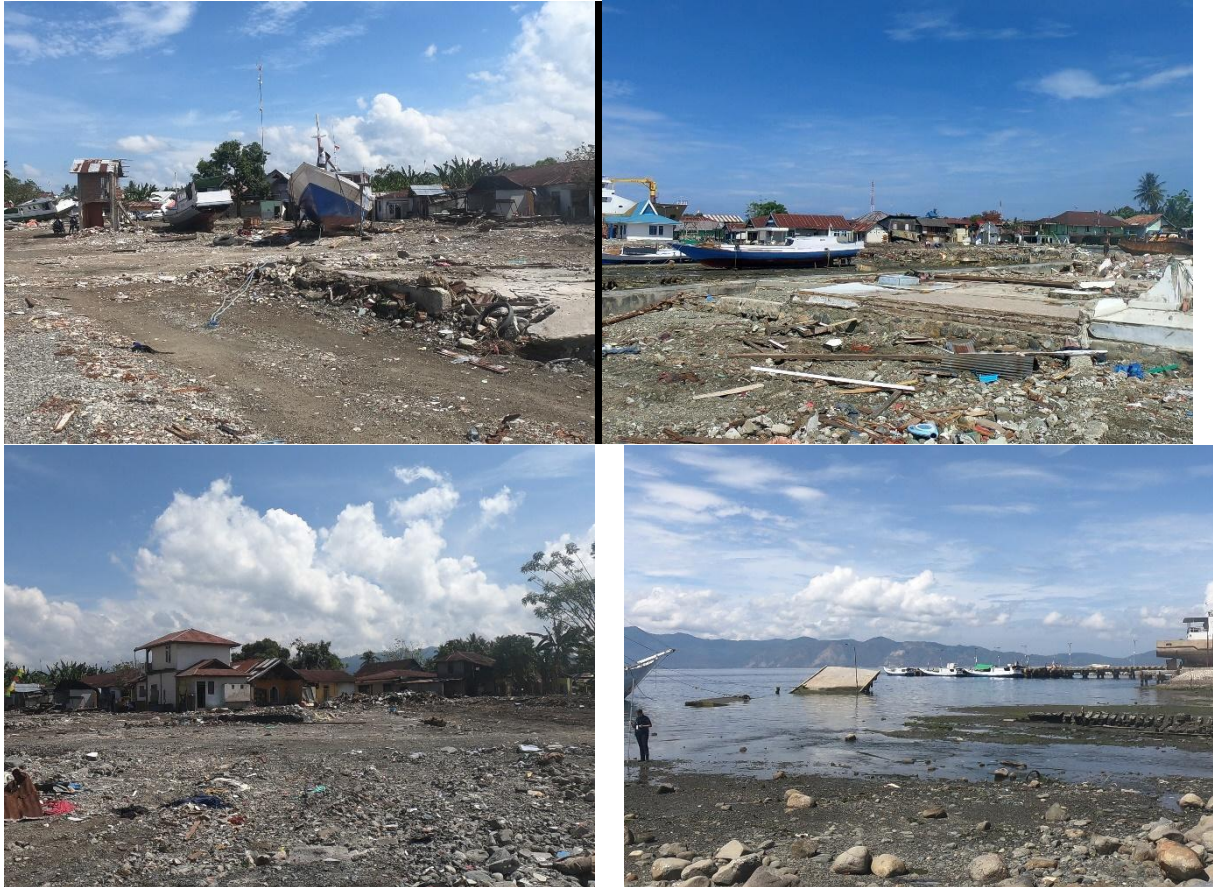
The measured runup height after detiding is 4.8m at this location according to the information obtained from eyewitnesses as well as traces observed.

Figure 3.22. Observed damage at Wani (Point E-09)

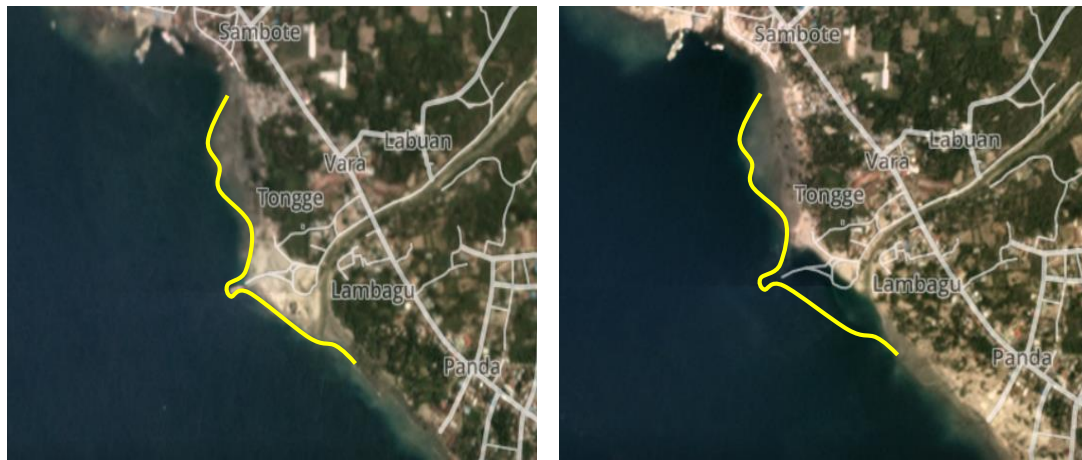
In this survey point (0.70137S 119.84438E) a landslide/coastal collapse is observed and can also be seen in satellite images before and after the event as given in Figure 3.24.

Figure 3.24 Satellite images before and after the event at Tongge region

Eyewitnesses stated that there was a coastal structure approximately 100m in length at this location which ships moored (Figure 3.24) and it has disappeared (went down to the sea) during the earthquake.

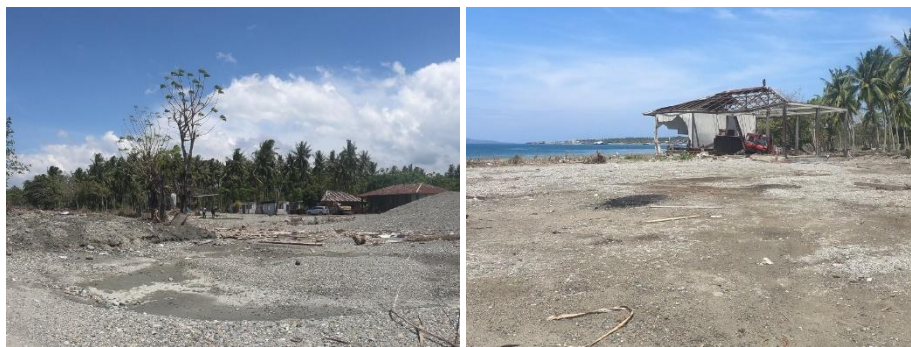
High damage was observed in Tongge region and according to the eyewitness reports, many people (they actually said as “all people”) died in this survey point. Figure 3.25 shows the damage and situation of the area at the time of the survey.

Figure 3.25. Observed damage at Tongge region (E-10)

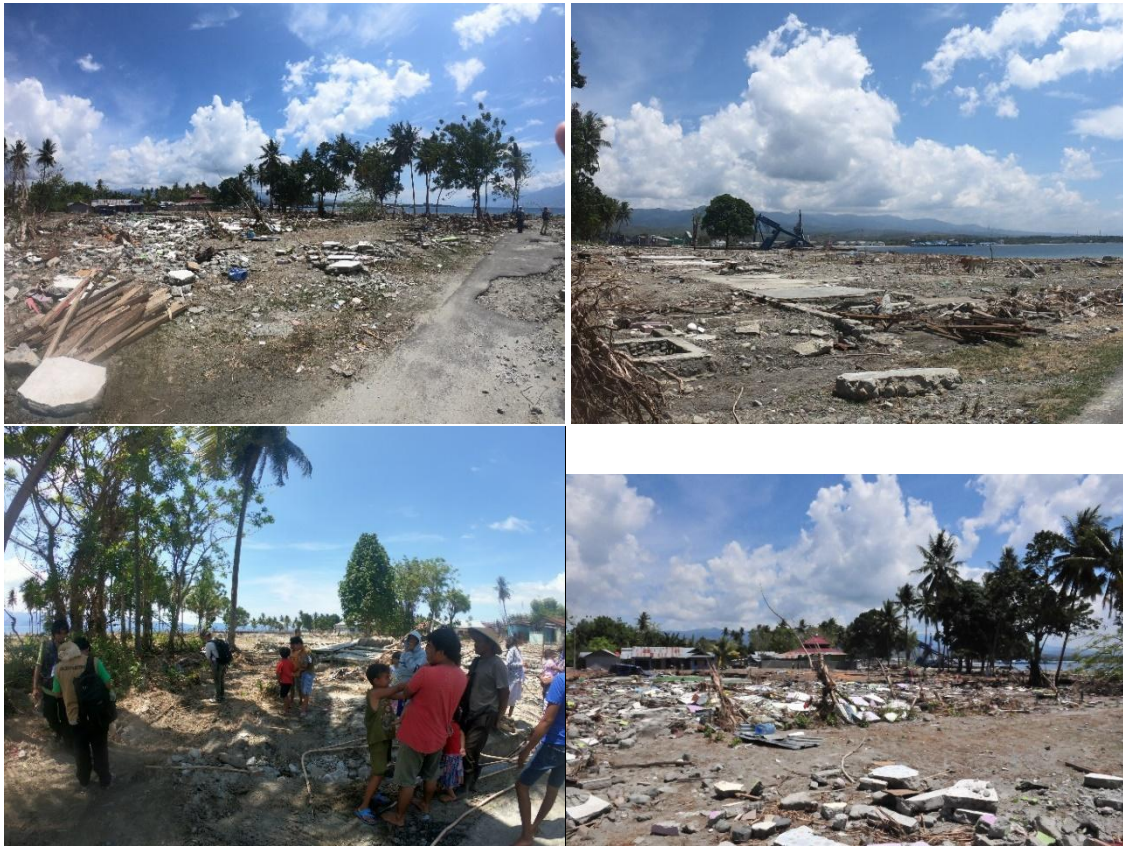
Point: E-11 Panda

The runup height is measured as 4.3m (after detiding) at this location (0.7072S 119.8520E) according to observations and tsunami traces. The eyewitnesses mentioned that the wave direction was from northern side and they estimated the loss of lives with more than 100 in this area. Figure 3.26 shows the observed damage in this surveyed area.

Figure 3.26. Observed damage at Panda (E-10)

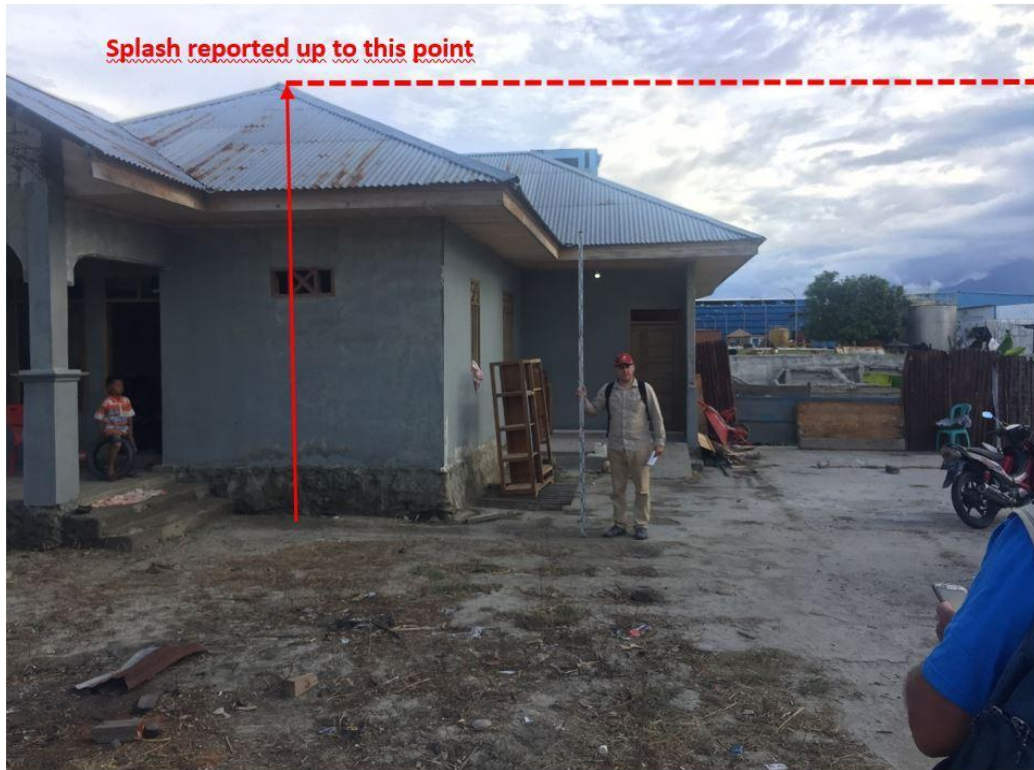
Point: E-13 South of Pantoloan

This survey point is near the northern side of a river mouth at the South of Pantoloan (0.7314S 119.8567E). The eyewitnesses reported that the waves reached the roof of the house shown in Figure 3.29. Therefore, the splash height is measured as 5.5m at this location. They also stated that houses were collapsed and damaged and even some of them were washed away by the tsunami. They reported two directions of the incident waves (one from Pantoloan (Northern) side and one from southern side).

Figure 3.29 The house eyewitnesses reported splash up to the roof (E-13)

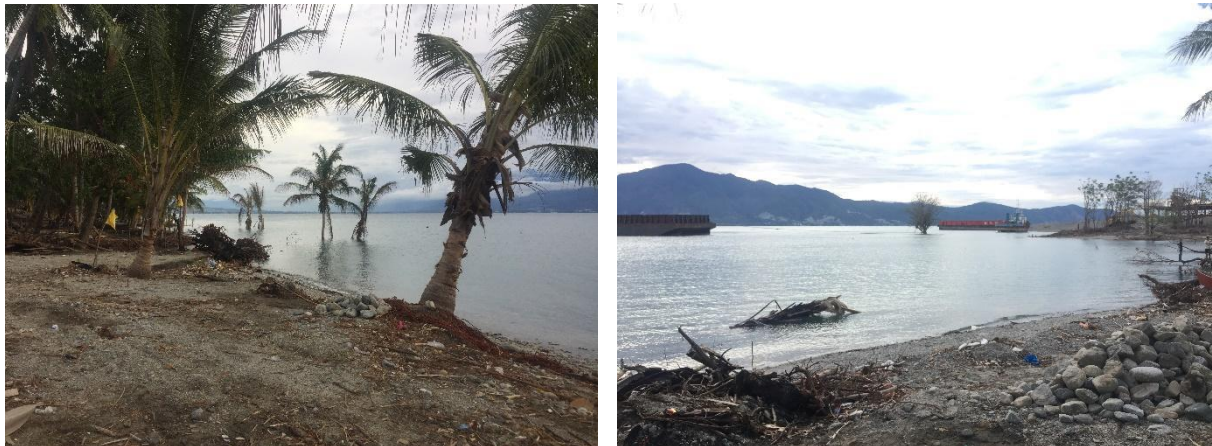
Point: E-14 Bamba

This survey point is at the southern side of the river mouth at Bamba region (0.7408S 119.8548E). The eyewitnesses reported that the first wave arrived to the coast 2-3 minutes after the earthquake. (Figure 3.30).

Figure 3.30 Observed coastal collapse/landslide phenomenon at Bamba region (E-14)

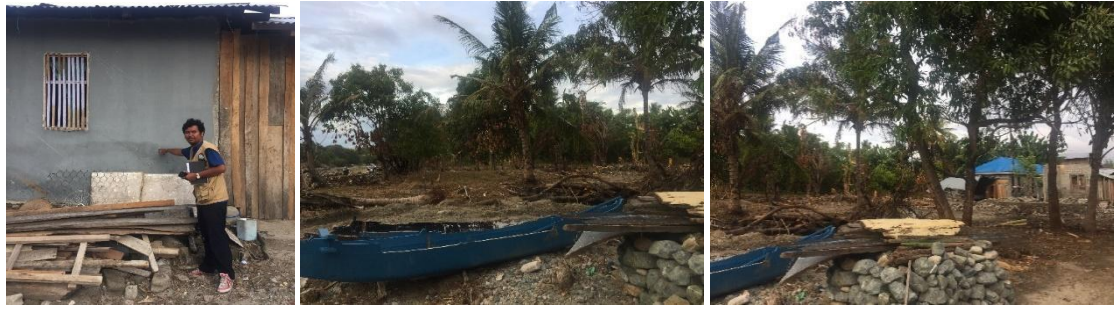
Point: E-15 Sambugan

The eyewitnesses at this survey point E-15 (0.7887S 119.86405E) reported that the wave came from the opposite side of the bay. The arrival of the first wave around 2 minutes after the earthquake according to a householder at this location. The flow depth is measured as 1.5m on the walls of this house as shown in Figure 3.31.

Figure 3.31. Water signs on the walls of a house at Sambugan and coastal damage (E-15)

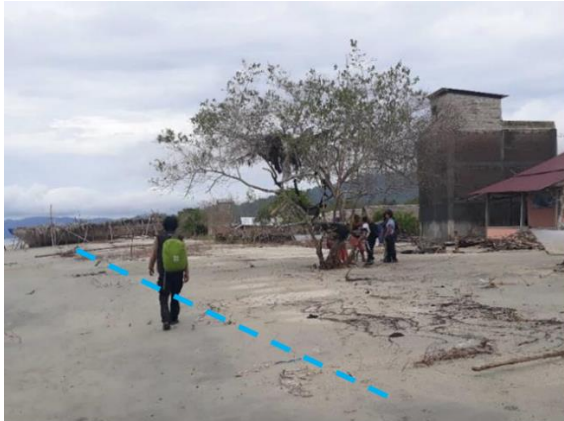
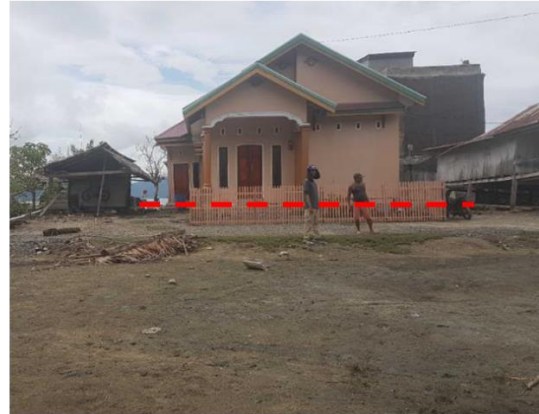
The variation of the sea level height has been measured: - 1.3 m (previous level: based on eyewitnesses reports; actual level: based on the trace on the external wall of the house)

Figure 3.34 Variation of the sea level height (left: Pre-EQ max tide level based on eyewitness's report; right: post-EQ max tide level, based on the trace on the external wall of the house)
