BIBLIOGRAPHIC REFERENCE

Cousins, W. J.; Power, W. L.; Palmer, N. G.; Reese, S.; Tejakusuma, I.; Nugrahadhi, S. 2006. South Java Tsunami of 17th July 2006, Reconnaissance Report, *GNS Science Report* 2006/33 p42.

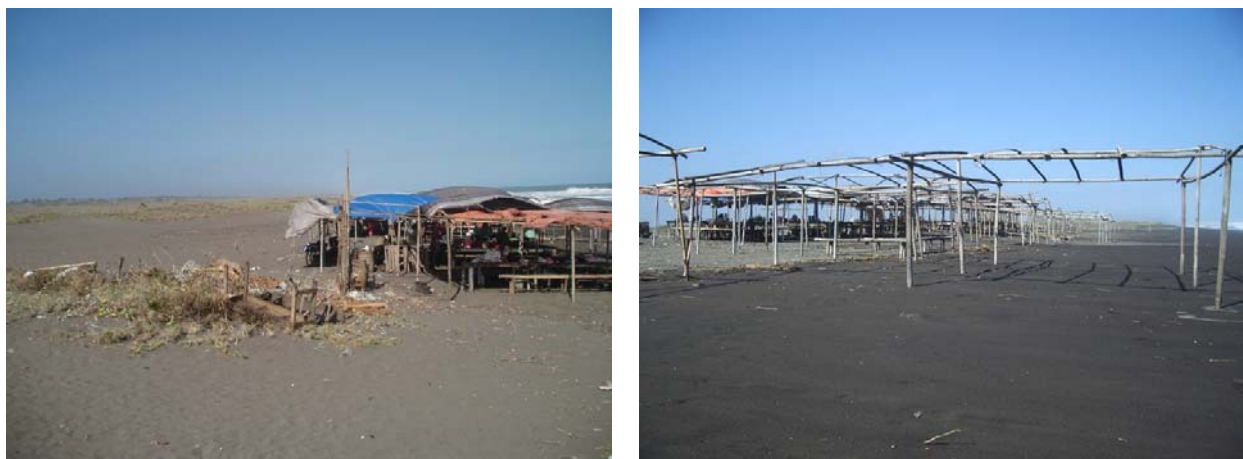
Figure 2.1.1 Semi-permanent shelters on Bulapesantren Beach.

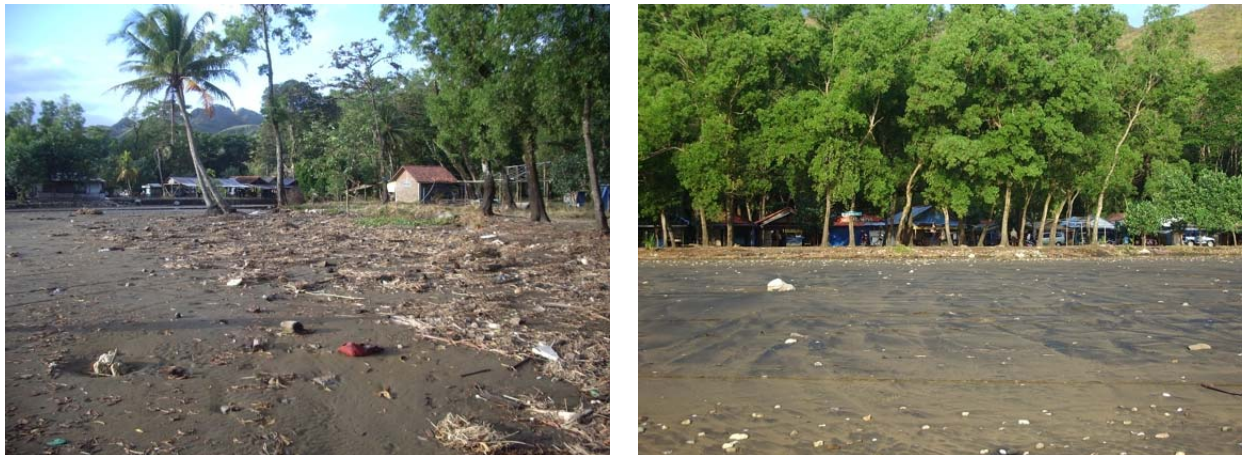
Figure 2.2.1 Semi-permanent buildings at Pantai Logending.

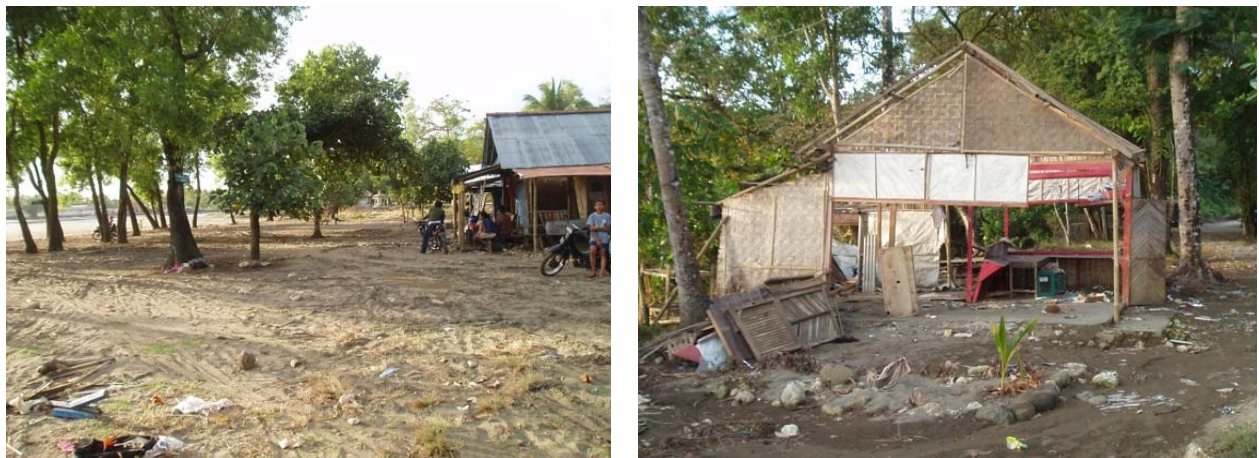
Figure 2.2.2 Typical damage to wooden buildings. A few were occupied, but most appeared to be vacant.

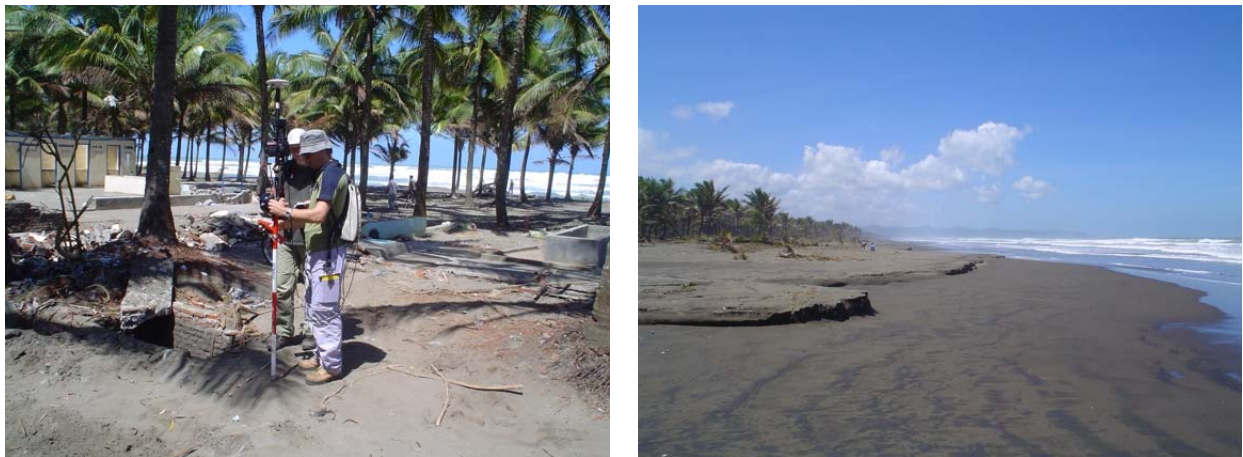
Figure 2.3.1 Overview of beach looking east (right image) and remains of brick buildings (left) at Widarapayung. Ground profile measurements were made here (Profile 1).

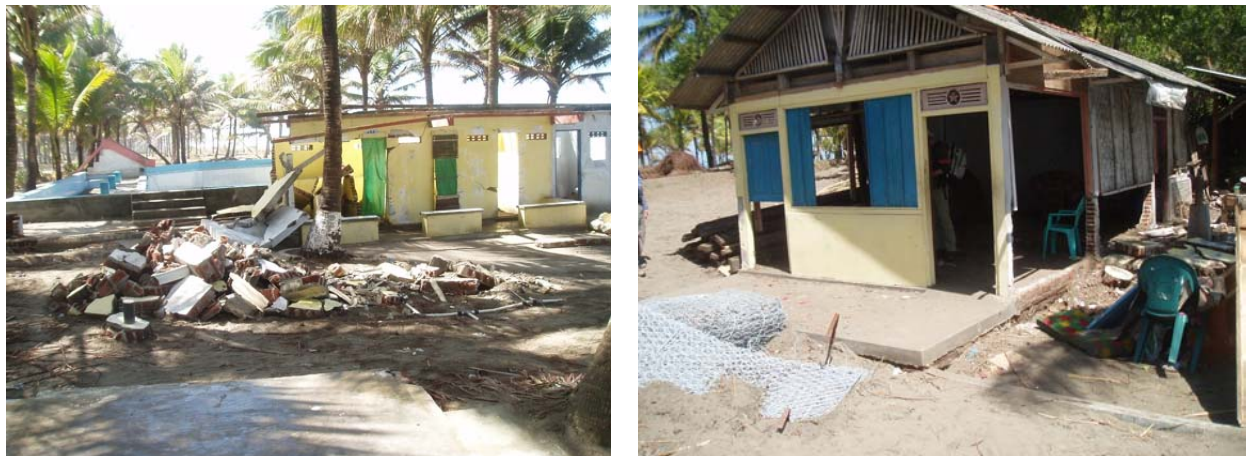
Figure 2.3.2 Remains of pools and nearby brick buildings about 50 m from the beach (left). The water depth was 3.5 m. The wooden building (right) appears to have been protected by sand ridges behind it. Sand marks on the inside of the walls indicated a depth of 1.5 m. The main structural damage was loss of windows and brick half-walls (700 mm high).

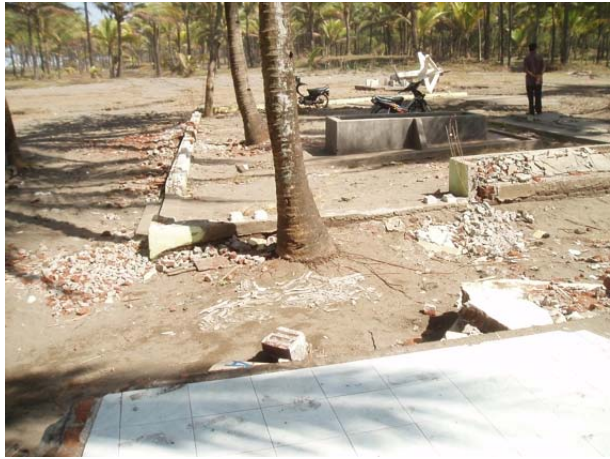
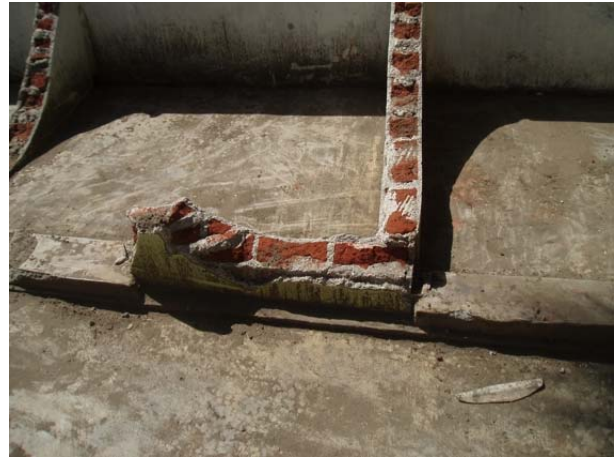
Figure 2.3.3 Foundations of brick buildings (left) and detail of wall construction (right).

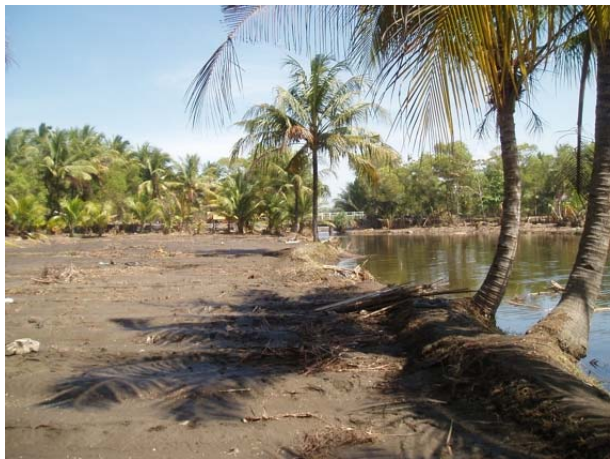
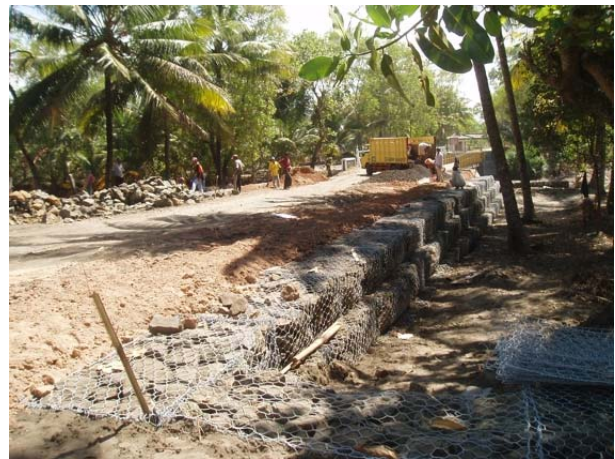
Figure 2.3.4 Silt covered paddy fields inland of main sand dune, bounded by river running parallel to coast (left). Just visible in the centre of the image is a bridge, the approaches to which were damaged by water draining away after the tsunami (right). The bridge itself appeared undamaged. The crops in the paddy fields had been covered by sandy silt and totally destroyed.

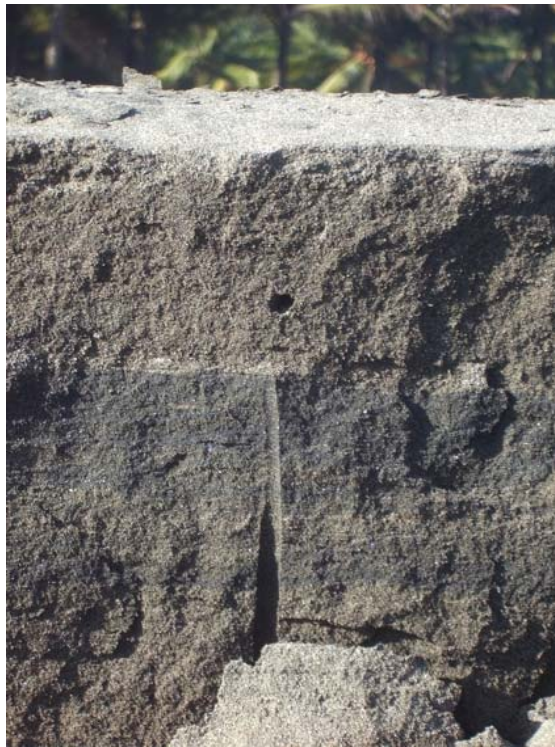
Figure 2.3.5 There were extensive new deposits of sand over the coastal dune and paddy fields immediately beyond it. Distinct layering could be seen in places.

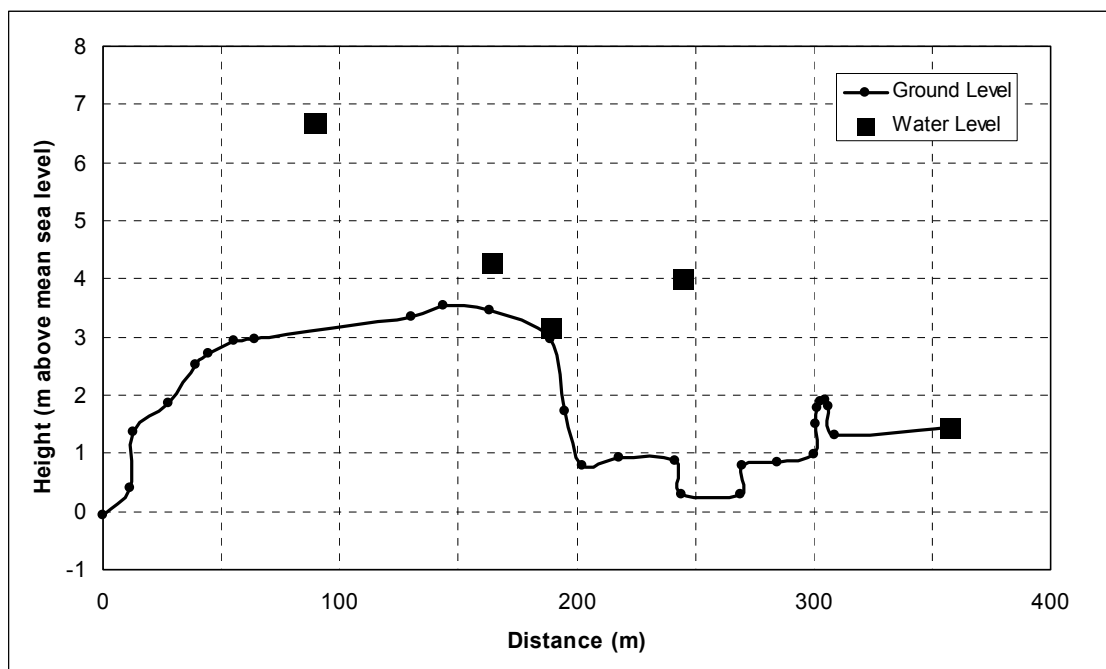
Figure 2.3.6 Ground profile 1, and estimated water levels at Widarapayung. Zero distance is the edge of the sea at the time of the profile measurement. At this location the beach was about 40 m wide. The water level estimate at 250m from the coast was from an eye witness account that the water reached the handrail on a bridge across the river behind the near-shore dune. It could have occurred during post-tsunami flood flow down the river rather than during the initial tsunami.

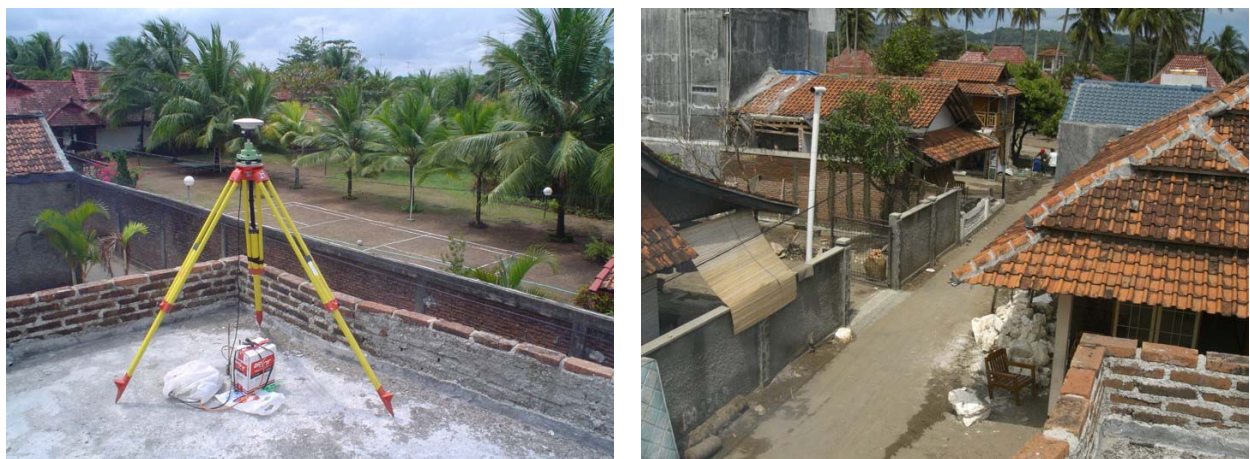
Figure 2.4.2 GPS base-station at Pangandaran (left), on the roof of a 1-storey brick house. The tsunami just reached our hotel which is at the top left of the image. The right hand image shows the view from the base-station roof towards the beach about 300 m away. Water depth in the alley was about 0.5 m, and damage to the nearby buildings was minor.

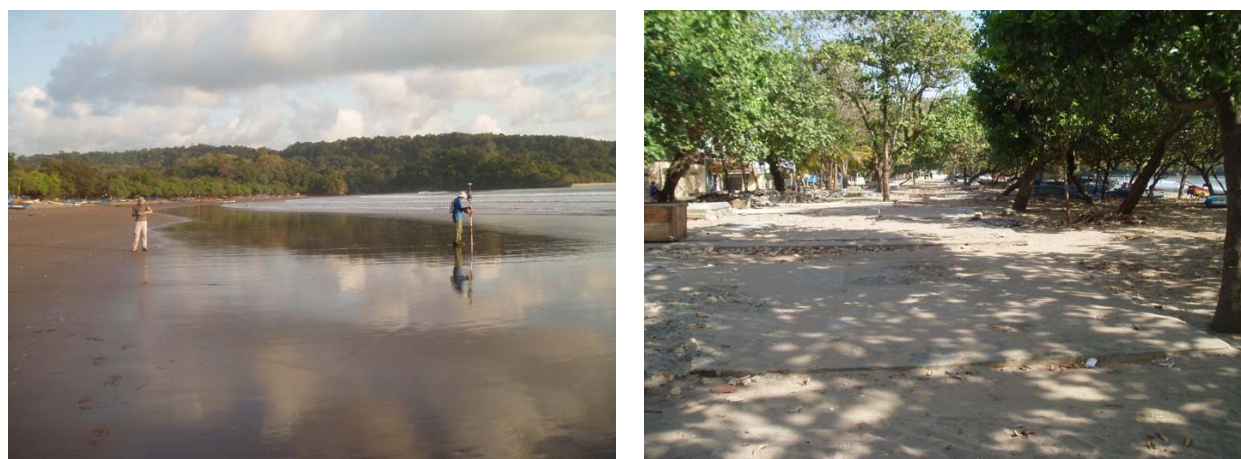
Figure 2.4.3 View south along the western beach of the Pangandaran Peninsula (left), to the forested hill which starts at the end of the sandy beach. The beach was gently sloping and terminated at a step of about 0.5 m. Along the peninsula the beach was bordered by trees, within which there used to be a row of timber-framed shops/stalls. All that remained (right image) were the concrete-pad foundations. The debris had been removed before our arrival. The buildings were probably similar to those shown in Figures 2.2.2 and 2.3.2 (right). The start of Profile 3 is shown in the left image, Profile 2 (and the right image) were closer to the hill.

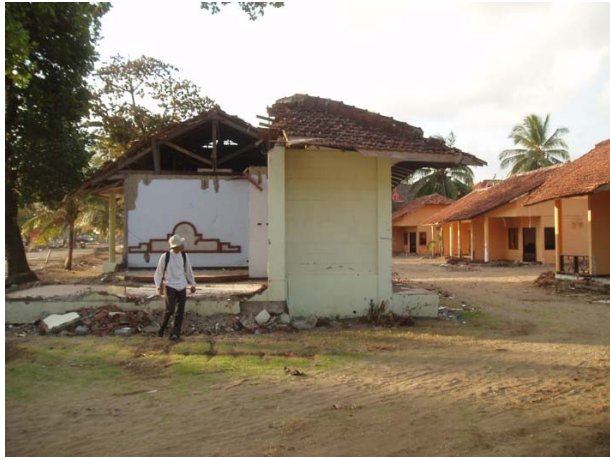
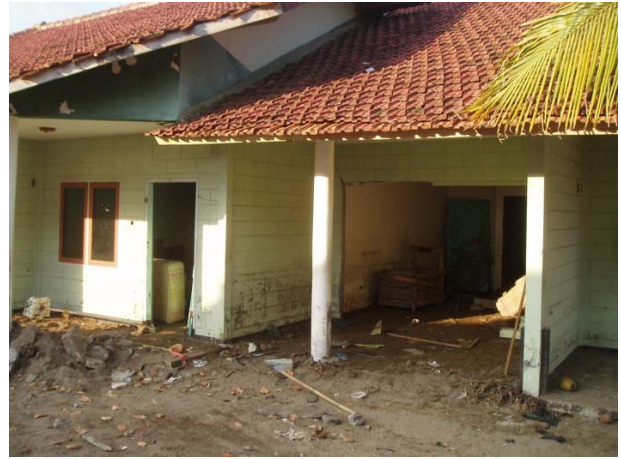
Figure 2.4.4 A group of relatively well-built tourist bungalows about 400 m from the hill and 25 - 90 m from the beach. There were no buildings between them and the coast. Those in the first row were heavily damaged (left image) (water depth about 2 m), while those in the third row (water depth < 1 m) had suffered little structural damage but were filled with sand and debris (right image). Ground Profile 3 was taken here. See also Appendix Figure A2.1.

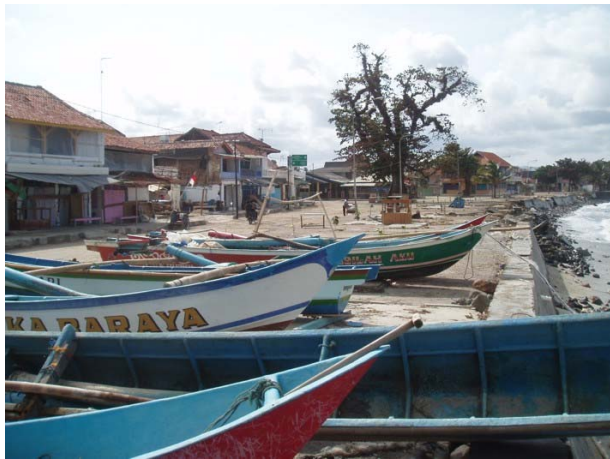
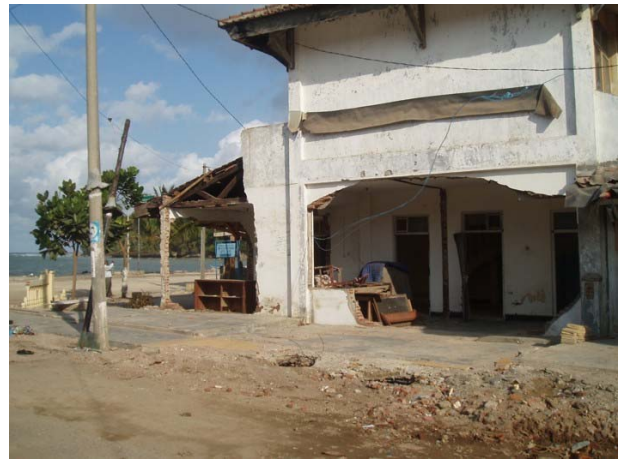
Figure 2.4.5 View north along the sea wall of the eastern beach of the Pangandaran peninsula (left image). Where the blue fishing boats are parked there used to be a row of timber-framed shops/kiosks. All had been destroyed. Many of the houses across the road had suffered moderate damage to the lower storeys. A few had been destroyed. Wall punch-out (right image) was common, but the concrete columns generally had survived and so collapse was rare. There were some instances of roof damage that could have resulted from tsunami “splash” effects.

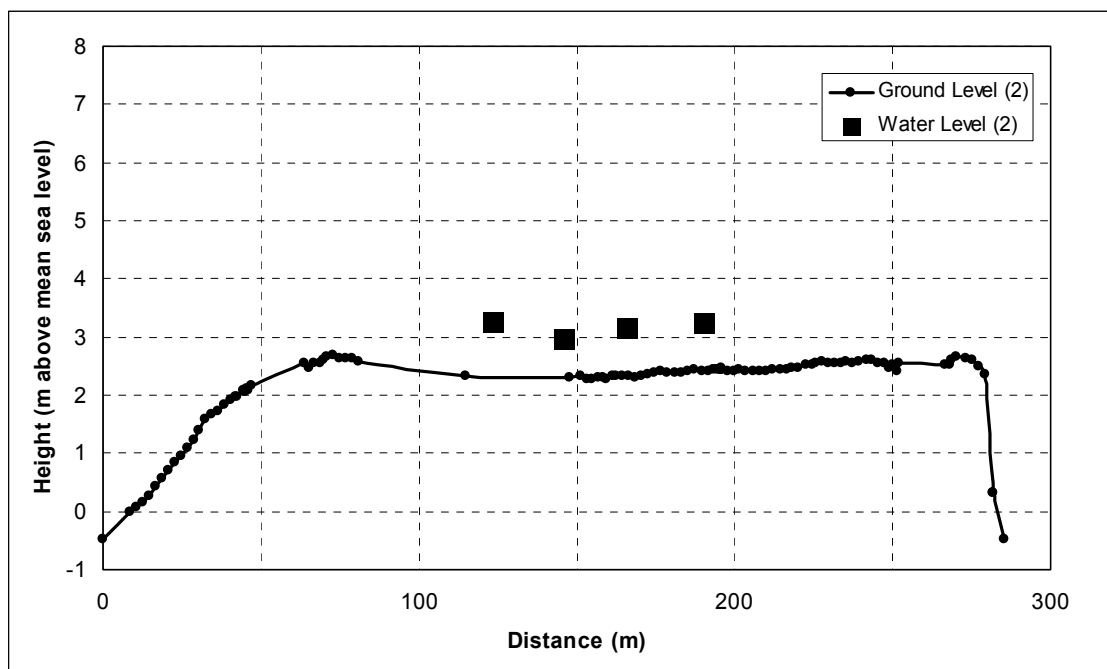
Figure 2.4.6 Ground profile 2 and estimated water levels on the Pangandaran Peninsula about 100 m north of the hill. The steep drop at the right-hand side is a sea wall. Wooden buildings adjacent to the beaches, at 70 m and 270 m (water depths probably c. 2m), were destroyed (e.g. Figure 2.4.3). Damage in the central part of the peninsula, 120 to 200 m, was minimal.

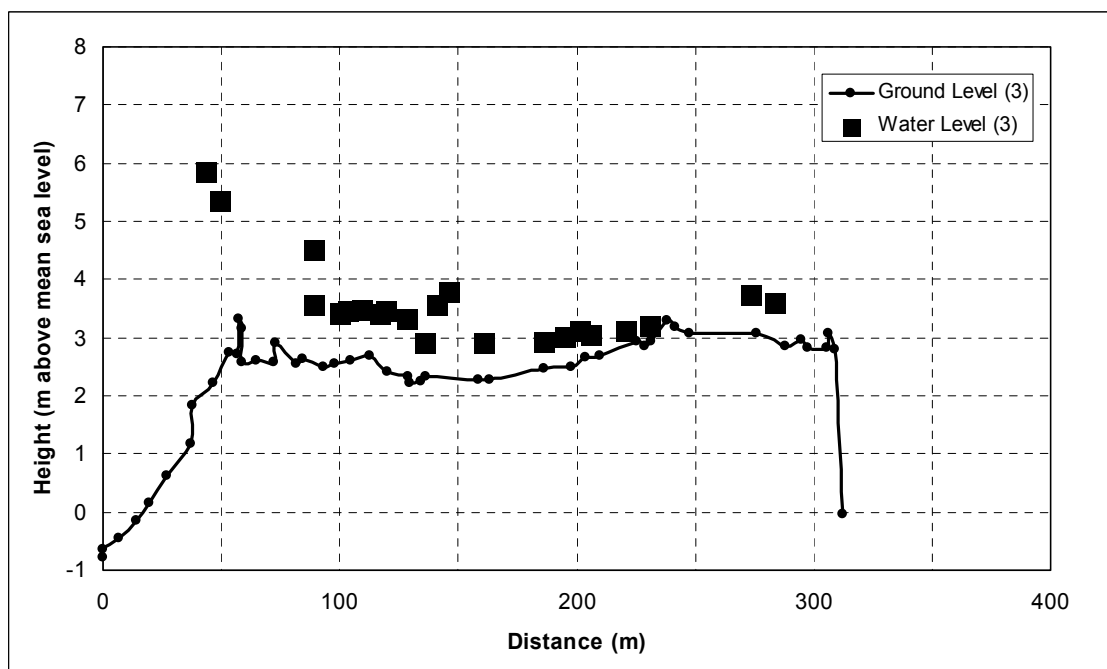
Figure 2.4.7 Ground profile 3 and estimated water levels on the Pangandaran Peninsula about 400 m north of the hill. The two points at 50 m were taken at a life-guard station at the edge of the beach. The vertical step at 60 m was a wall.

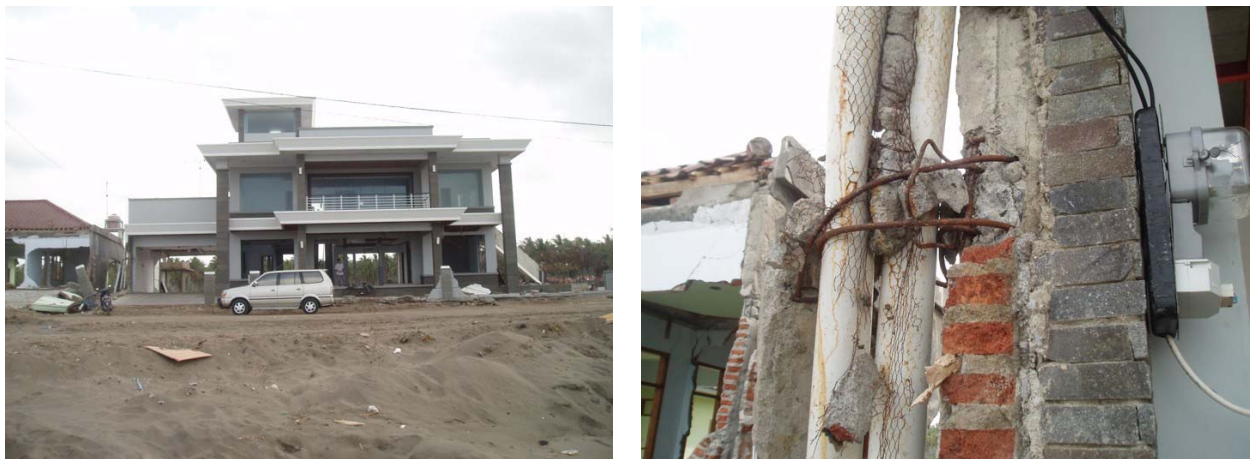
Figure 2.5.1 One of three luxury villas close to the beach, viewed from the beach. It was very strongly built, with reinforced-concrete columns (c. 250 mm x 250mm), beams and floors, and walls of plastered brick infill. The reinforcement was 12 mm smooth bars, possibly 6 per column (bars were visible in one broken fence post), with stirrups at about 250 mm spacing. Damage was restricted to the loss of ground floor windows/walls that had been perpendicular to the direction of flow, the loss of most of the ground floor ceilings, collapse of concrete fences, and collapse of one balcony. The ceiling damage suggested the water had reached at least to the ceiling level. Ground Profile 11 was taken here.

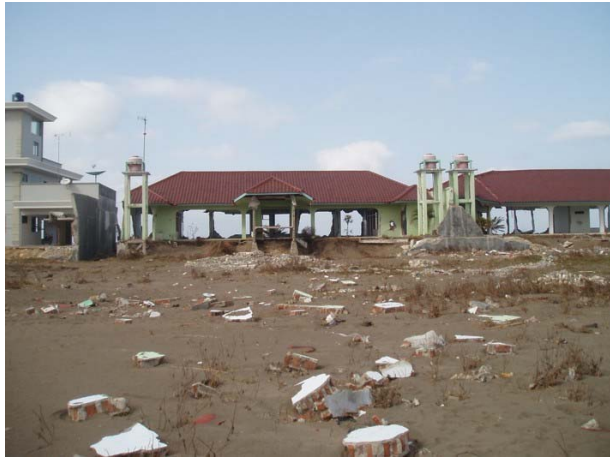
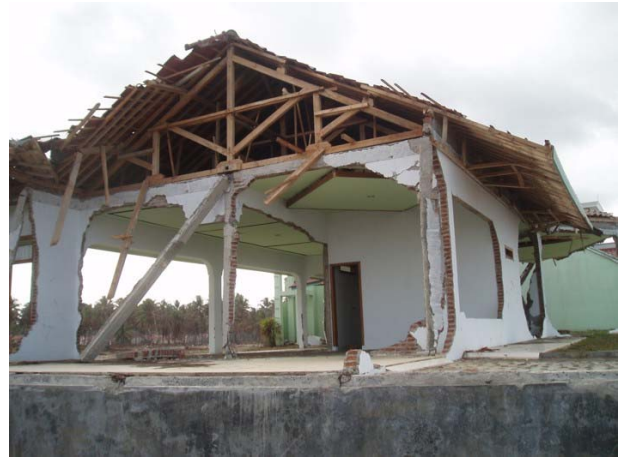
Figure 2.5.2 Two relatively well-made villas adjacent to the grey villa shown in Figure 2.5.1. The construction was reinforced-concrete columns and beams with plastered brick infill. Columns were c. 100 mm x 100 mm and reinforcement was c. 8 mm smooth bar. The roof structure was bolted timber, clad with clay tiles. The left image is the view towards the beach and shows the debris field inland of the villas, and the right image the western end of the villas where two rooms appear to have been torn off. Four water storage tanks are visible in the left image, one (black) on top of the grey villa, and three on stands at the ends of the green houses.

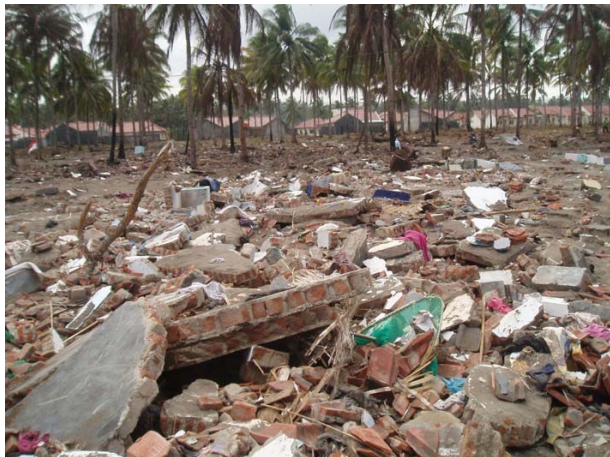
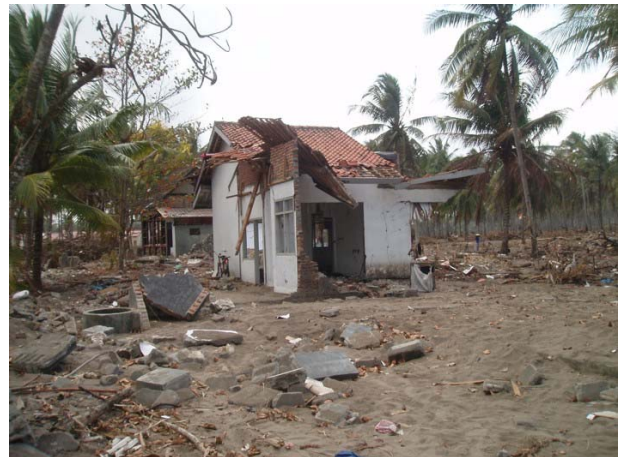
Figure 2.5.3 The remains of older brick houses. The construction was brick, probably without concrete columns and beams. Most had been demolished. There were a few partially intact (right image), and a very few that were largely undamaged. In the left image some of the more modern and undamaged brick houses are visible behind a belt of coconut palms. Ground Profile 10 was taken here.

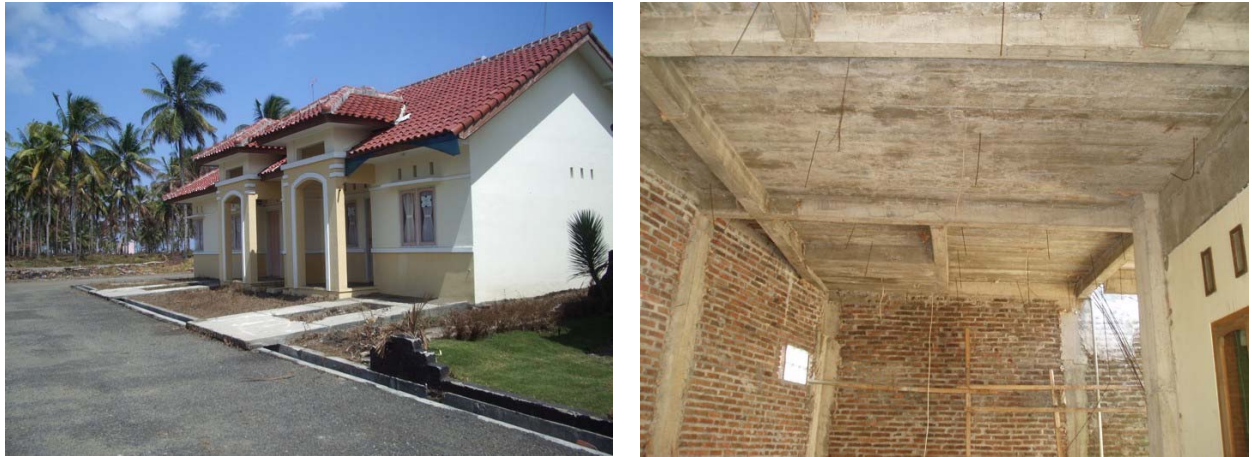
Figure 2.5.4 One of a group of about 60 very similar and relatively modern, well built, brick houses, exterior view (left) and garage interior view (right). A combination of strong construction and low water depth meant that damage was minimal. Ground Profile 10 passed through here.

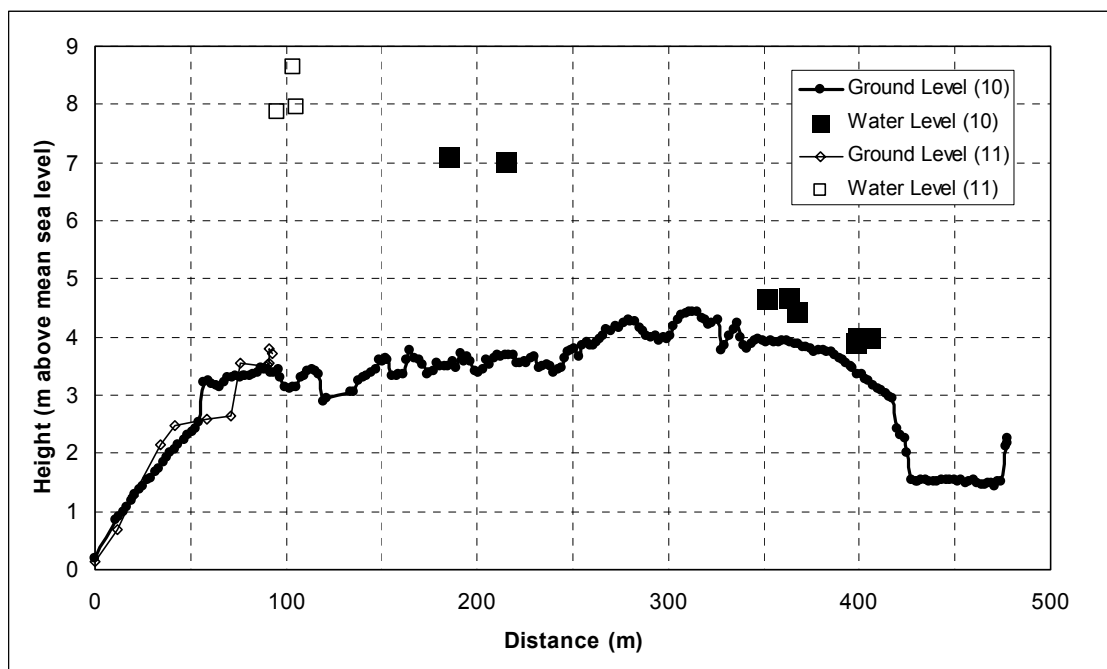
Figure 2.5.5 Ground profiles 10 and 11 and estimated water levels (10) through Cikembulan village and (11) in front of the luxury villa (Figure 2.5.1). The two profiles were about 100 m apart.

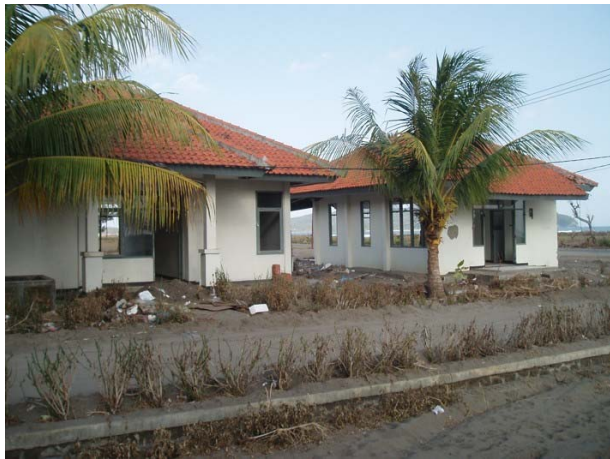
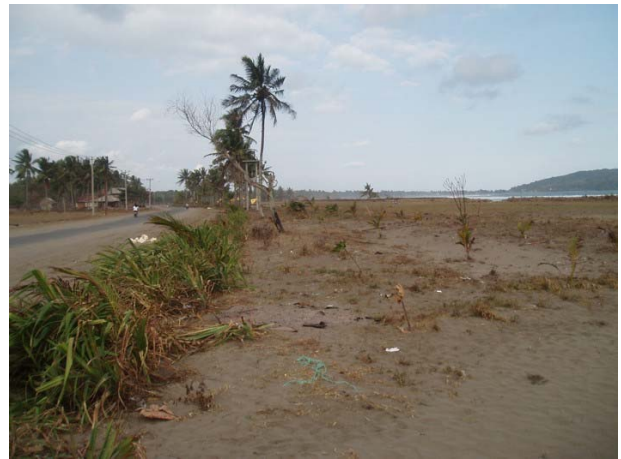
Figure 2.5.6 Houses (left) immediately across the road from the beach (right) at Wonoharjo Orphanage. The house closest to the beach had lost about one third of its wall area, most of which occurred in a wall perpendicular to the beach. There was extensive tile loss on the seaward side, but this was not a reliable indicator of water depth because of the likelihood of upwards splash against the seaward wall. There were no palm trees between the road and the sea. Ground Profile 9 was taken here.

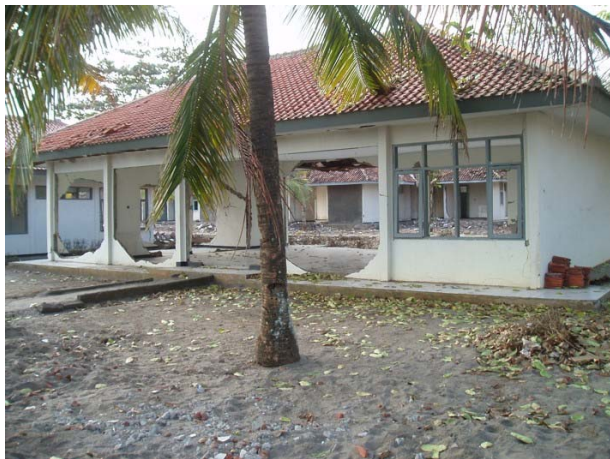
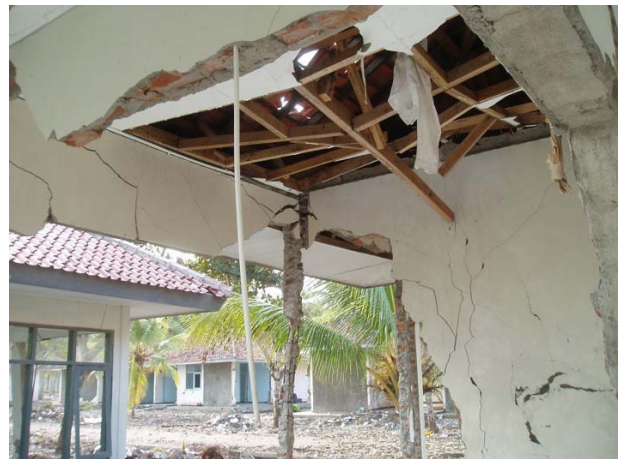
Figure 2.5.7 A (probable) classroom, separated from the road by a 30 m wide paved area. About 50% of its wall area (mostly windows) had been punched out and there was significant ceiling damage (right).

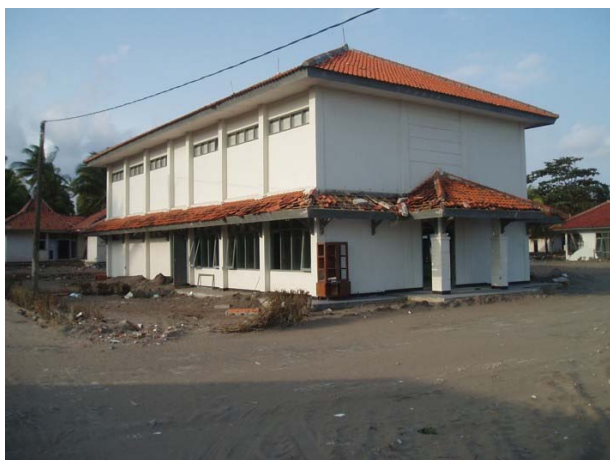
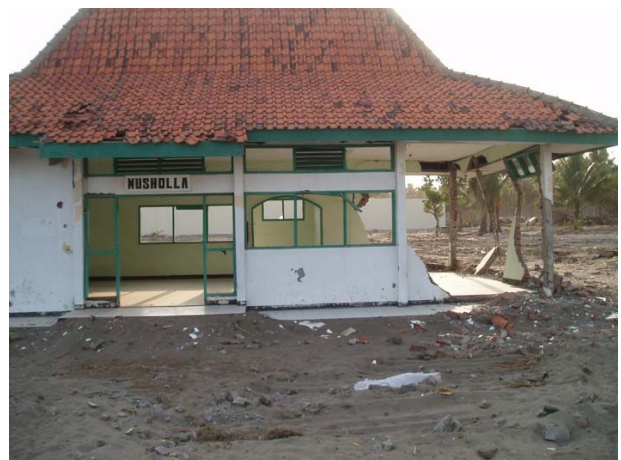
Figure 2.5.8 Gymnasium with minimal damage (left) and chapel with rear wall damage (right).

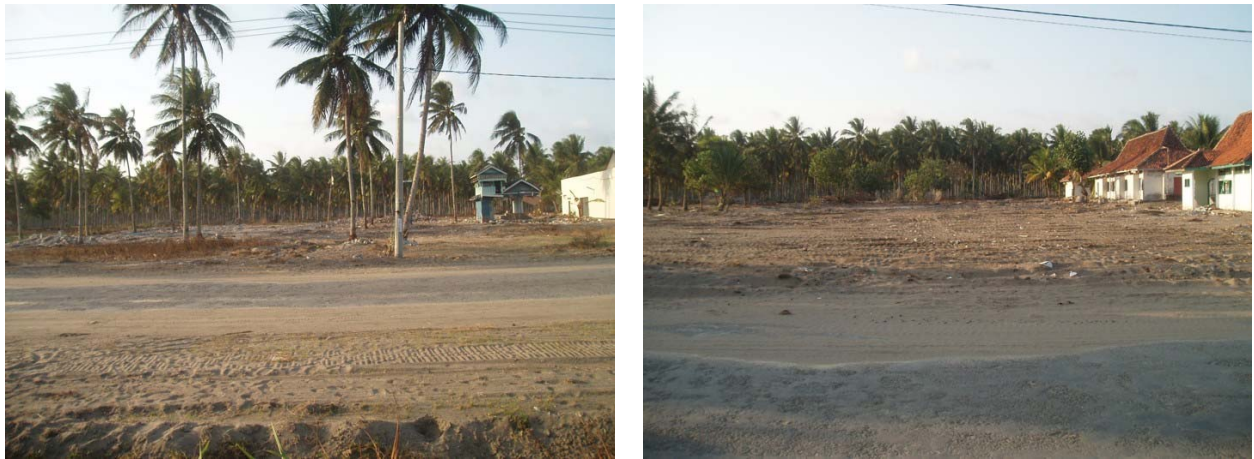
Figure 2.5.9 Sites of what presumably had been brick houses, in the vicinity of Wonoharjo Orphanage. The area had been cleared by bulldozing before our visit. Orphanage buildings are visible in the right image.

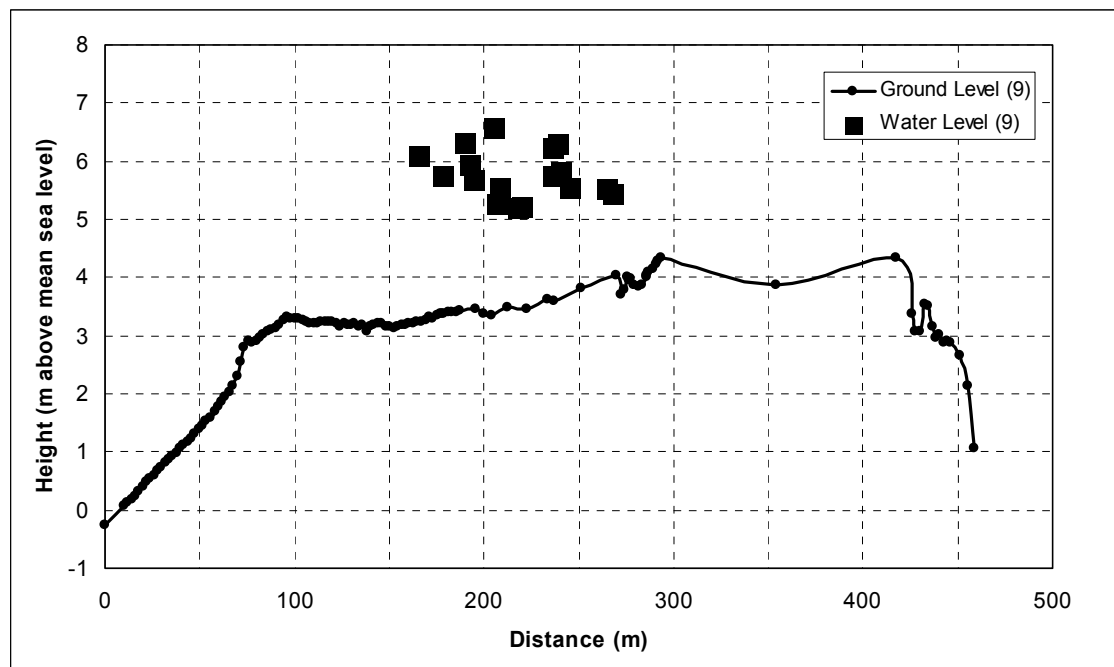
Figure 2.5.10 Ground profile 9 and estimated water levels through the Wonoharjo Orphanage. One reason for the apparent scatter in the water levels is that some of the buildings at 200 to 250 m were partly shielded by other buildings between them and the sea. This was reflected in reduced damage levels in the shielded buildings.

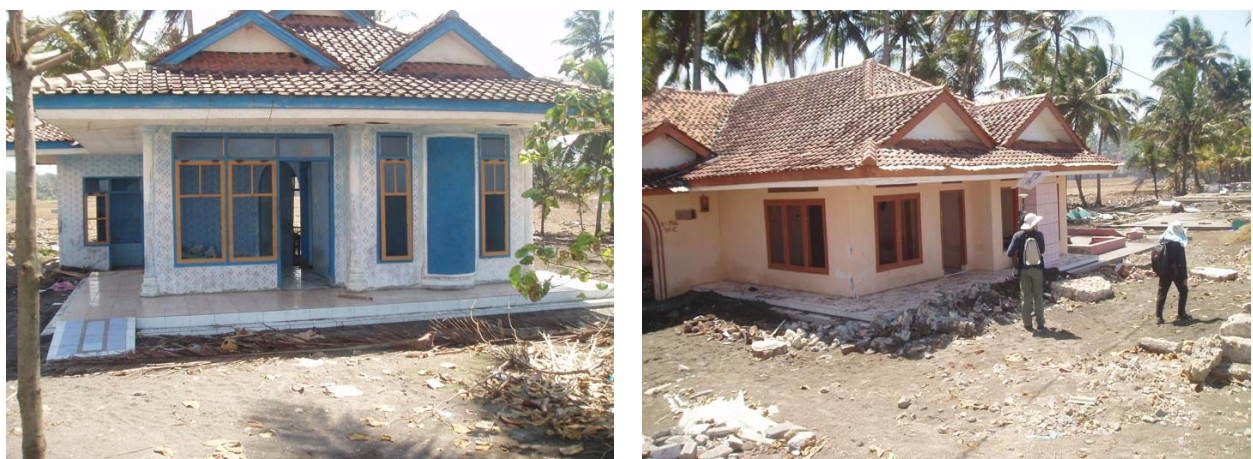
Figure 2.6.2 Relatively lightly damaged houses. Both had many broken windows (but not all) and had lost large portions of the rear walls. Both were brick. The blue one (left) had relatively substantial columns, presumably of reinforced concrete.

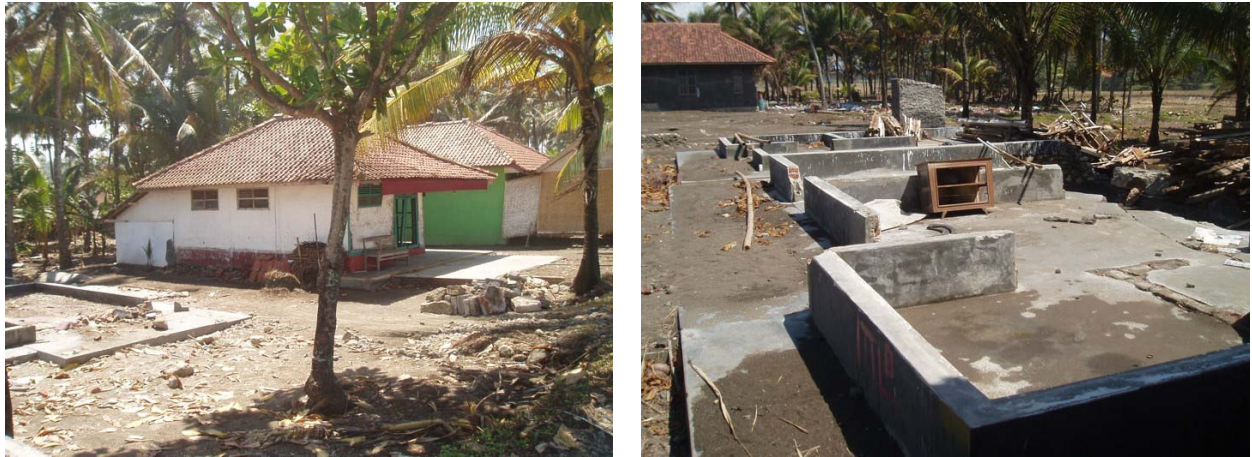
Figure 2.6.3 Moderately heavily damaged wooden house (left). Some walls were distorted, and the rear brick wall had been punched out. Other wooden houses had been totally destroyed (right) with just the concrete foundations remaining.

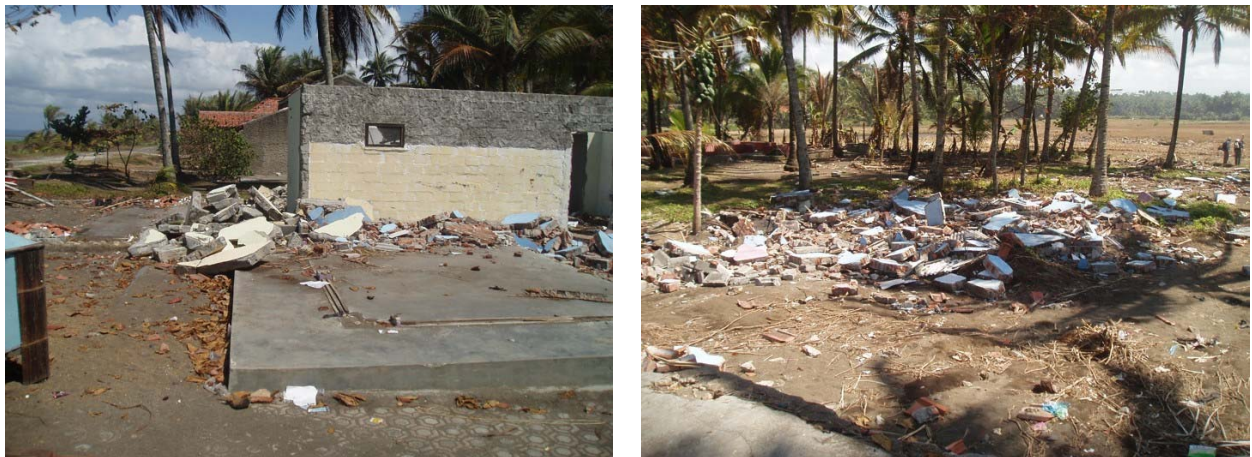
Figure 2.6.4 Foundation pad of a destroyed wooden house (left), partly covered by the remains of destroyed brick houses that had been between it and the sea. The road along the crest of the ridge is visible in the top left corner. To the right of the concrete pad were further remains of brick houses (right). Paddy fields inland of the ridge are visible in the upper right of the image. Some of the rice crop was being salvaged.

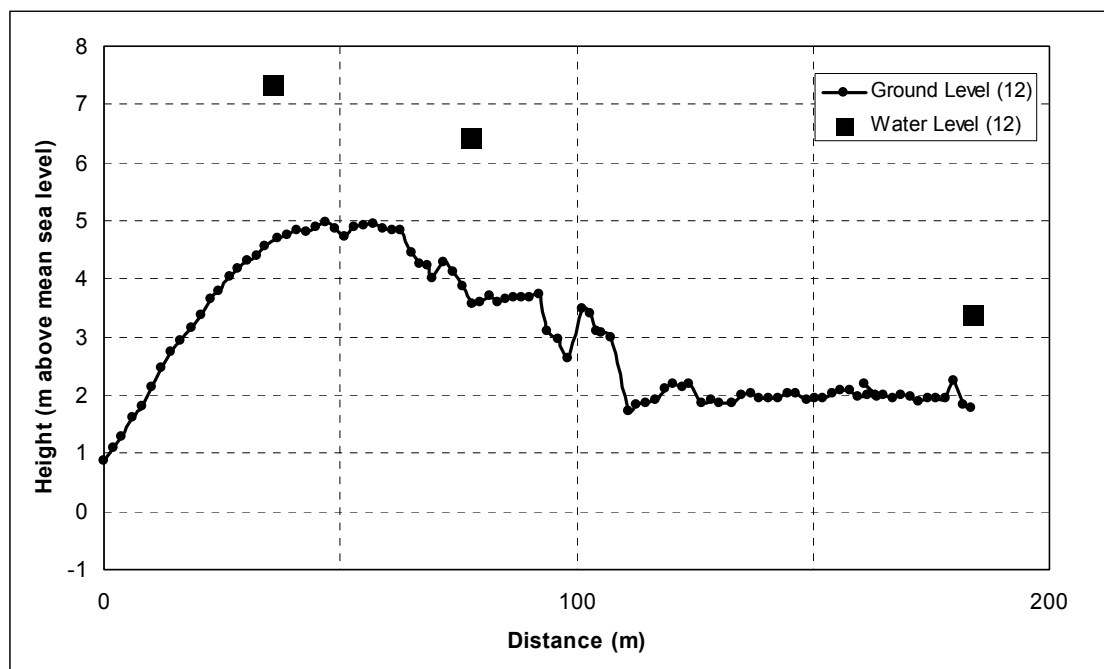
Figure 2.6.5 Ground profile and estimated water levels at the eastern end of Batuhiu. The road is near the crest of the ridge at about the 60 m mark. From the road the ground slopes down to about 3 m elevation, then falls steeply to paddy fields at 2 m elevation.

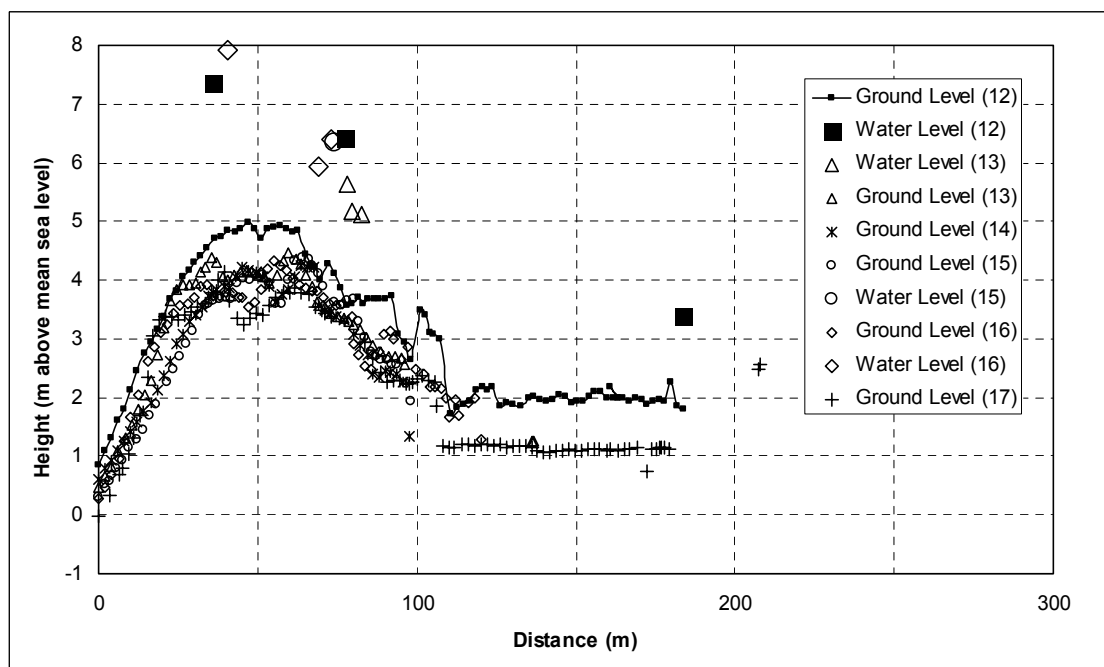
Figure 2.6.6 Ground profiles 12 -17 and water levels throughout Batuhiu. Profile 12 was at the easternmost end, profile 17 at the westernmost. There was a steady decrease in height of the ridge crest from east to west, by about 1 m. Profile 12 traversed the dune then crossed paddy fields to an “island” (Figure A2.3, p 37), while profile 17 traversed the coastal dune then paralleled a road through the paddy fields. The remaining profiles terminated at the inland edge of the coastal dune.

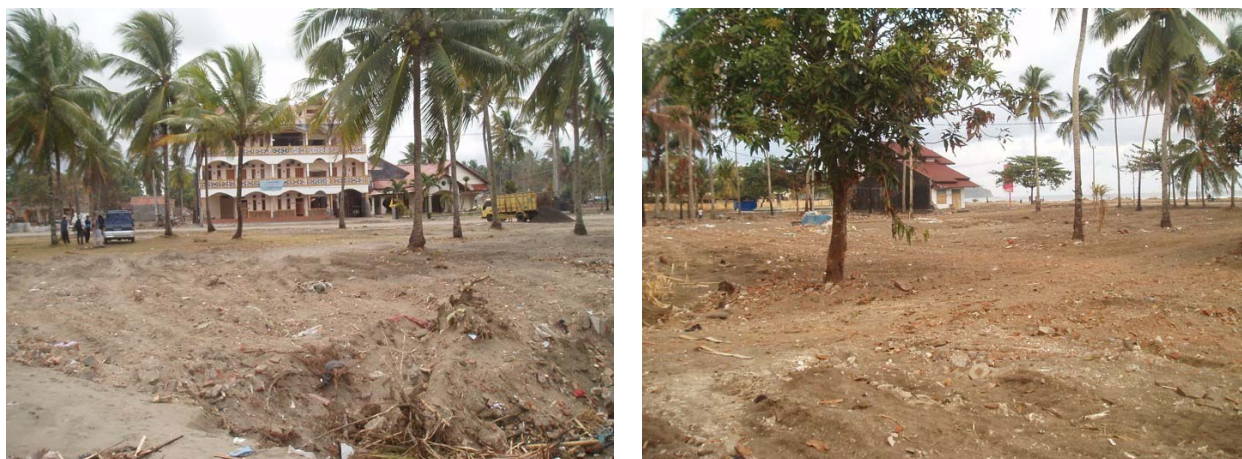
Figure 2.6.7 Hawaii Beach Hotel viewed from the beach (left). It was a well-built reinforced-concrete three-storey structure (columns and floors) with brick infill walls. Damage was restricted to punch-out of a few ground-floor walls and some ceiling damage. A few other well-built buildings in the area also had survived, but the majority of buildings had been destroyed. Part of the area had been bulldozed clear before our visit (right). Ground Profile 8 was taken here. The water depth was c. 3.5 - 4 m above ground level.

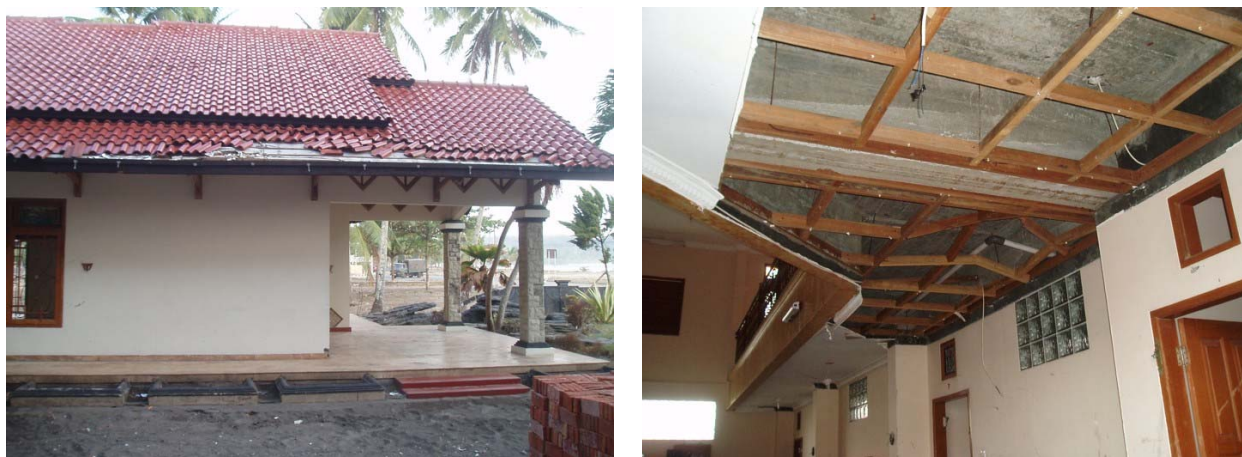
Figure 2.6.8 Tile damage on a house adjacent to the Hawaii Beach Hotel (left) (the house is visible in Figure 2.6.4 left). The roof eaves were fully sarked with timber (minimising splash effects) and so the tile damage is likely to be a good indicator of flow depth. Ceiling damage in the Hawaii Beach Hotel (right) indicated a similar flow depth.

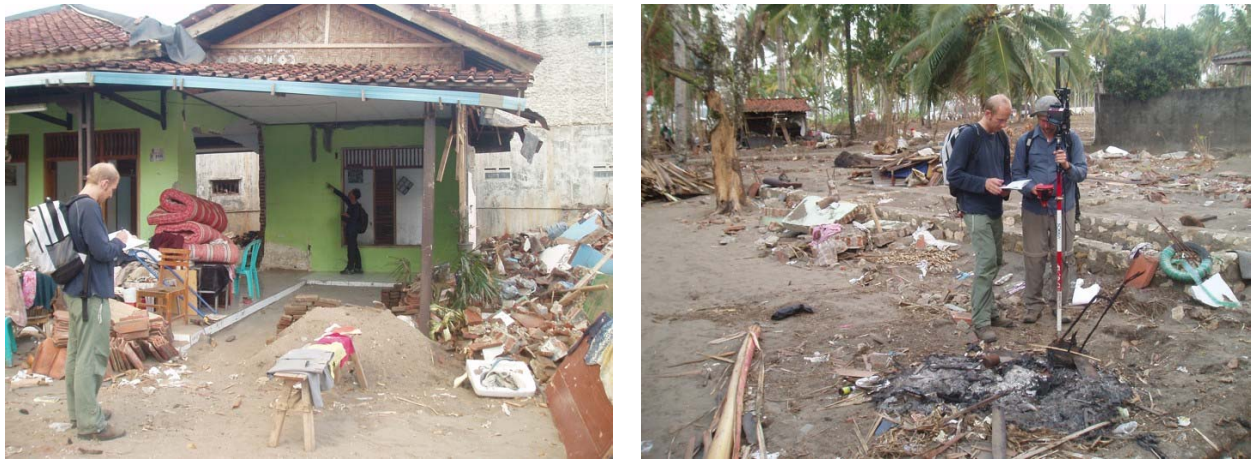
Figure 2.6.9 A brick house immediately behind the Hawaii Beach Hotel was badly damaged (left), but had not collapsed, whereas other houses just a few metres away had been destroyed (right). Presumably the survivor had been shielded by the Hawaii Beach Hotel and another strong three-storey hotel visible behind it. Ground Profile 8.
