BIBLIOGRAPHIC REFERENCE

Cousins, W. J.; Power, W. L.; Palmer, N. G.; Reese, S.; Tejakusuma, I.; Nugrahadhi, S. 2006. South Java Tsunami of 17th July 2006, Reconnaissance Report, *GNS Science Report* 2006/33 p42.

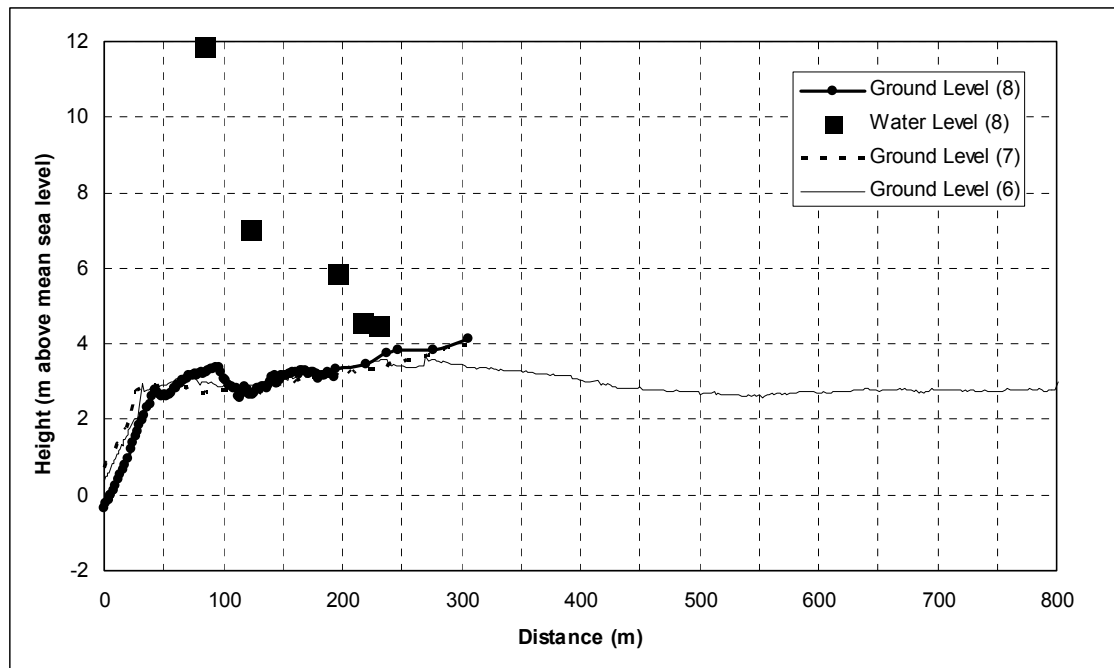
Figure 2.6.10 Ground profiles and estimated water levels through Pananjung Village. Profile 8 was just west of the Hawaii Beach Hotel, profile 6 was along a main highway approximately 200 m east of the hotel, and profile 7 was between the two. The water height of 12 m (above mean sea level – depth about 9 m above ground level) was an observation made by the manager of the Hawaii Beach Hotel in relation to palm trees between the hotel and the sea. It is much higher than all other estimates and so, assuming that it is as reliable as the others, must have been a localised phenomenon.

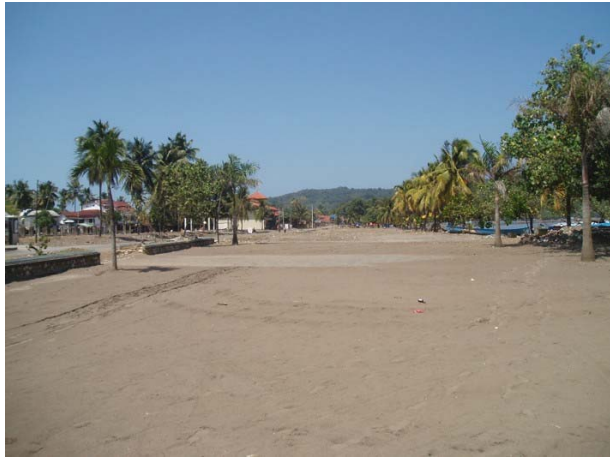
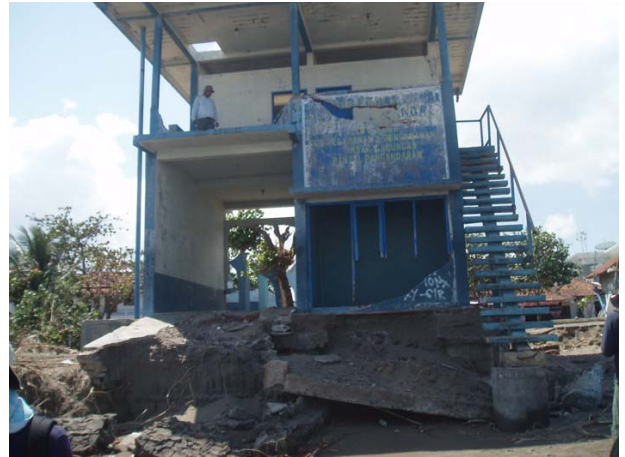
Figure 2.7.1 Site of a row of semi-permanent shops along the western beach of Pangandaran Village (left). All that remained were the concrete foundation pads. Image at the right shows a lifeguard station at the same location. There was considerable damage to the low wall of the upper storey – more than seemed reasonable for water pressure alone. Impact by fishing boats (Figure 2.4.5) carried by the tsunami wave was a probable cause.

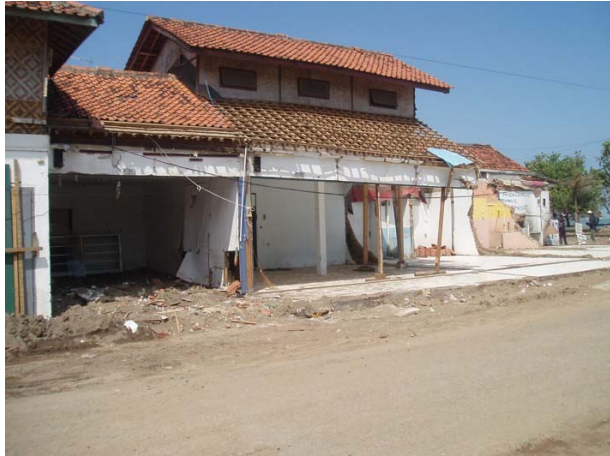
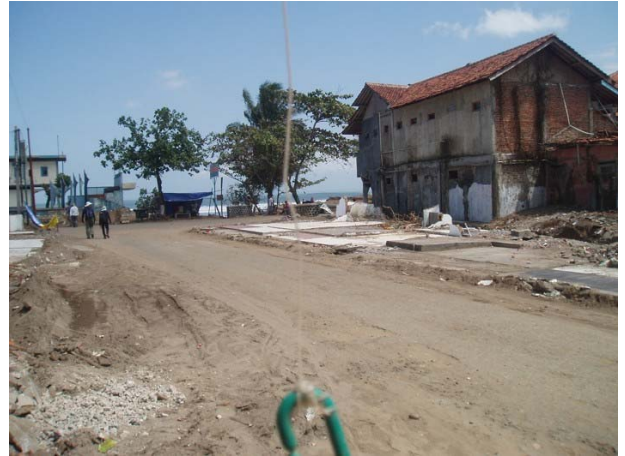
Figure 2.7.2 Near the sea end of profile 4. Buildings adjacent to the street had been destroyed, but others equally close to the sea had survived apparently with minor damage only. The water depth was about 2.5 m.

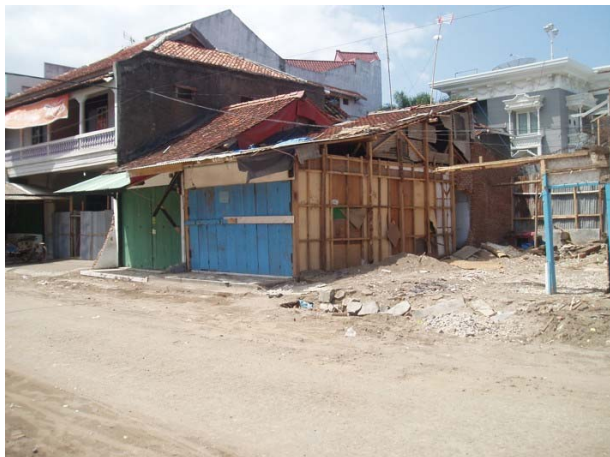
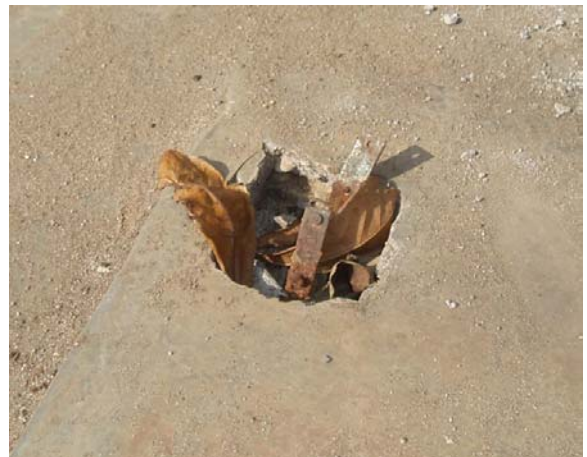
Figure 2.7.3 A mix of timber and brick buildings adjacent to those of Figure 2.6.2 (left). Hold-down detail for post of wooden shop (right).

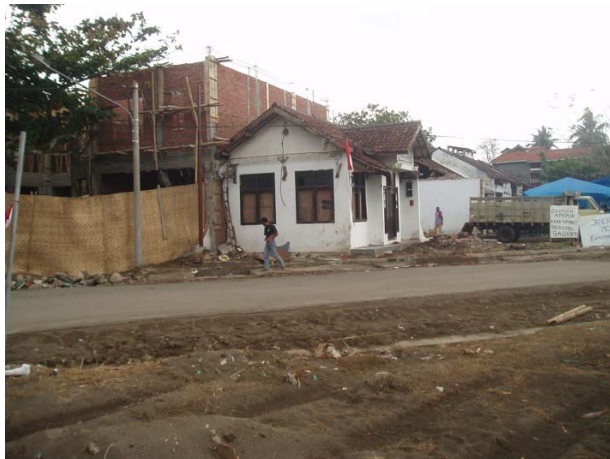
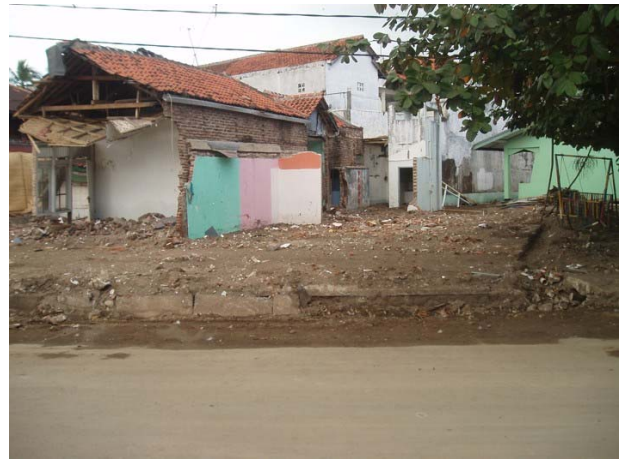
Figure 2.7.4 Pangandaran village – buildings about 120 m from the sea on profile 5. Buildings with reinforced concrete columns had suffered much less damage than those without. The two-storey building in the left image was under construction. Note the upright power pole in front of it. Damage to poles was rare.

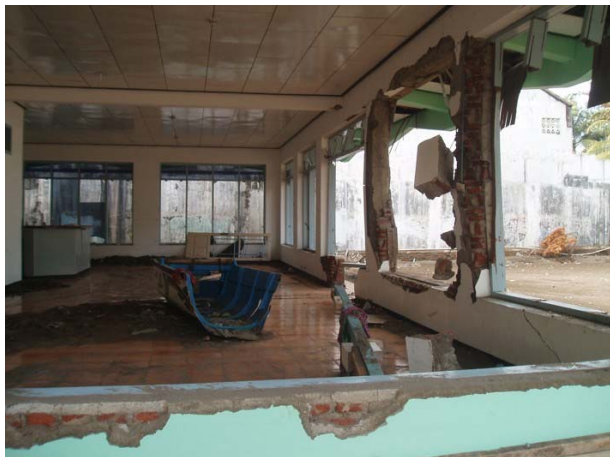
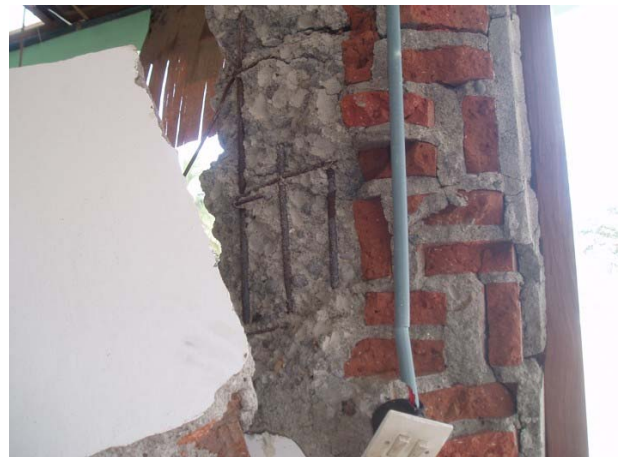
Figure 2.7.5 Interior of a well-constructed hotel (left) and column detail (right). The worst structural damage, the minor buckling of two columns, appeared to have been caused by boat impact. The remains of the boat were in the foyer of the hotel (left).

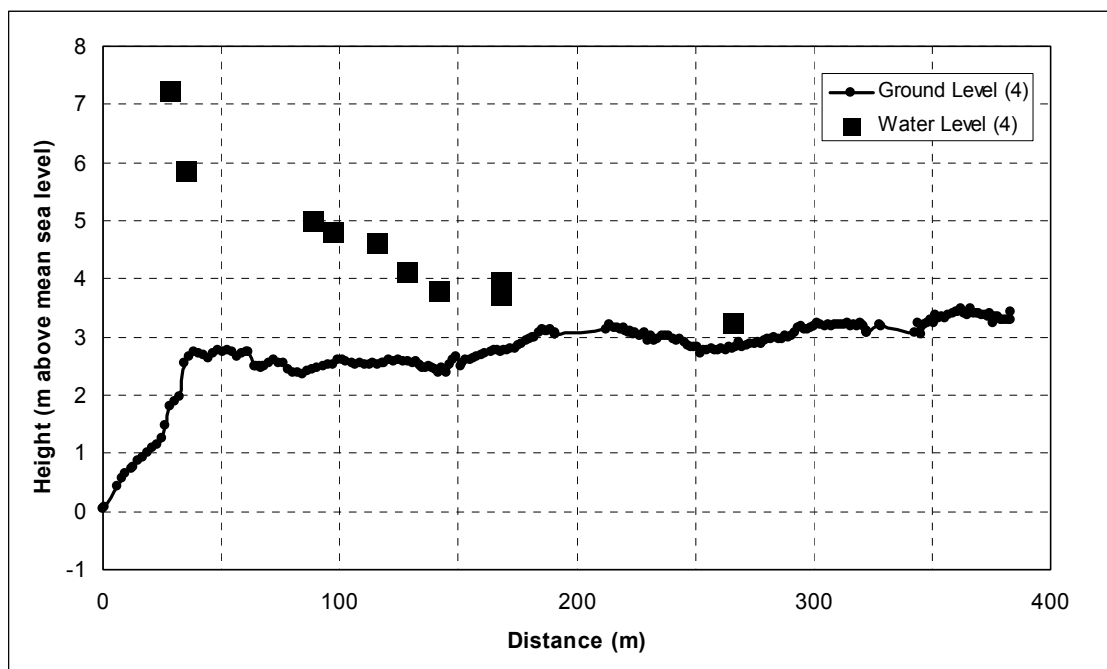
Figure 2.7.6 Ground profile 4 and water levels in Pangandaran Village. The two left-most measurements were taken on the blue lifeguard station of Figure 2.7.1 and probably bound the true water level. The site of former shops in the same figure was at a distance of 50 m.

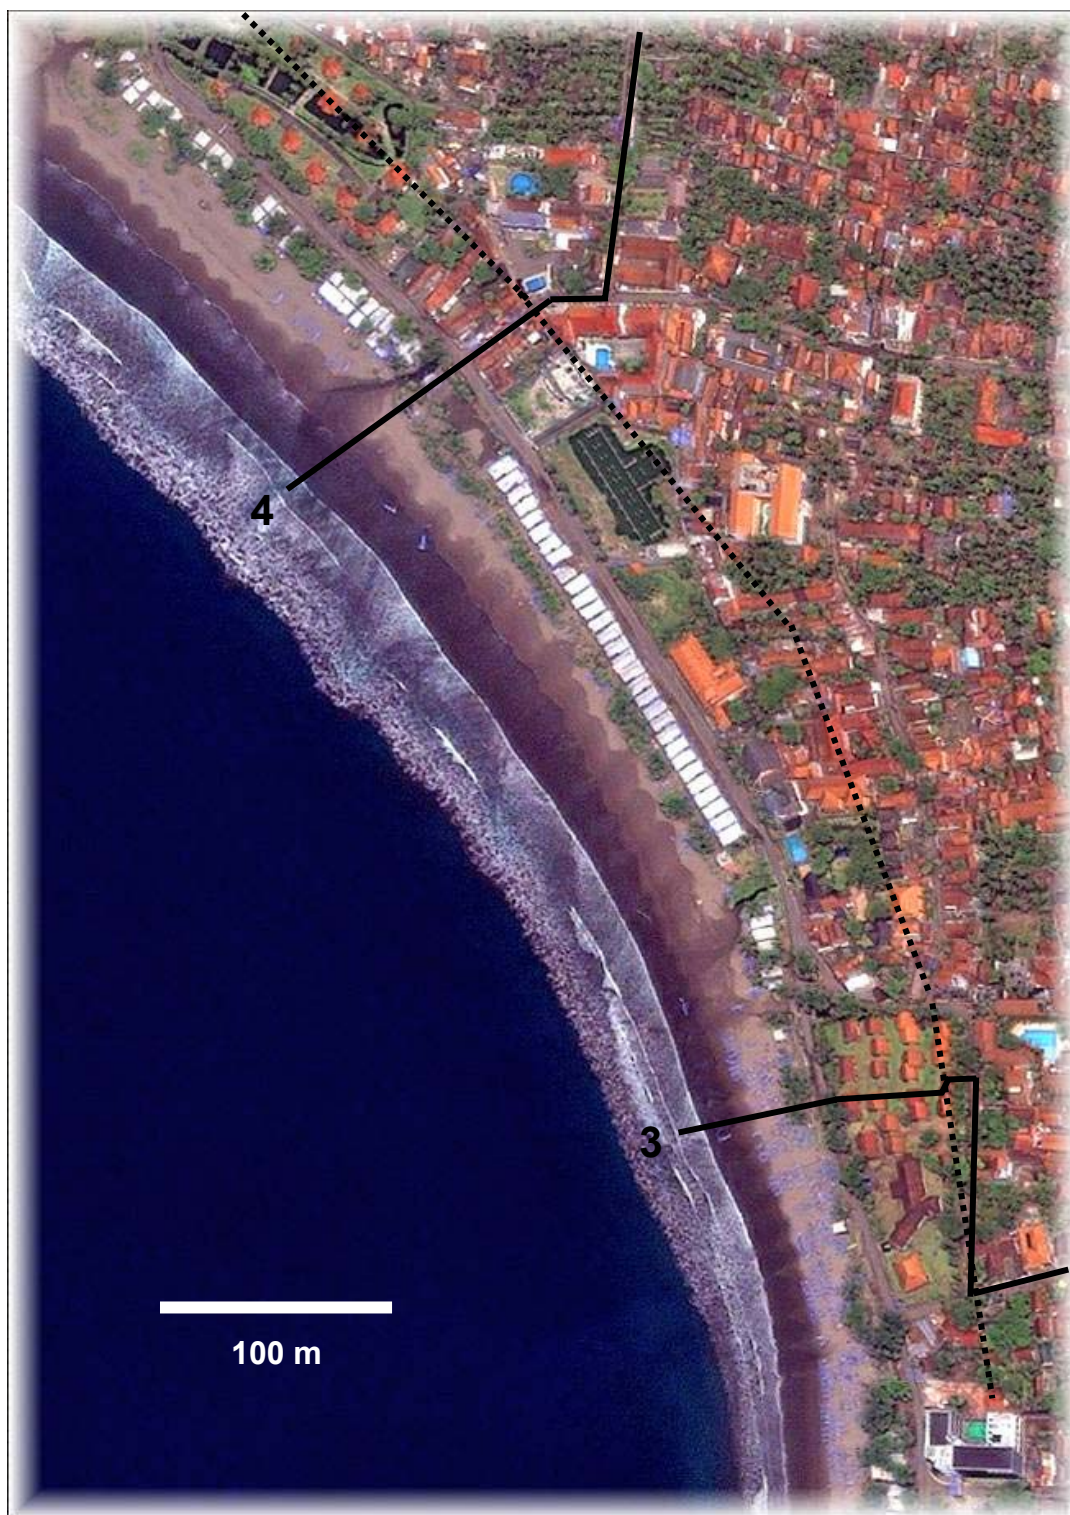
Figure A2.1 Ikonos satellite image of part of Pangandaran Village – before the tsunami. Portions of profiles 3 and 4 are shown. The white buildings along the beach, which we believe to have been semi-permanent shops constructed from wood, were totally destroyed by the tsunami. Most of the area shown here will have been at least wetted by the tsunami, with the approximate limit of significant structural damage being the dotted black line.

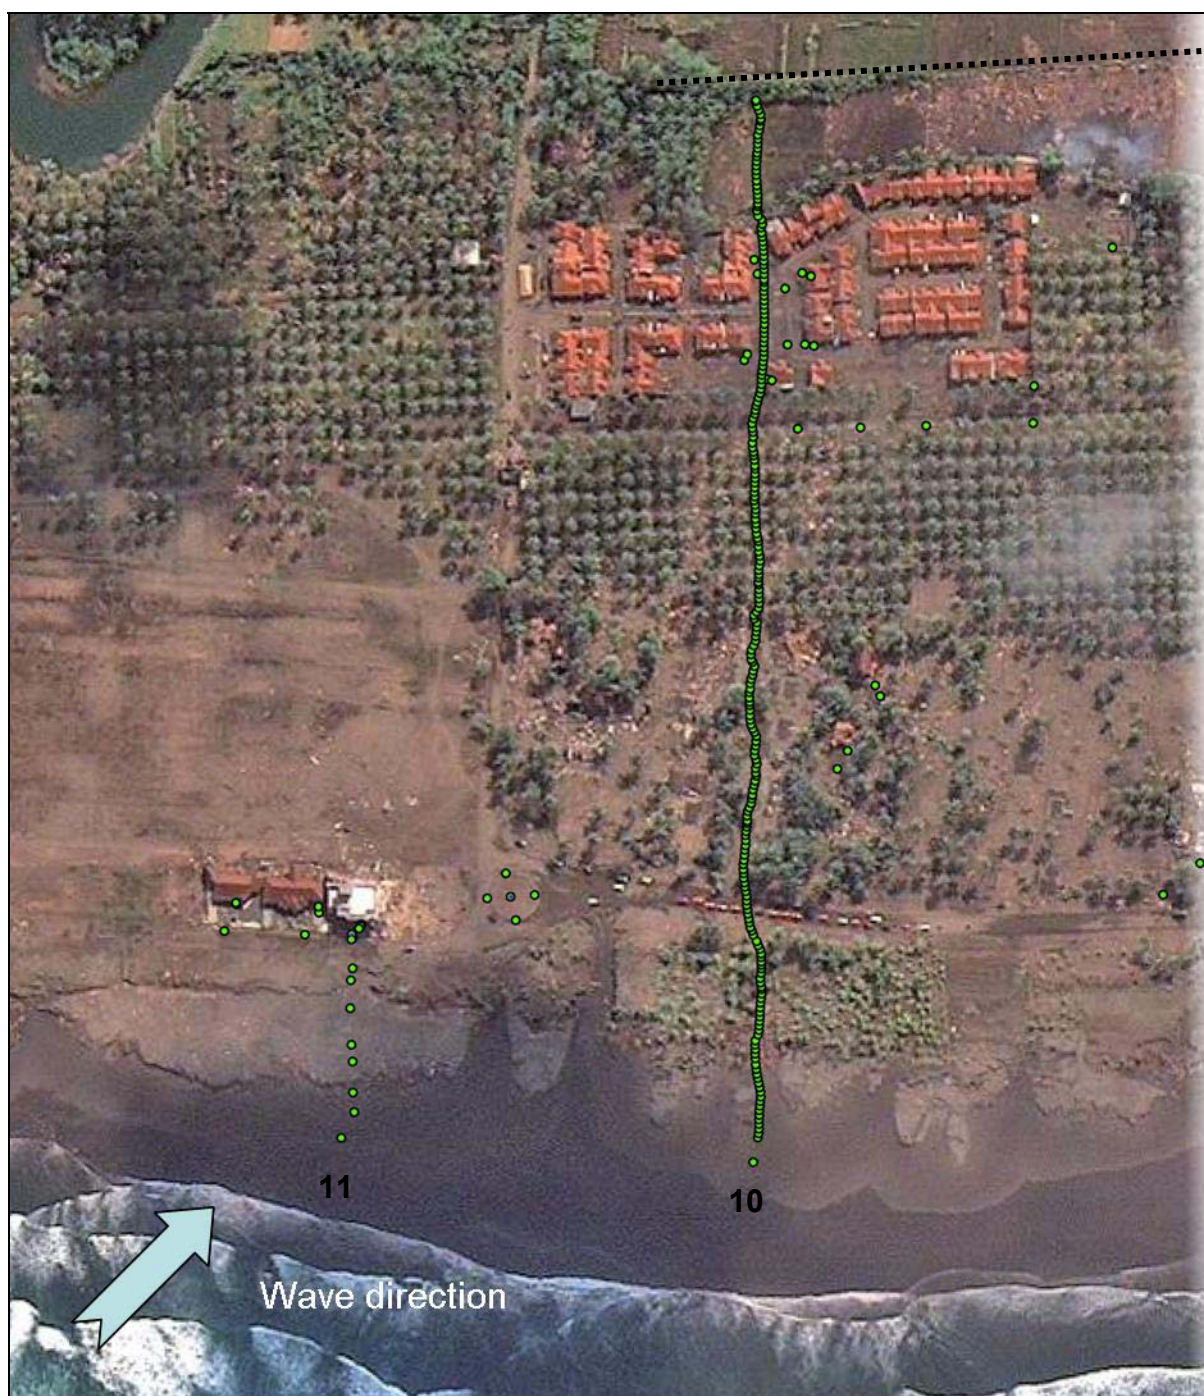
Figure A2.2 Ikonos satellite image of Cikembulan Village – after the tsunami. The limit of inundation was a border dike at the edge of a paddy field, just below the dotted black line. At the top right is a group of modern houses that had largely escaped damage (water depth < 1 m), right centre is an area of near-total destruction of brick houses (water depth c. 3 m), and to the left is a group of three well-constructed buildings that did not collapse (water depth c. 4 m). The green dots are points of elevation measurement (profiles 10 and 11).

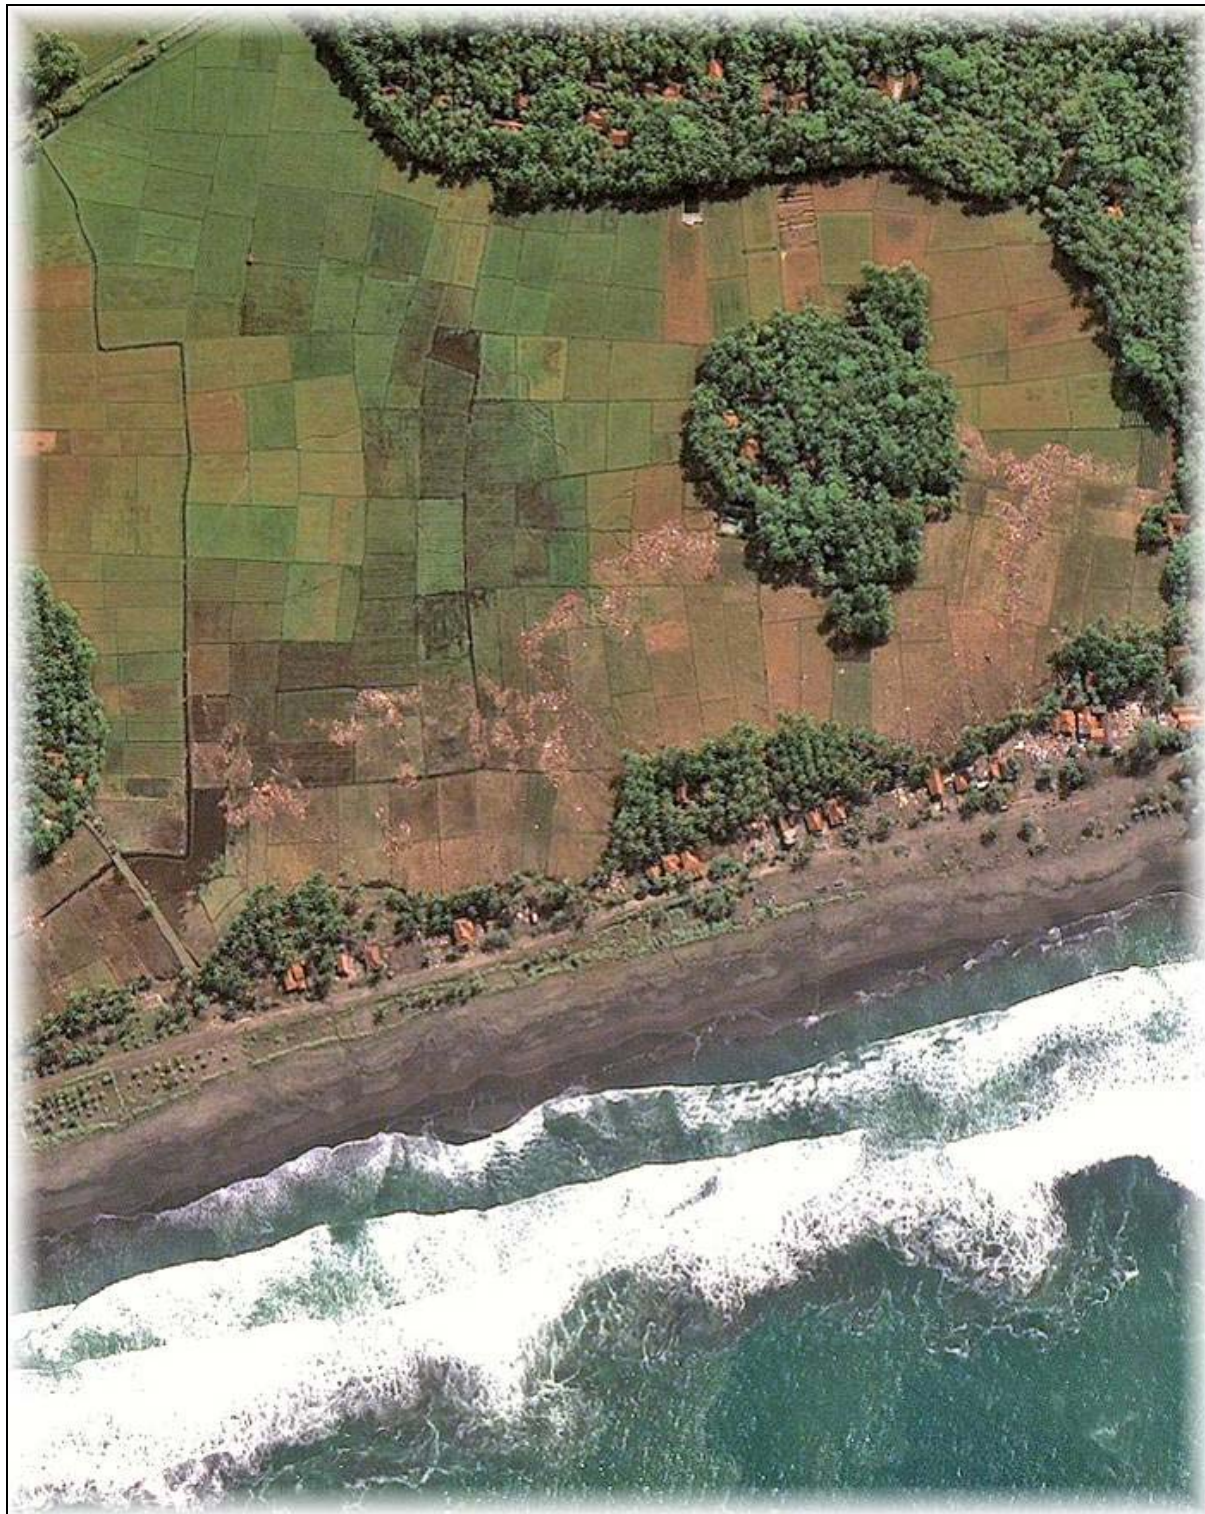
Figure A2.3 Ikonos satellite image of the coastal part of Ciliang Village – after the tsunami. The extent of inundation is clear. About 30% of the houses did not collapse. Water depth at the houses was about 2.5 m.
