StEER: Structural Engineering Extreme Event
Reconnaissance Network
PALU EARTHQUAKE AND TSUNAMI, SUWALESI, INDONESIA
PRELIMINARY VIRTUAL ASSESSMENT TEAM (PVAT) REPORT

Released: October 2, 2018

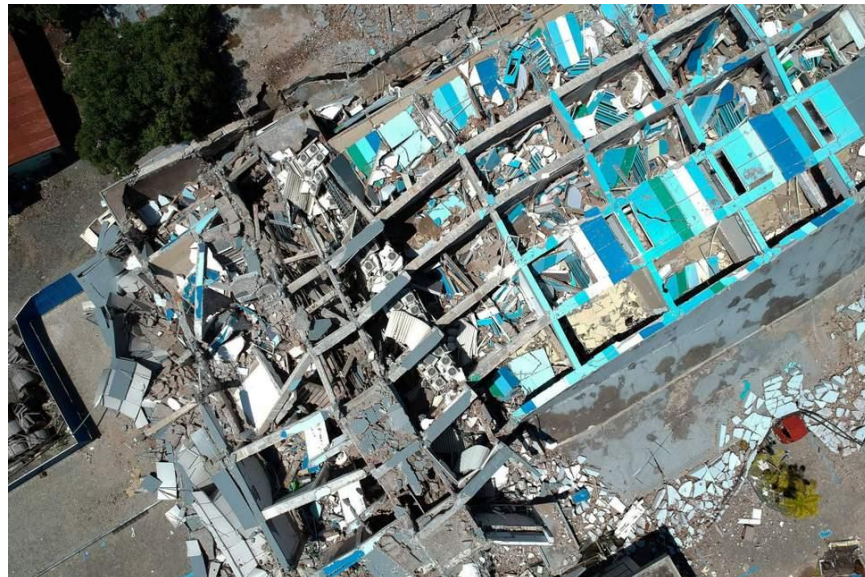
A number of multi-story reinforced concrete buildings are reported to have collapsed during the earthquake. Most notable was the eight-story Roa-Roa Hotel (0.90290 S, 119.86869 E) which collapsed resulting in multiple deaths (Figure 10 and Figure 11). The building lateral force resisting system appears to be a reinforced concrete moment frame structure (Figure 12 and Figure 13). Details of the beam-column framing are visible in Figure 14.

Figure 12: Collapsed Roa-Roa Hotel after earthquake

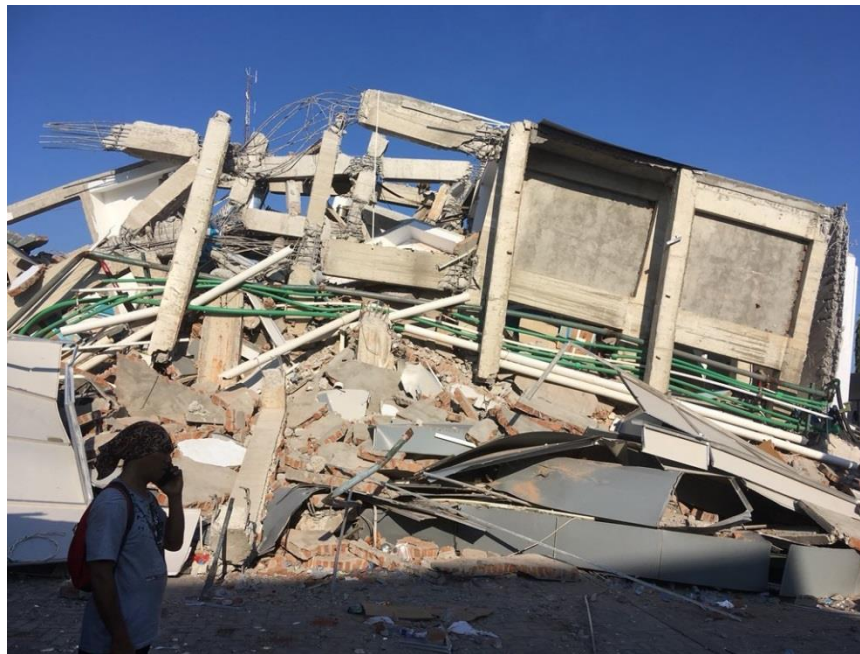
Figure 14: Lower levels of Roa-Roa Hotel after collapse due to earthquake

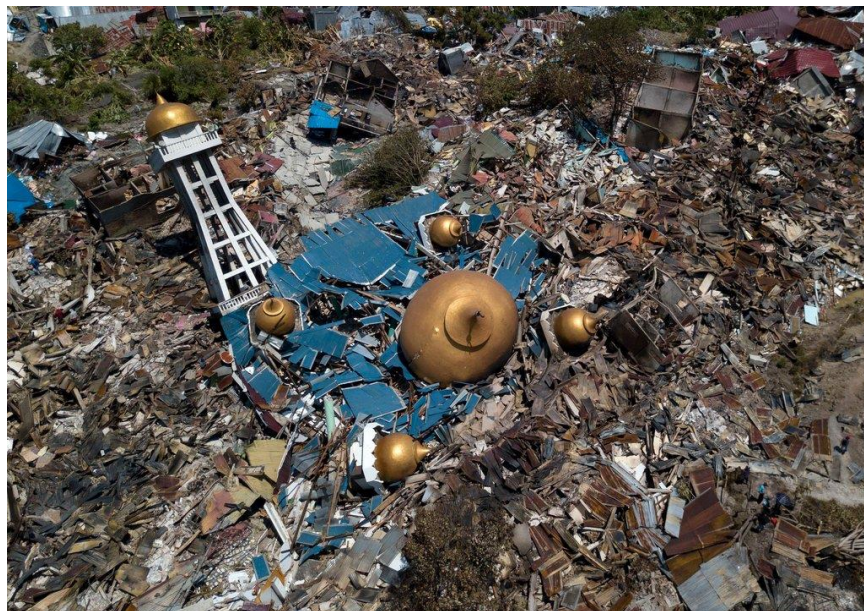
A reinforced concrete shopping center in Palu experienced partial collapse during the earthquake (Figure 15). A number of mosques also suffered severe damage or even collapse (Figure 16 and Figure 17). The Baiturrahman Mosque experienced both the earthquake shaking and the subsequent tsunami. It appears that the partial collapse of the roof dome can be attributed to the earthquake shaking, while the extent of tsunami damage is unknown at this time (Figure 18). The Apung Palu Mosque located on piles slightly off-shore from the Palu coastline suffered severe damage apparently due to significant settlement or damage to the supporting piles (Figure 19). The bridge that provides access to the mosque has collapsed. It is not known whether this damage was the result of the earthquake or tsunami, or a combination of the two.

Figure 16: Collapse of mosque (location unknown)

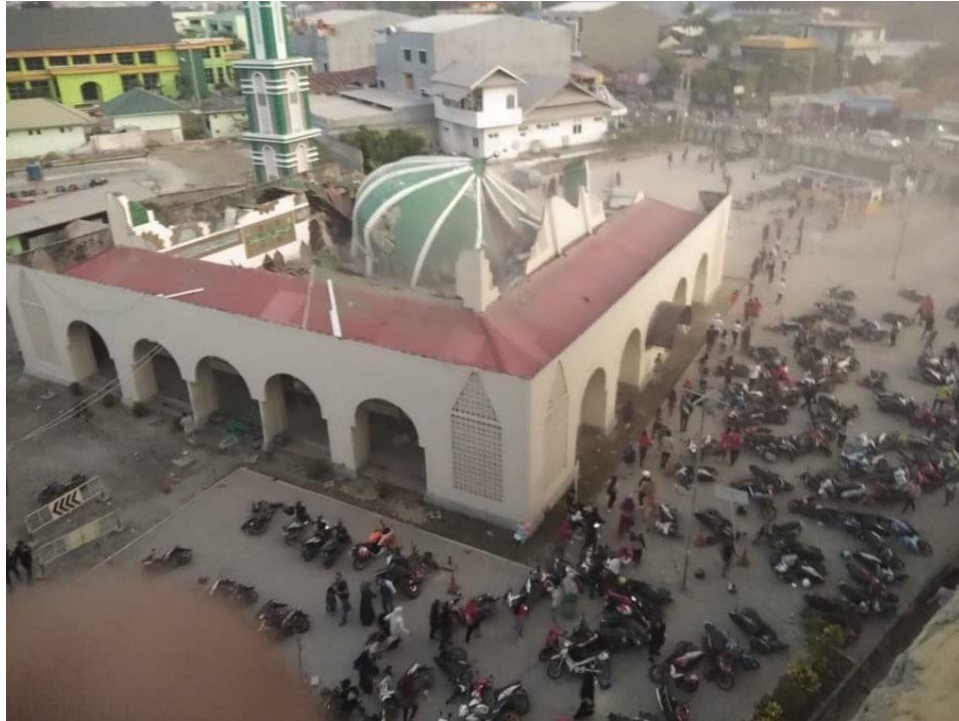
Figure 17: Damage to Baiturrahman Mosque

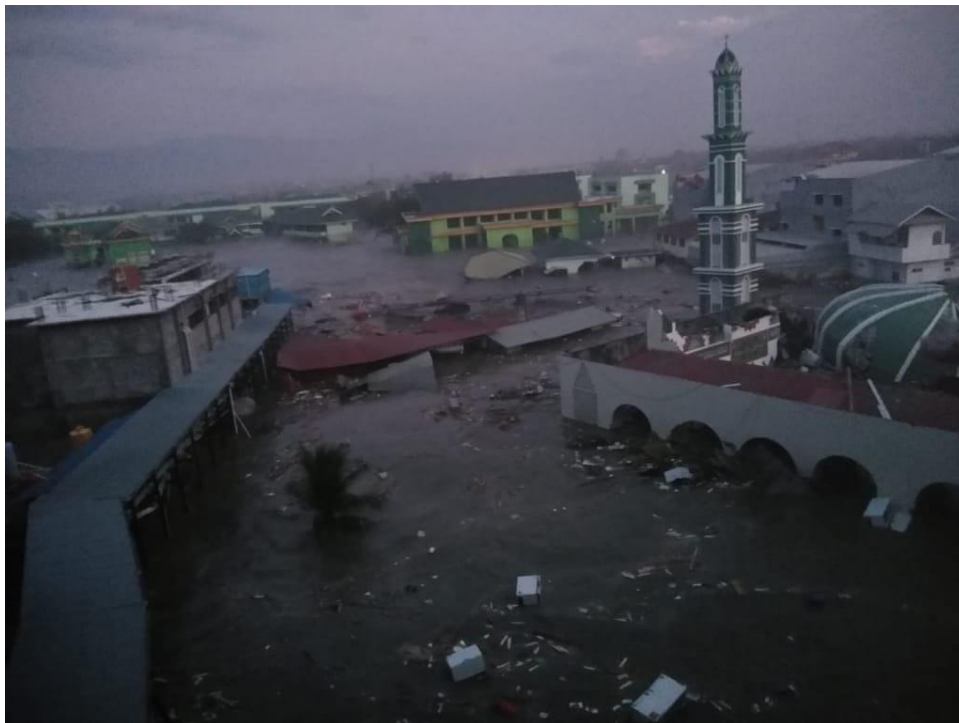
Figure 18: Baiturrahman Mosque during tsunami inundation

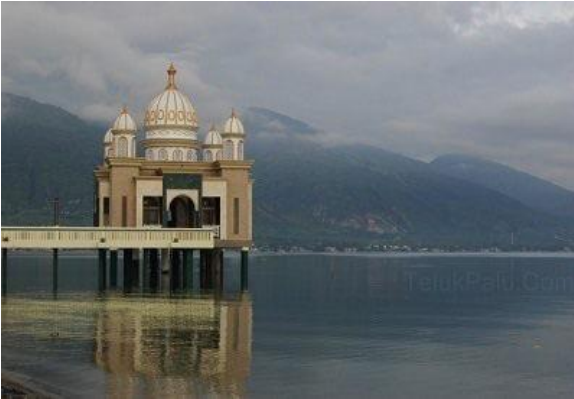
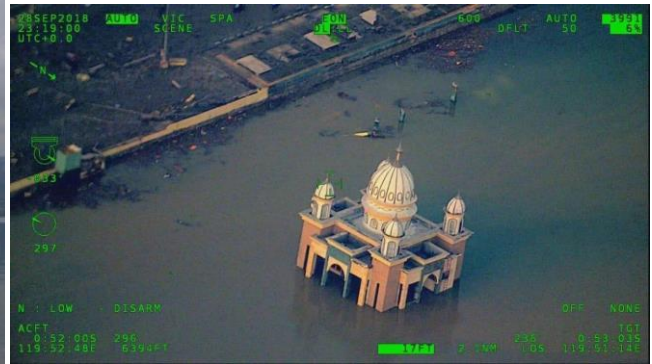
Figure 19: Apung Palu Mosque before (left) and after (right) the earthquake and tsunami. Exact cause of damage not yet established but could be due to earthquake shaking prior to the tsunami, or possibly a combination of both events.

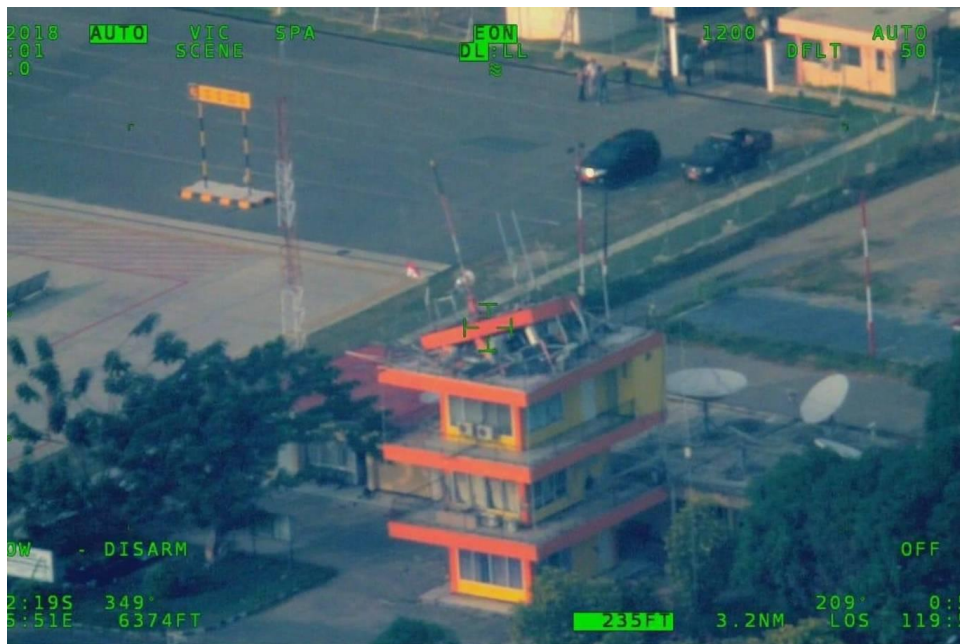
The top level of the Palu Mutiara Sis Al Jufri Airport control tower collapsed during the earthquake (Figure 20 and Figure 21). This is a common occurrence for airport towers because of the large window openings generally required at the control room, and the frequent lack of adequate lateral framing system supporting the roof. One air traffic controller, twenty-one-year-old Anthonius Gunawan Agung, was reportedly on duty in the tower and continued to assist a Batik airplane during take-off, even as the earthquake occurred. He apparently leaped from the control tower just before it collapsed, but died due to injuries suffered in the fall (Times of Isreal, 2018). Damage also occurred in the main terminal building (Figure 22).

Figure 20: Airport Control Tower after earthquake with top level collapse (0.91670 S, 119.90654 E)

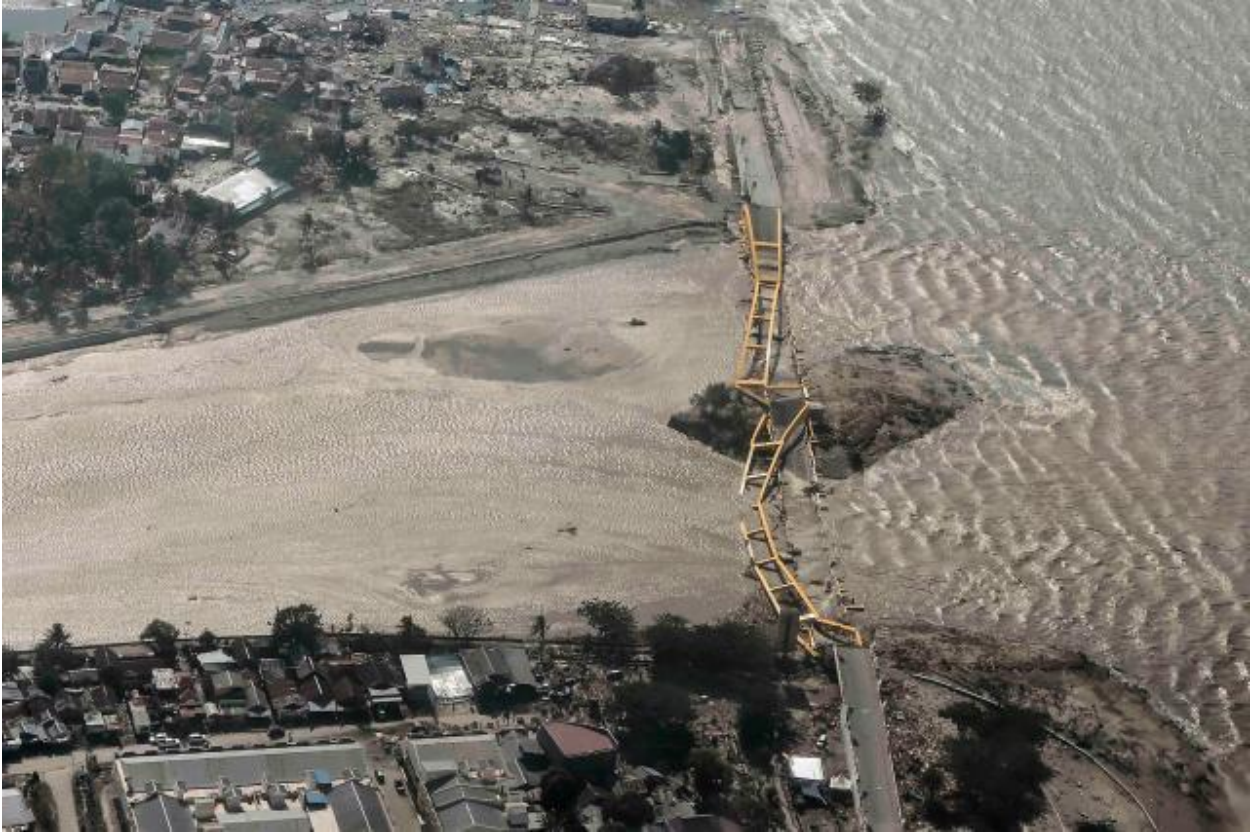
The iconic twin steel arch cable-suspended Palu Bridge IV over the mouth of the Palu River (Figure 23 and Figure 24) collapsed, presumably during the earthquake (though this needs to be confirmed) (Figure 25 and Figure 26). The bridge had a total span of 250 meters and the steel box arches were 20 meters tall. A number of other bridges are reportedly damaged, hampering road traffic in and around the city.

Figure 25: Palu Bridge IV after earthquake and tsunami

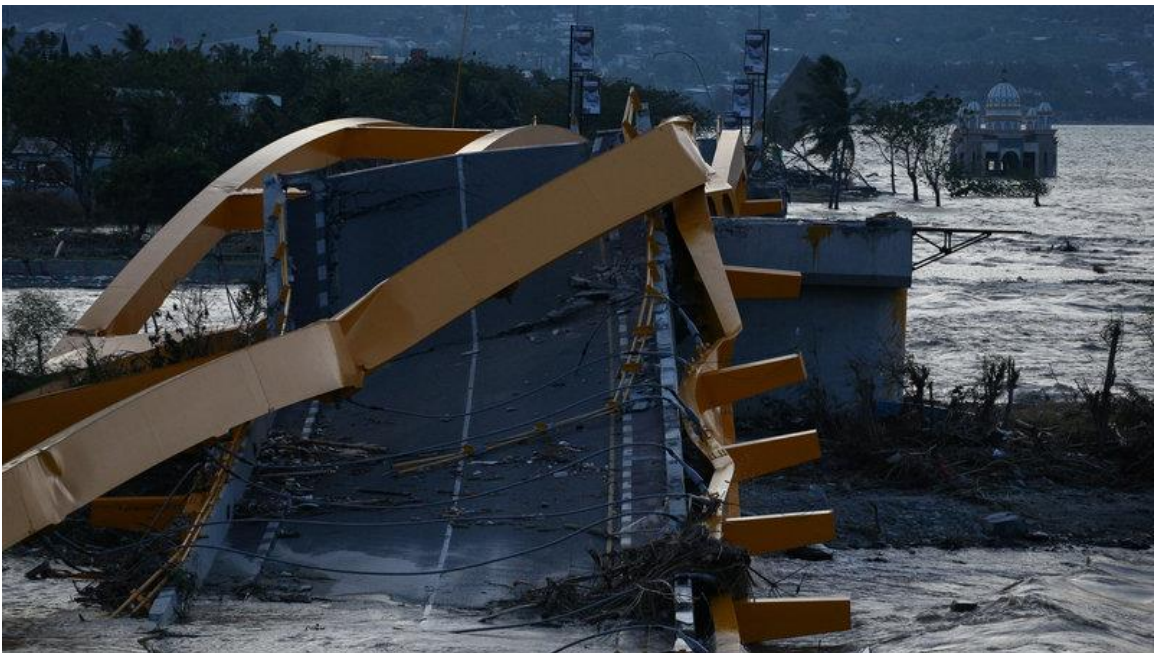
Figure 26: Palu Bridge IV after earthquake and tsunami (Photo: Athit Perawongmetha/Reuters)

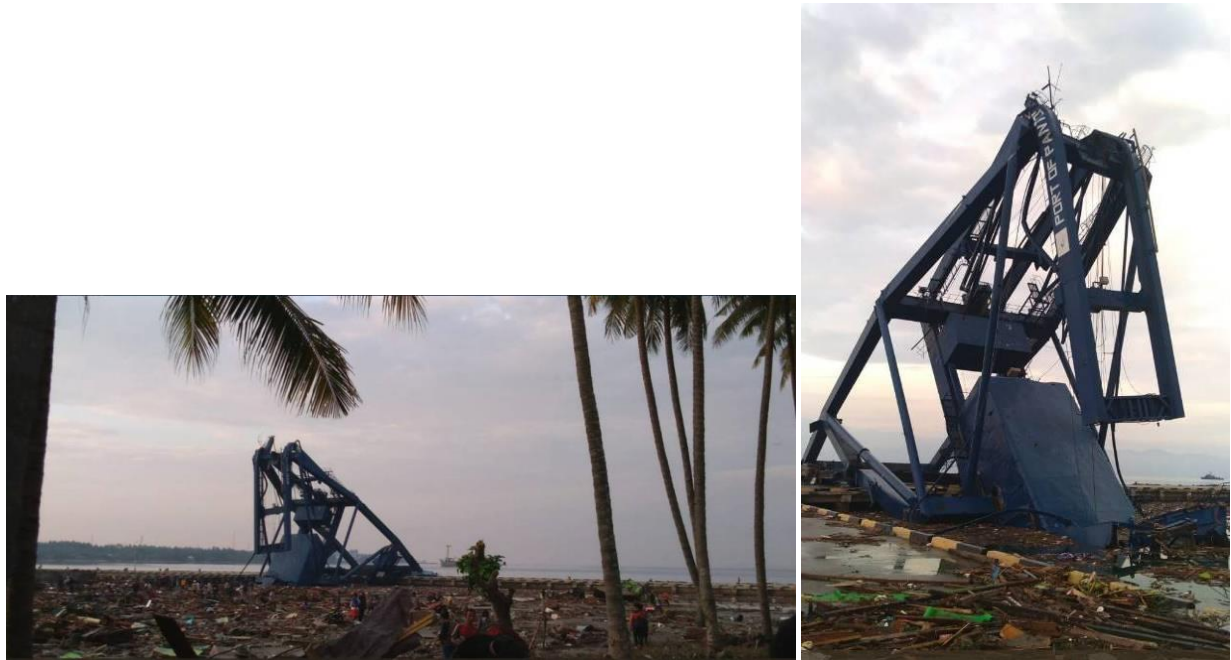
A gantry crane at a port facility to the Northeast of Palu (exact location not yet confirmed) appears to have collapsed during the earthquake, though the exact timing of failure is unknown (Figure 27). Damage is also evident to a port facility further to the North, probably also attributable to earthquake shaking (Figure 28).

Figure 27: Failure of gantry crane (possibly at 0.710899 S, 119.85577 E)

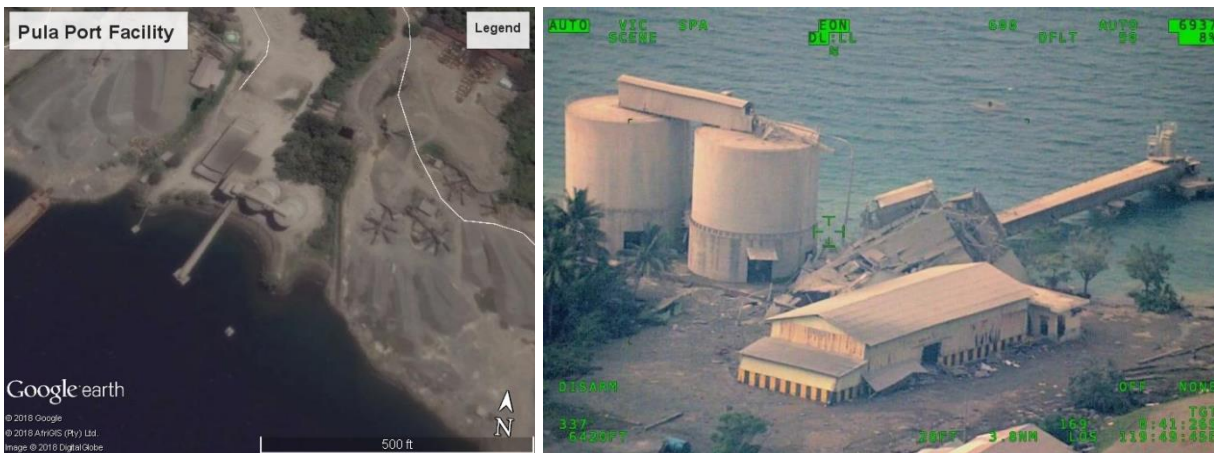
Figure 28: Damage to port facility (0.690718 S, 119.82923 E)

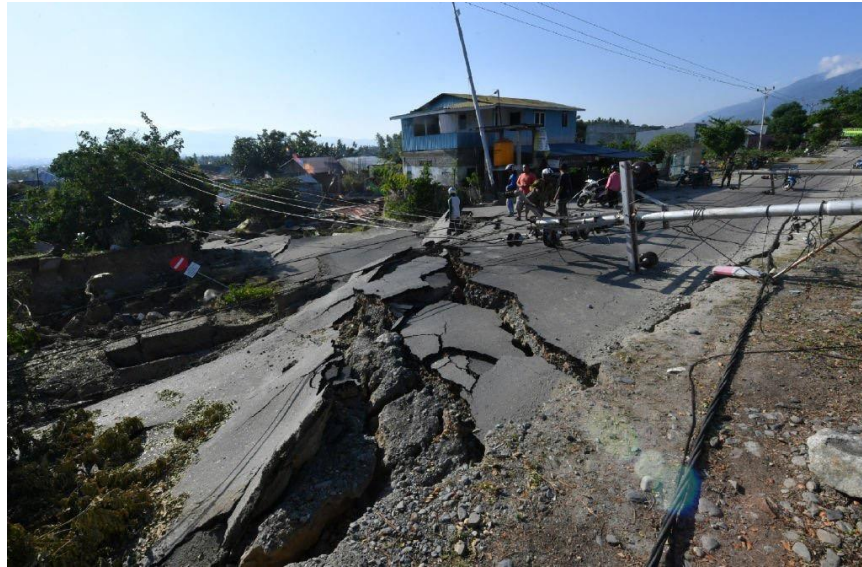
Substantial damage has occurred to roadways in the Palu area (Figure 29, Figure 30 and Figure 31). It appears that some of this damage is due to surface rupture, liquefaction and lateral spreading, while other damage is due to landslides and rockfalls triggered by the earthquake.

Figure 29: Significant damage to roadways due to fault rupture and liquefaction.

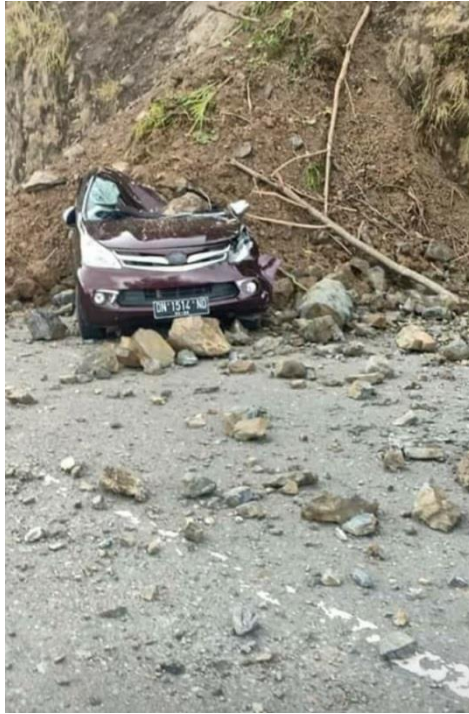
Figure 31: Landslide damage to car and roadway (location unknown)

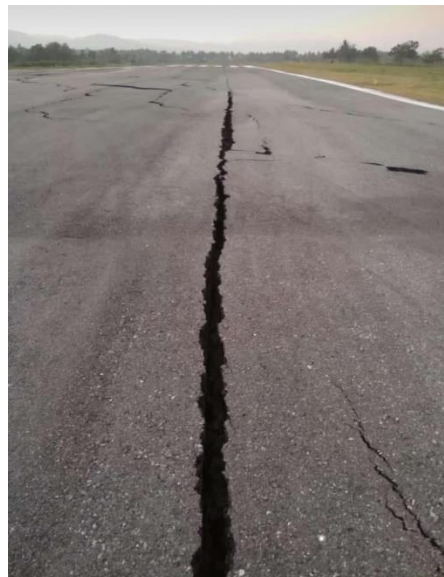
Similar damage due to earth movement has resulted in large cracks in the asphalt paving on the runway at the Palu Mutiara Sis Al Jufri Airport (Figure 32).

Figure 32: Damage to Palu's Mutiara Sis Al Jufri Airport runway due to ground movement.

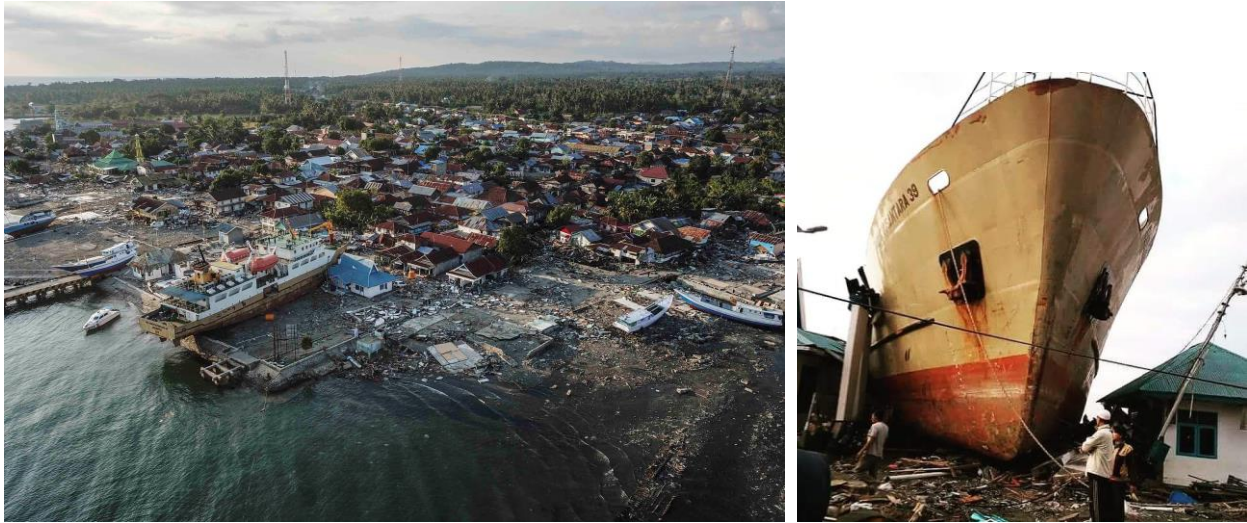
A number of ships have been washed onshore by the tsunami (Figure 33 and Figure 34). Other ships and barges broke free of their moorings and were washed out into the bay (Figure 35).

Figure 33: Ship and boats washed onshore by tsunami (Sources: Left image – NYT, 2018c; Right image – phys.org, 2018) (0.69482 S, 119.8403 E)

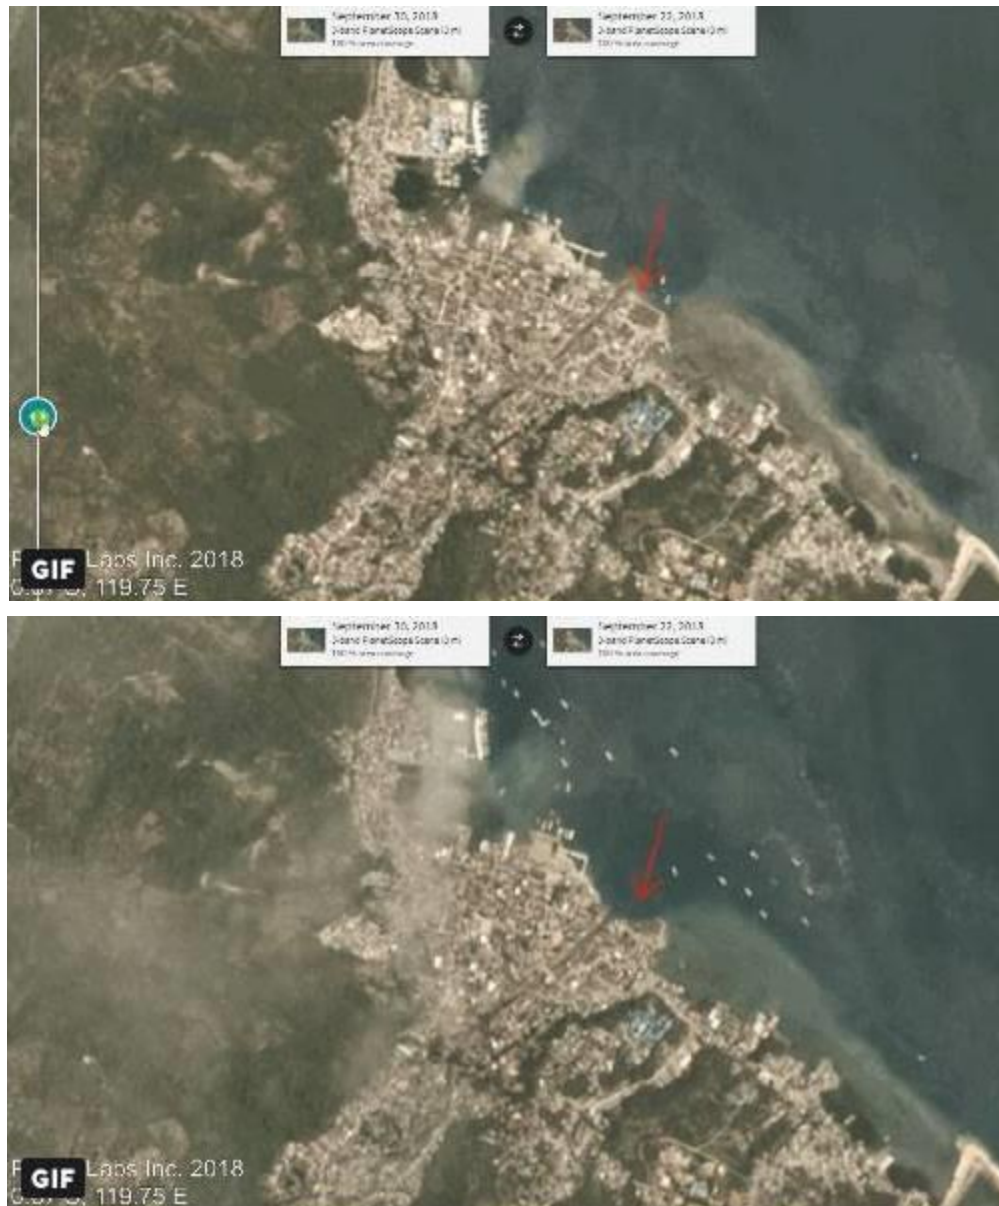
Figure 35: Before (top) and after (bottom) images of ships washed from their moorings by the tsunami. Port damage and erosion evident along coastline. (Source: Murray Ford twitter feed @mfordNZ)

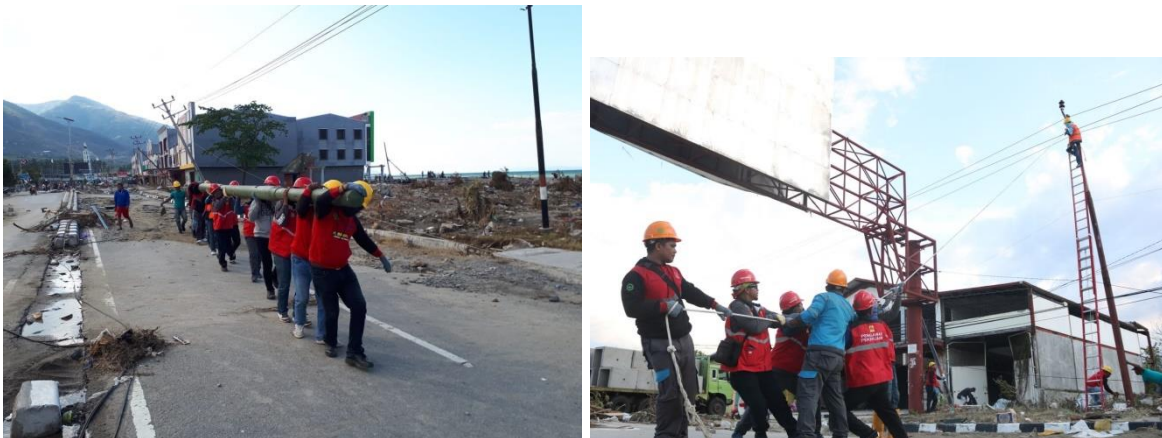
Numerous power poles were destroyed during both the earthquake and tsunami. Power was lost to Palu city and had not been reinstated at the time of writing this report. Work is already underway to restore power as quickly as possible (Figure 37 and Figure 38).

Figure 37: Installation of new power distribution poles within days of the earthquake.
