Summary of Earthquake and Tsunami Damage Assessment in Port Vila

Dr Graham G. Shorten, SOPAC

Summary

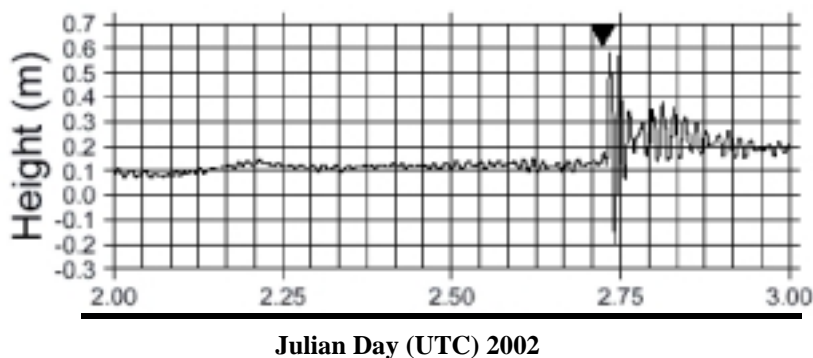
A tsunami generated with the earthquake struck Port Vila Harbour some 15 minutes later according to records of the National Tidal Facility (Australia) supplied by Bill Mitchell through the Acting Director of the Vanuatu Meteorological Office. Although the tsunami only registered on the tide gauge as having a crest to trough amplitude of 0.8 m (Figure 3), eyewitness accounts in different parts of the harbour (Figure 6) put the maximum effect at around 3.0 m, nearly four times that of the height recorded on the water level gauge, making it large enough to have the potential to cause significant damage.

Figure 2:
Tsunami record,
Port Vila Wharf –
differences
between observed
and predicted sea
level (NTF)

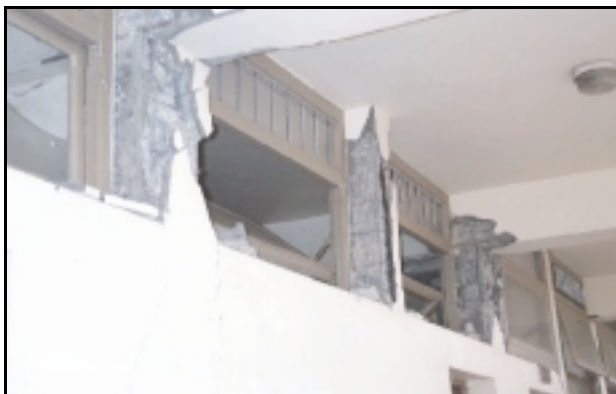
Significant structural damage occurred to the Lycee Bouganville where a 3-storey school classroom building was severely damaged, displaying short-column failure concentrated at the top of the infill walls throughout the entire ground floor level (Figure 4), an adjacent dormitory block suffered similar, significant structural damage, and a 2-storey classroom block reached the stage of incipient failure. The school buildings are built on a cut and filled slope.

Figure 4: Short columns spalled and failed, ground floor, Lycee Bougainville

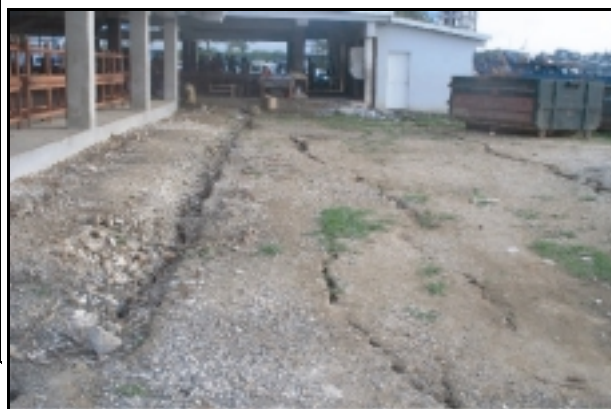
A large number of buildings suffered apparently minor structural damage, including shearing of infill walls and window breakage. Movement of the sea wall during the main shock has led to permanent deformation seaward and subsidence of the foreshore in reclaimed areas around the Central Business District (CBD). The worst affected area runs for some 150 m from the open park area north of the main public Market (Figure 5), southward through the seaward end of the Market building and car park and then through the seaward end of the Sea View Restaurant/Bon Marché in a 25 m-wide zone adjacent to the sea wall.

Figure 5: Fissuring in back-fill behind sea wall, north of Market

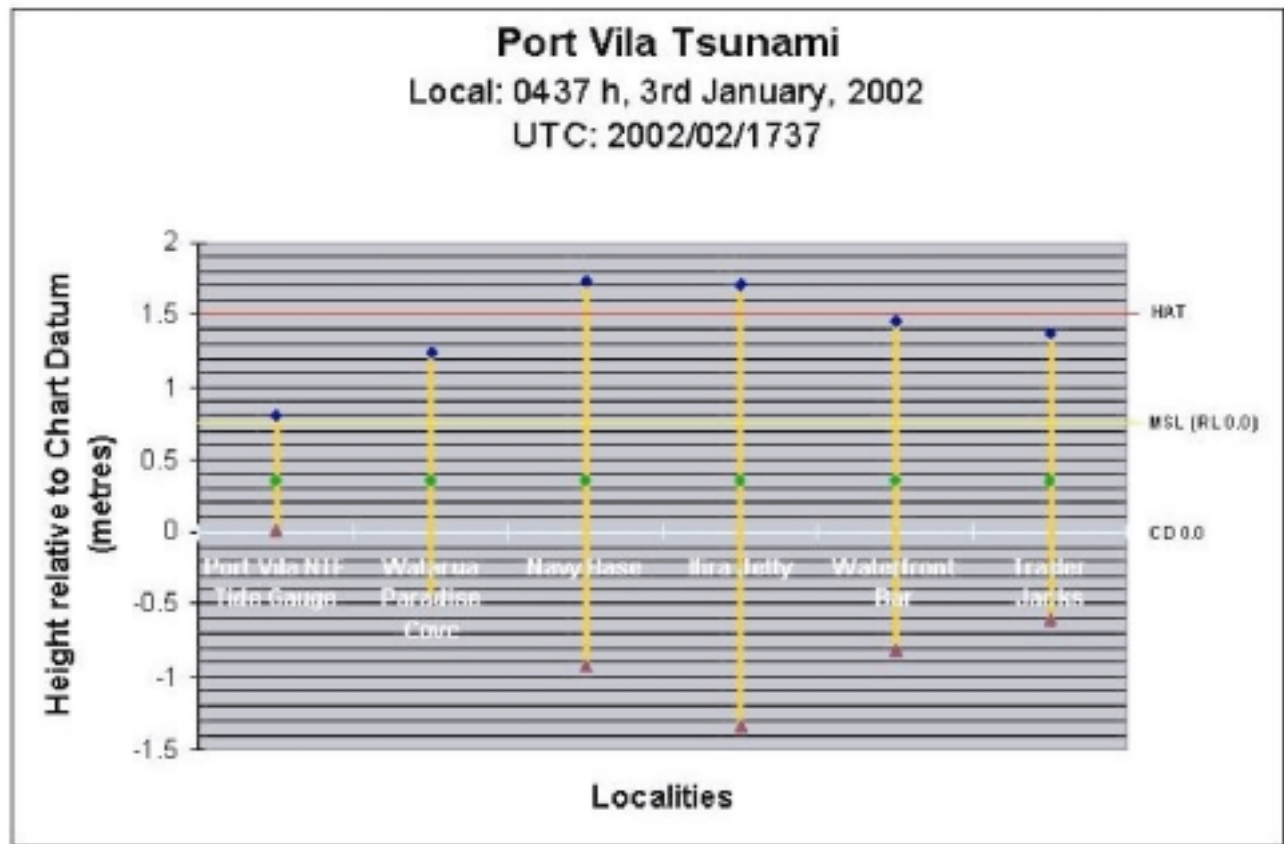
A tsunami of appreciable size was generated with the earthquake, but was fortunately small enough, given the extremely low tide at the time, not to cause any significant flooding above Highest Astronomical Tide (HAT) level (Figure 6). Had it struck at high tide, much flooding, damage and perhaps loss of life could have resulted. The potential for Port Vila to experience similar, or even significantly worse, earthquakes and tsunamis in the future can be considered relatively high in the 50-100 year timeframe, as this was not an isolated or unexpected event.

Figure 6: Eyewitness accounts of tsunami amplitudes around Port Vila Harbour (event tide is CD+0.35 m)

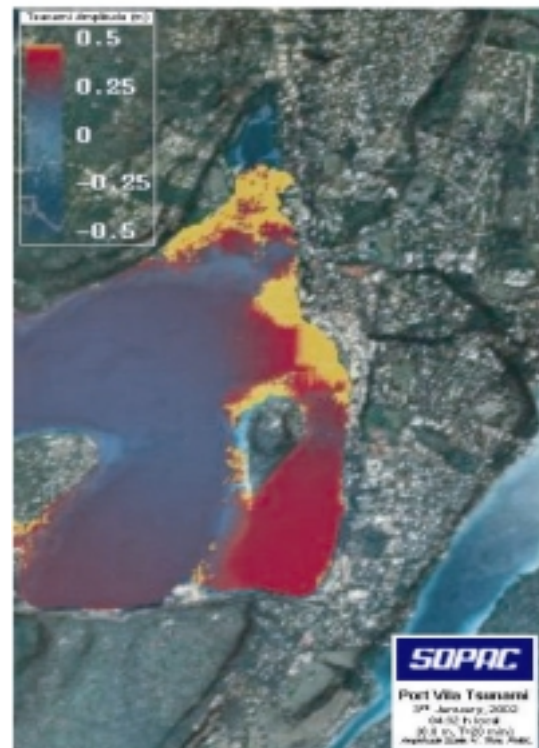
Predictive tsunami modelling carried out prior to the actual event by Vasily Titov, NOAA Pacific Marine Environmental Laboratory, USA, in conjunction with Stan Goosby of the Pacific Disaster Center, Hawaii, USA, as part of the SOPAC Port Vila Pacific Cities project, confirms that such amplifications are likely due to resonance and interference effects within the harbour (Figure 7). Final modelling will incorporate actual tide gauge records and eyewitness accounts of the event. A video-animation of the simulated tsunami in Port Vila harbour prepared by Vasily Titov, but based on the scenario of a larger, M 8.2 earthquake occurring in a similar location, is available from SOPAC.

Figure 7: Model of tsunami heights in Port Vila Harbour based on tide gauge record (V. Titov)
