Historical Tsunami Effects near the Tonga Trench (1837-2015)

Introduction

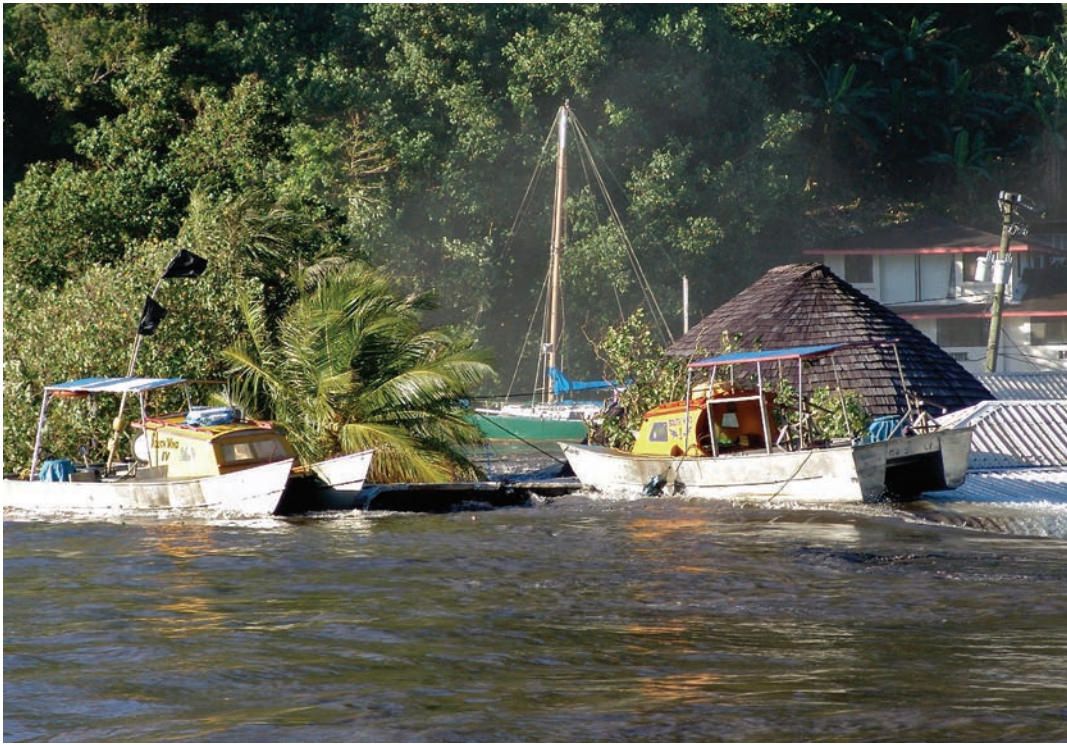
2009 tsunami flooding Pago Pago Bay, American Samoa, lifting boats onto submerged structures and into the tops of coconut trees. credit: R. Madsen, aboard sailboat Barbarella

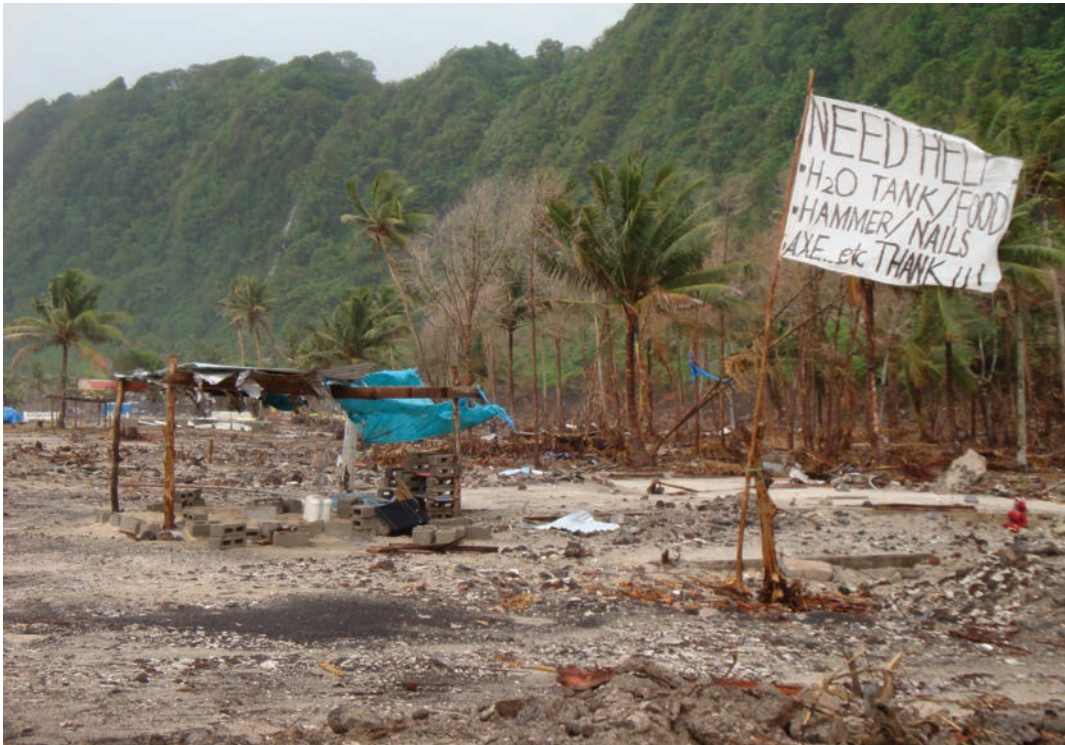
Many coastal villages along the south and east coasts of Upolu, Samoa were destroyed in the 2009 tsunami - only foundations of homes remained afterward. credit: ITST Samoa Social Science team

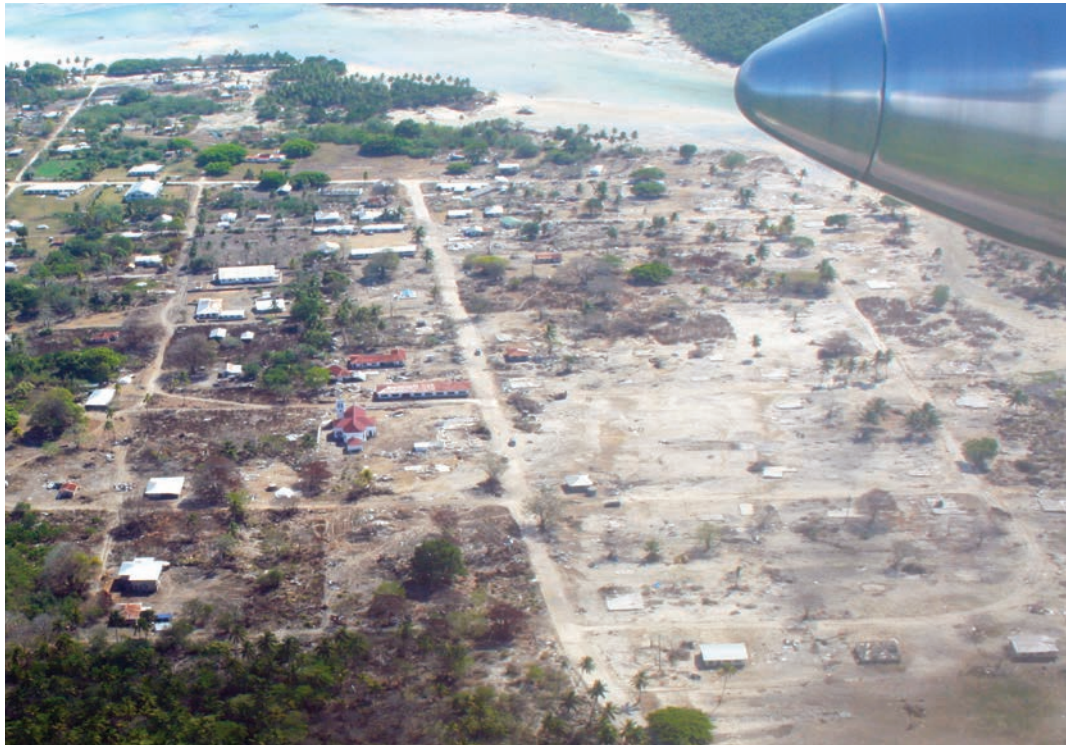
Aerial photo of tsunami-damaged Hihifo, the main town in Niuauputapu, Tonga. Overall, the highest runups (> 22 m) for the 2009 tsunami were measured here on the island's eastern coast. credit: Tonga Met. Svc.

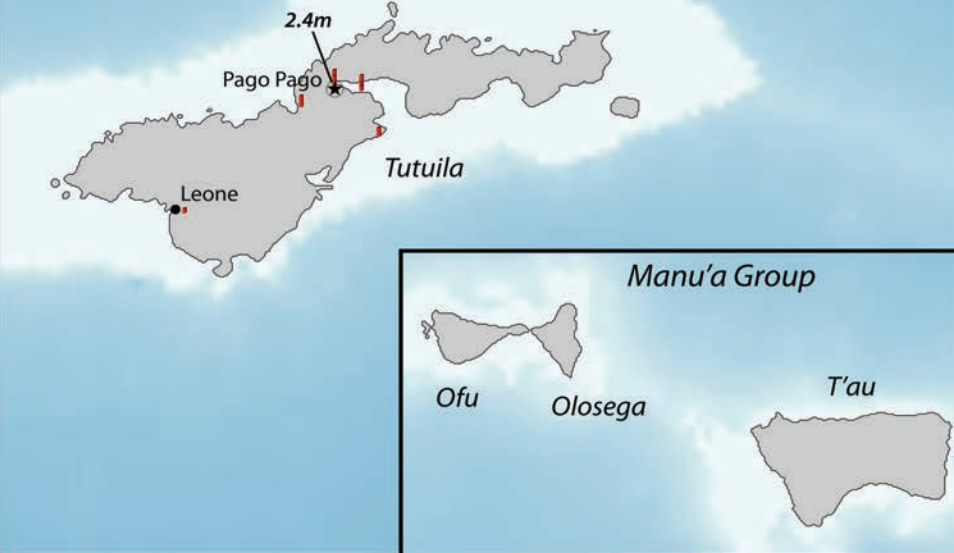
American Samoa

All Other Tsunami Observations

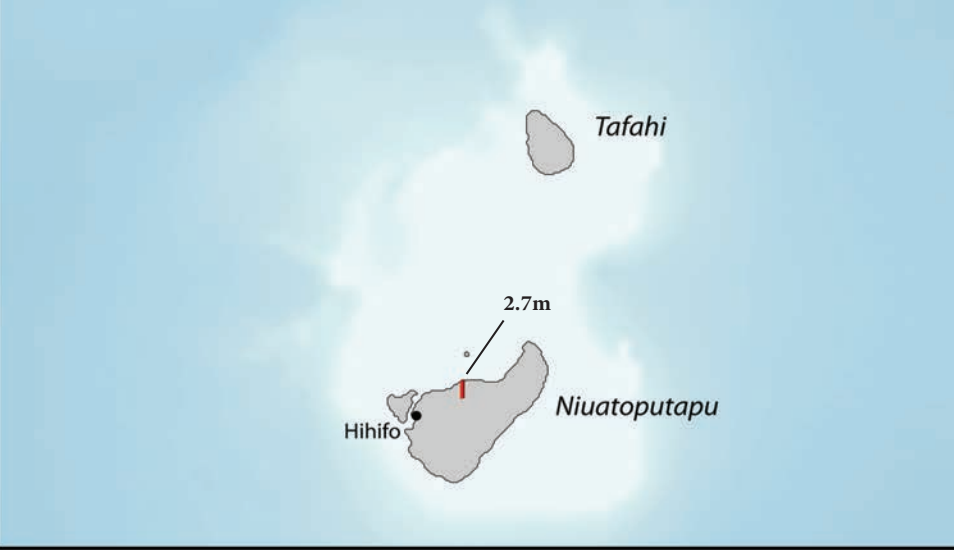
Tonga

All Other Tsunami Observations
