# Historical Tsunami Effects near the New Hebrides Trench (1849-2019)

## Introduction

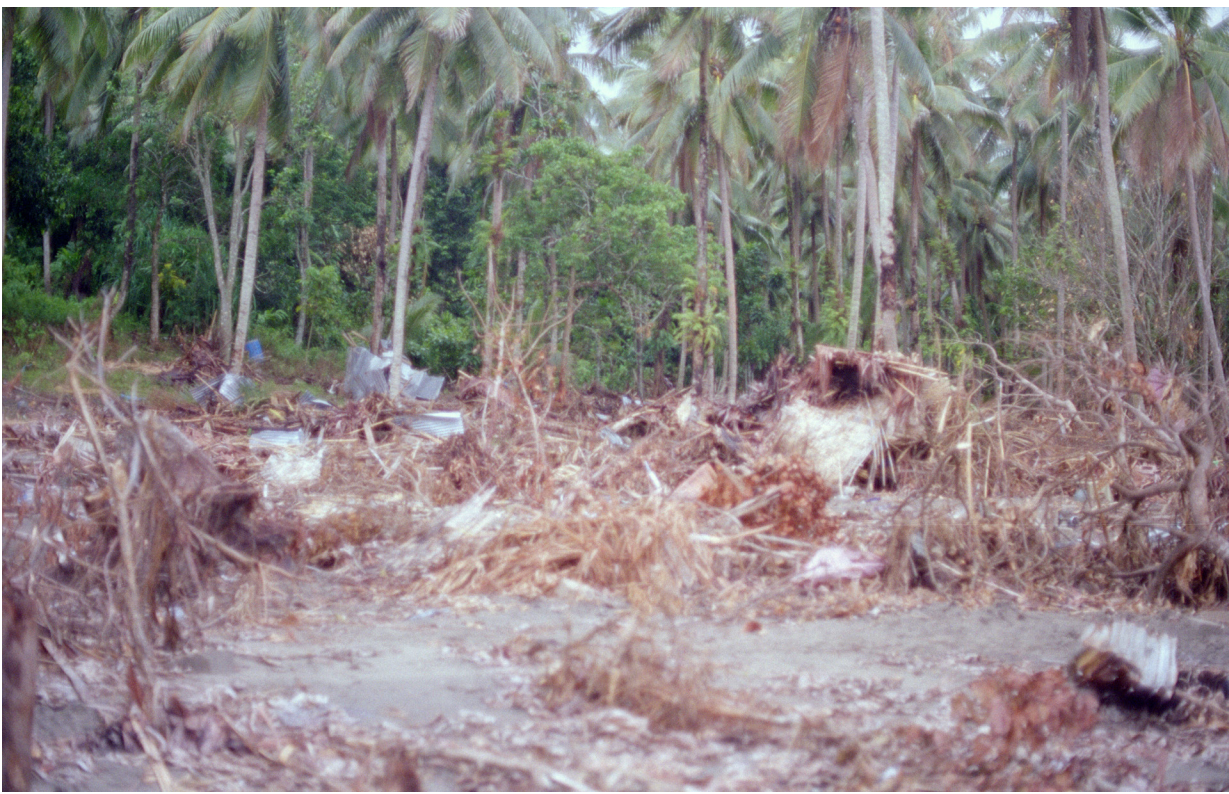
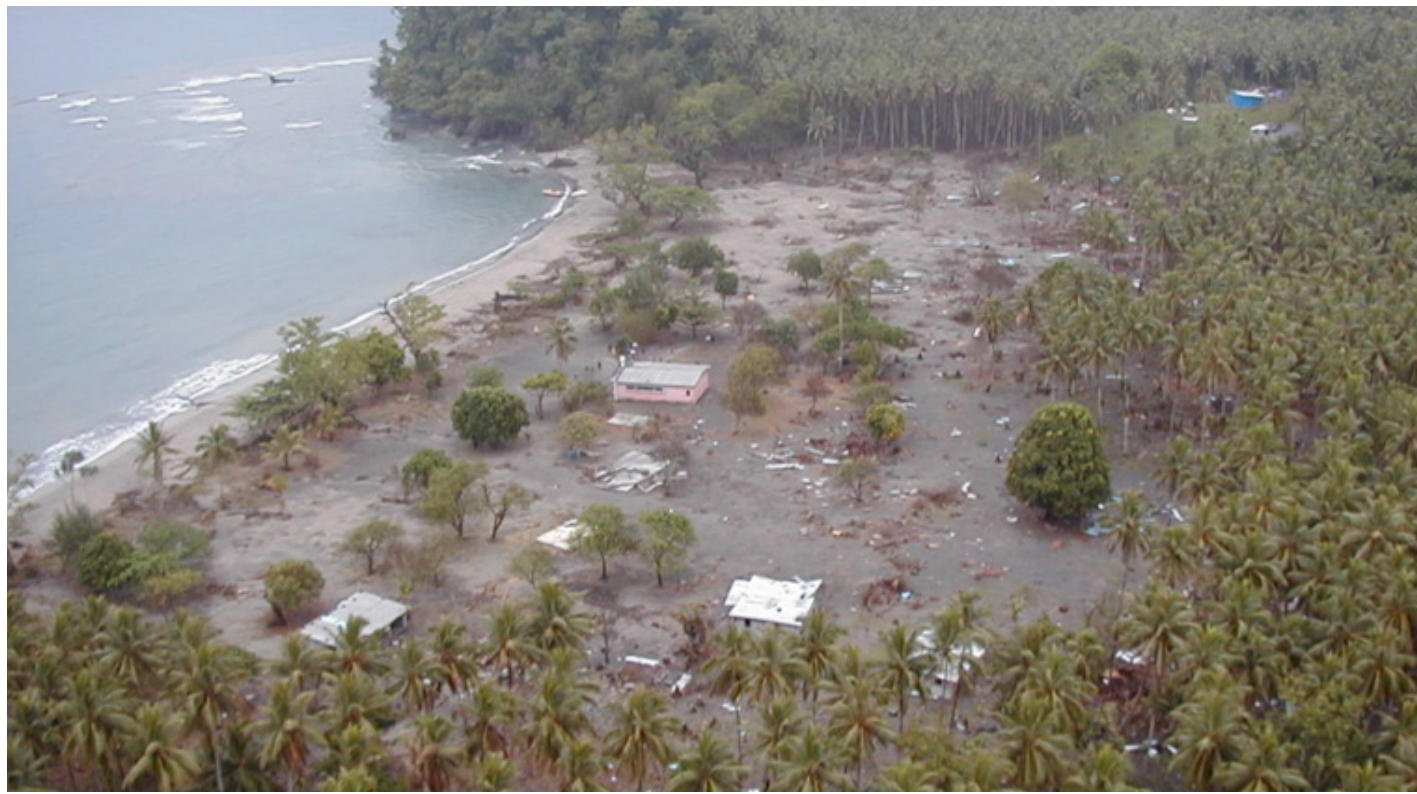
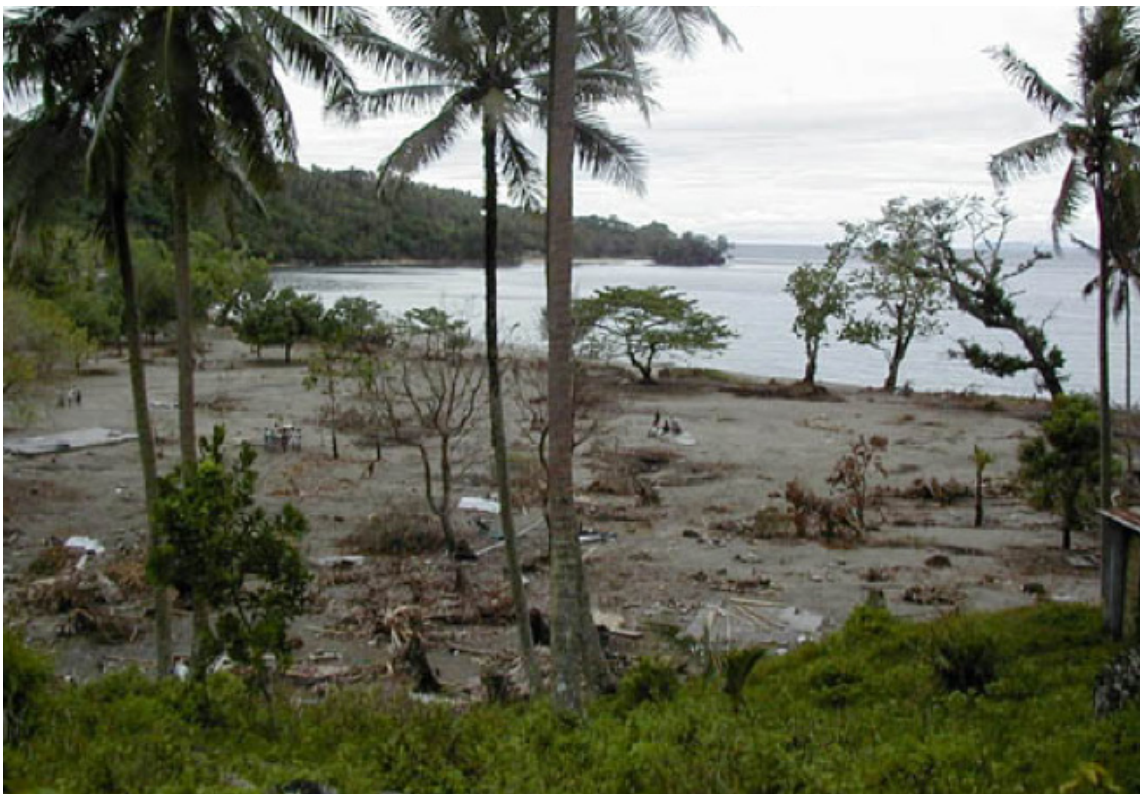
The village of Baie Martelli, Vanuatu, was destroyed after the 1999 tsunami. The large concrete village church (center image) was one of the few structures that remained standing following the tsunami. However, water surged over the top of the church (over 4 m above ground surface), crushing its corrugated metal roof. (Image Credits: Costas Synolakis (left), Utku Kanoglu (center, right))

The only other confirmed historical tsunami to cause deaths in the region occurred in 1999, generated on the previously described reverse fault in the back-arc of Vanuatu. The tsunami resulted in a 6.6 meter wave and five deaths at Baie Martelli, Vanuatu. The death toll could have been much higher had it not been for indigenous knowledge, as well as public outreach conducted three weeks prior by the Vanuatu National Disaster Management Office. The highest historical tsunami wave runup in Vanuatu is 12 meters on Tanna Island generated by a nearby earthquake in 1878.
