Disaster Report: sc20181204

Coastal Subsidence Induced Several Tsunamis During the 2018 Sulawesi Earthquake

Keywords: earthquake, tsunami, Sulawesi, field survey, subsidence

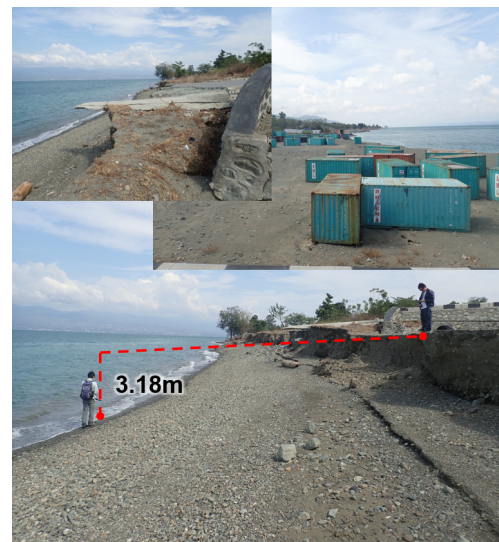
Fig. 2. Different view of the beach where elevation changes were measured nearshore. The red dashed line shows measured change in elevation at location G. The container yard disappeared about 100 m long from the coast.

At point G, a large subsidence occurred in the presence of several eyewitnesses. They reported that the container yard disappeared about 100 m long from the coast. According to a UAV survey, it is estimated that one or more landslides occurred about 1 km along the coastline.

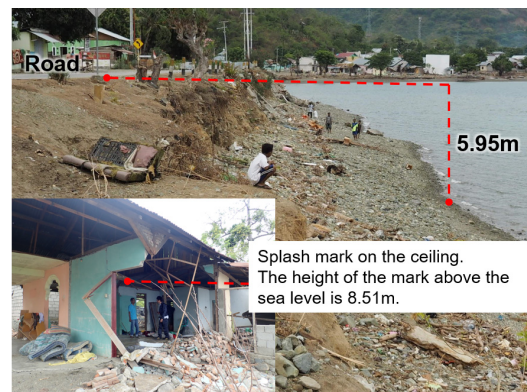
Fig. 3. Inundation height and splash height measured between locations D and G. The splash height at this area is more than 8 m.

Figure 3 shows the inundation height and the splash height between points D and G. The splash height was greater than 8 m and the walls of the houses were destroyed by the tsunami splash. The cliff shown in **Fig. 3** seemed to have formed following the 1968 earthquake, said a resident. This area appears to be prone to landslides. Therefore, it is important to understand the ground characteristics and consider them during reconstruction plans.
