# Field Survey of Runup and Inundation in Tonga from the January 2022 eruption of the **HUNGA VOLCANO**

# Field Survey of Runup and Inundation in Tonga from the January 2022 eruption of the Hunga Volcano

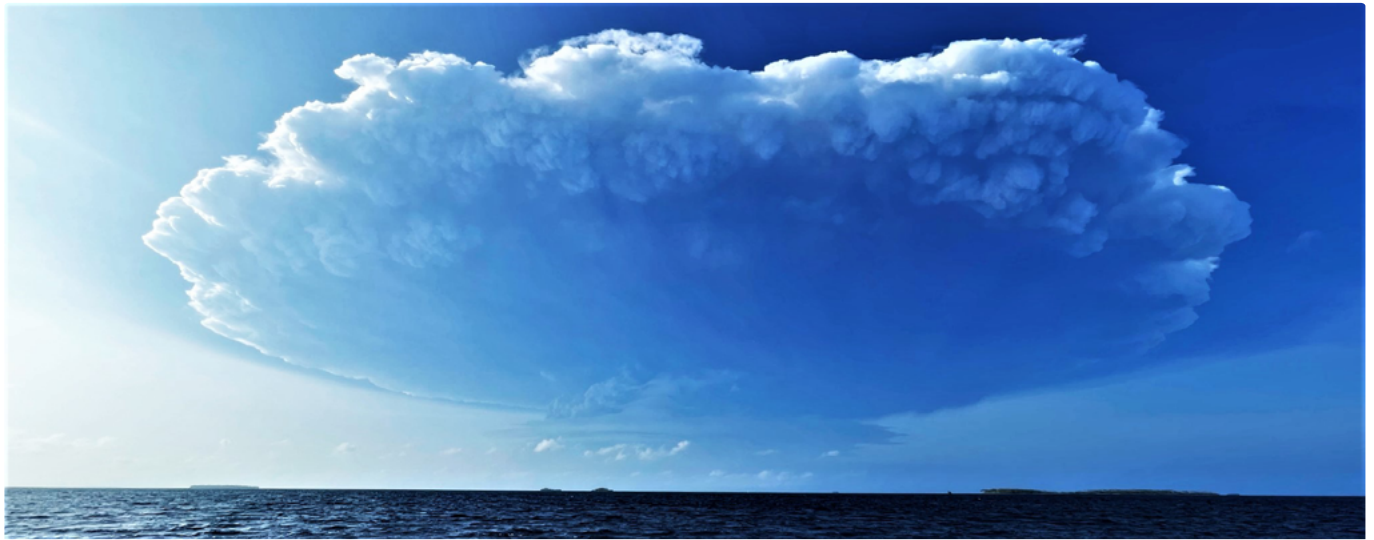
**Figure 1.1 (top)** The eruption rising to its climax at 5.24 pm (0424 UTC) January 15th from ~10 km north of Tongatapu (Photo: Branko Sugar); the upper plume is already >100 km wide. **Lower left** shows the location of major islands in the Kingdom of Tonga, with Hunga volcano indicated with a red triangle. **Lower right** shows the bathymetry around Tongatapu and Eua islands.

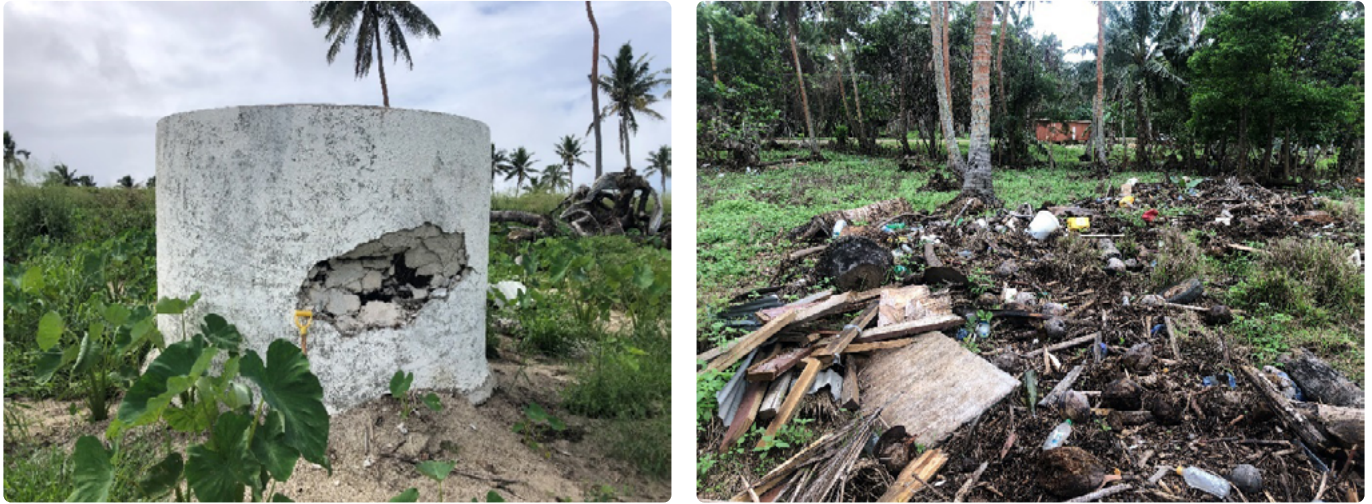
**Figure 1.5** Examples of field indicators used to deduce flow depths and inundation distances (left) evidence of debris impact on a concrete water tank and (right) deposited debris near the limit of inundation (Photos: Shane Cronin and TGS).

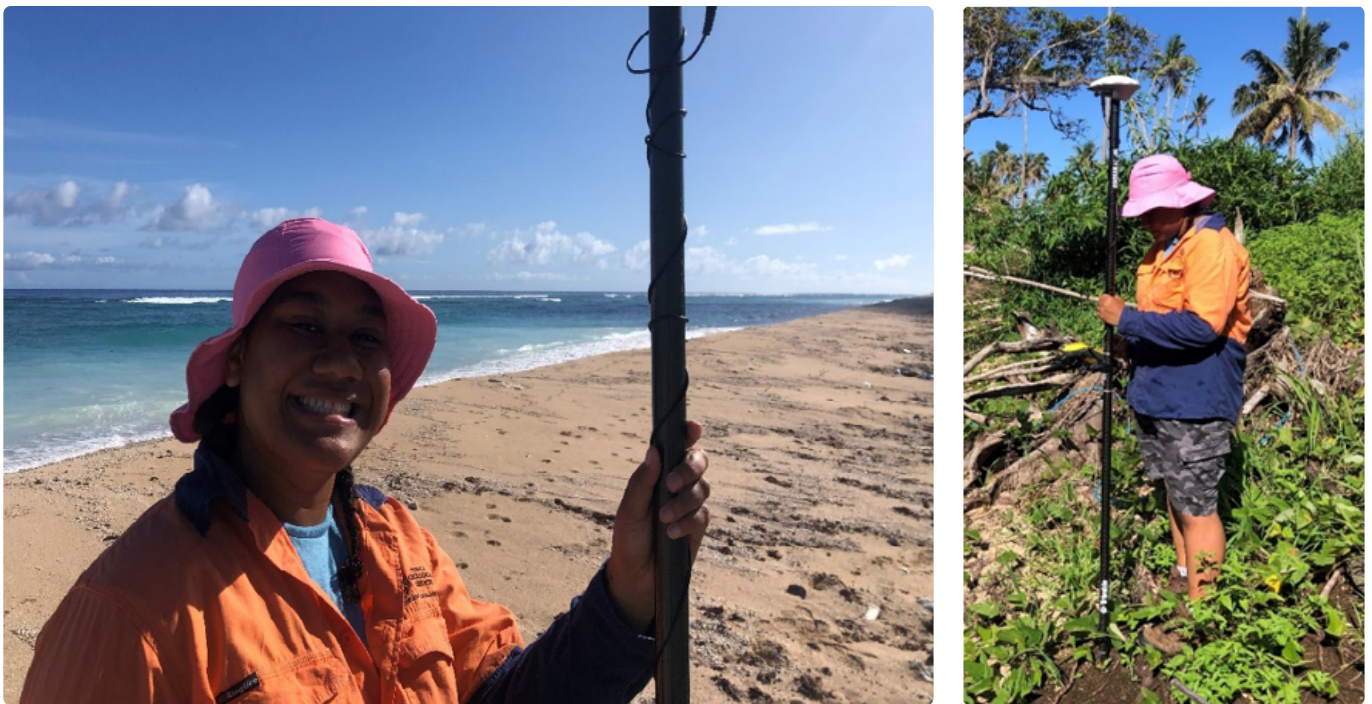
**Figure 1.6** Collecting position and elevation using a Trimble Geo7x RTK GPS receiver with additional Zephyr3 Antenna (GNSS data were collected in rover mode and differentially corrected using the Tonga base-station using Trimble Data Office software). (Photos: Shane Cronin and TGS).

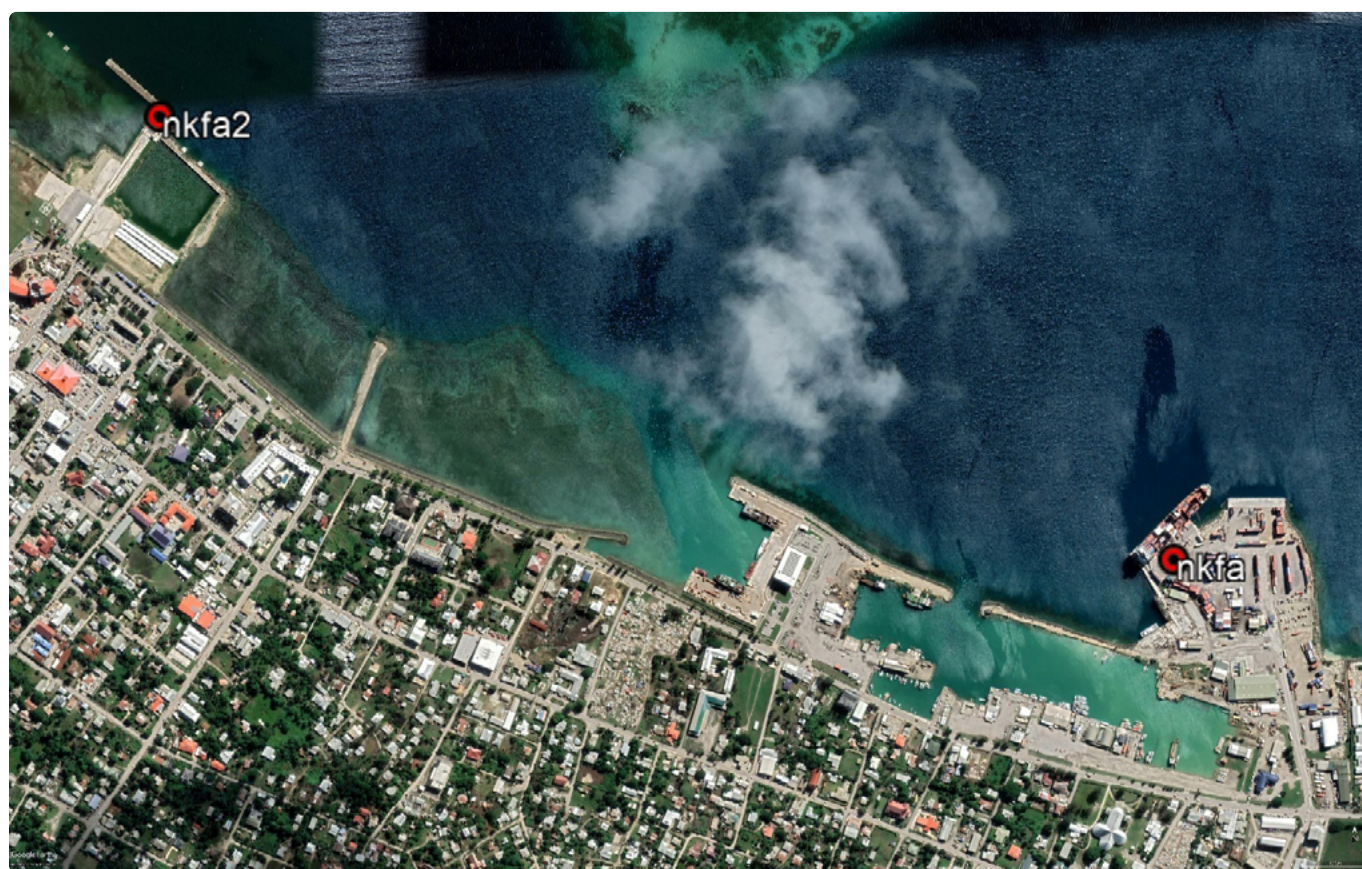
**Figure 1.8** Locations of the nkfa and nkfa2 tide gauges along the Nuku'alofa waterfront. (Google Earth)

Two tide gauges were in operation on the Nuku'alofa waterfront during the tsunami, the 'nkfa' sensor at Queen Salote Wharf and 'nkfa2' located 1.8 km to the west at the Vuna Wharf (see Figure 1.8 with station details in Table 1.3). Water level data was also recorded at Neiafu on Vava'u some 300 km north of Nuku'alofa (see Figure 1.1). In Nuku'alofa, at the time of the tsunami, only the 'nkfa' (Queen Salote Wharf) sensor was transmitting data to the IOC Sea Level Monitoring Facility website in real time (<https://www.ioc-sealevelmonitoring.org/>) and this gauge failed during the tsunami event as shown in Figure 1.9. After the event the Australian Bureau of Meteorology (BoM) released the complete data from the station at Vuna Wharf (nkfa2).

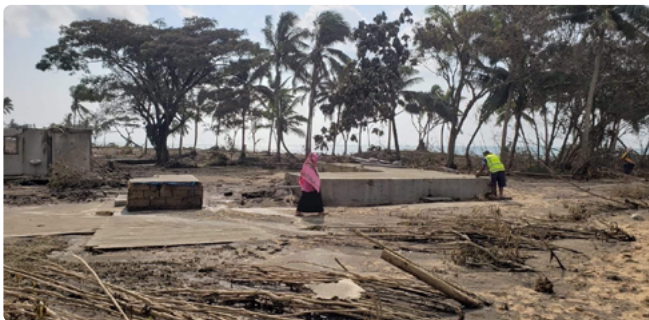
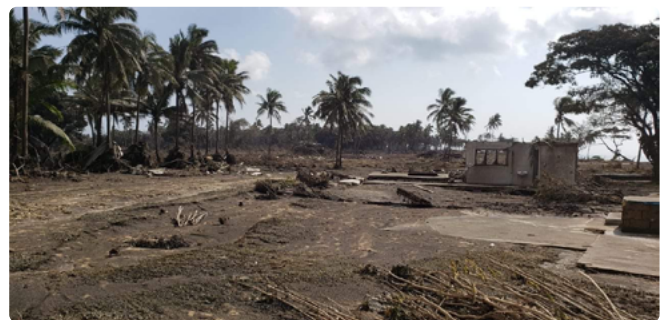
Figure 3.3 Buildings reduced to concrete foundations at the Ha'atafu Beach Resort (photos courtesy Moana Paea).

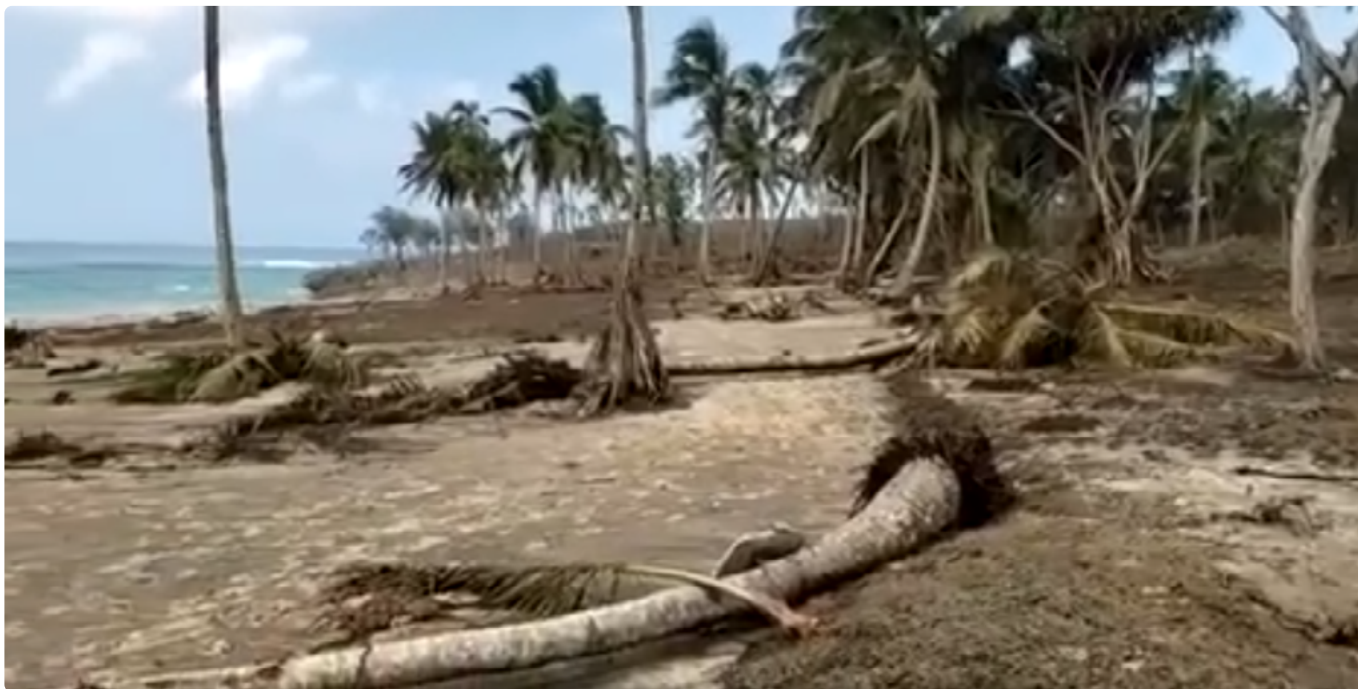
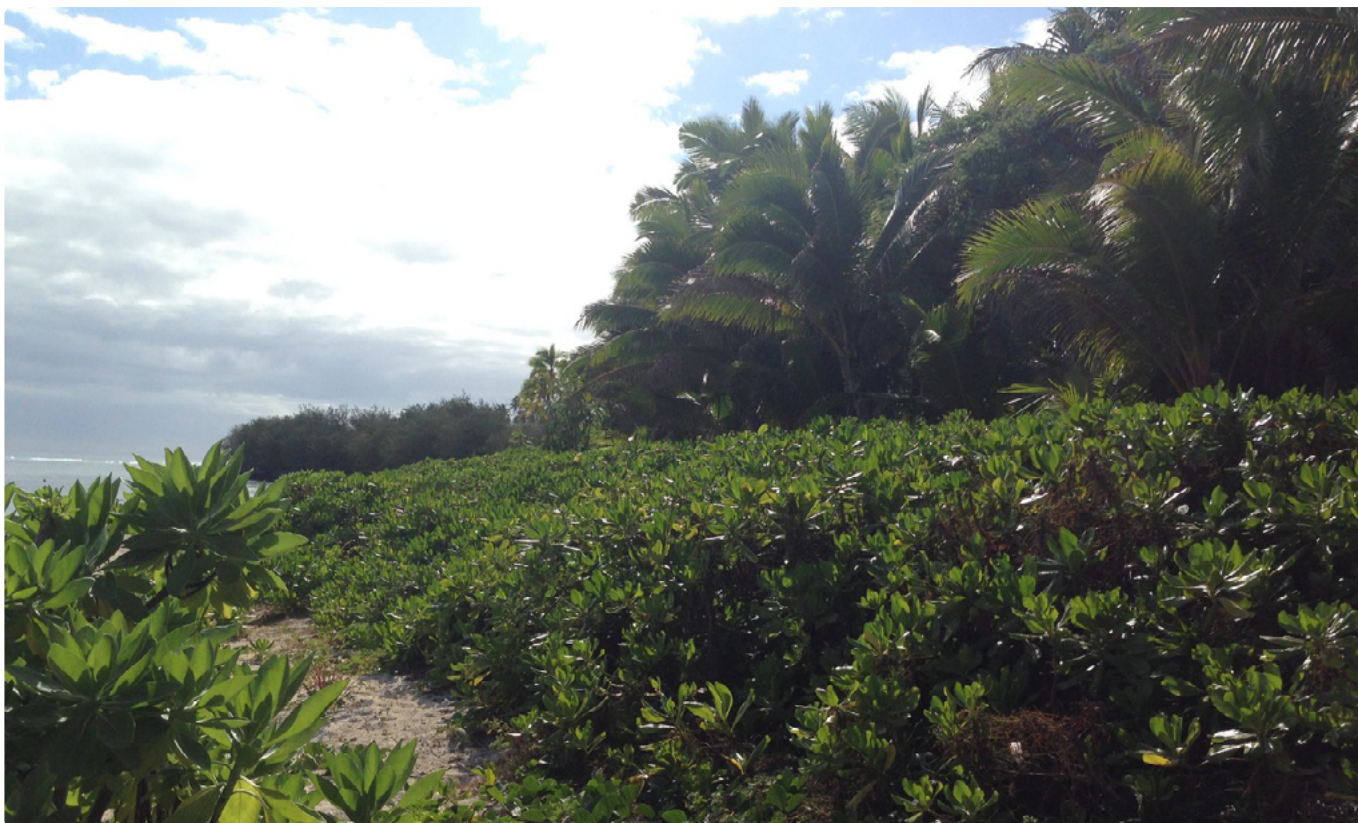
**Figure 3.4** The beach at Ha'atafu after the tsunami (top) and as it looked in 2015 (bottom). Top photo courtesy Moana Paea, bottom photo Jose Borrero.

At Ha'atafu near the northern tip of the peninsula, locally high topography did not allow for complete overtopping with runup stopping at 13-15 m. Just south of these transects, several beach resorts were located on land at elevations of ~5-7 m. This area was completely overrun by the tsunami which destroyed every structure, reducing reinforced concrete buildings to bare foundations (Figure 3.3). The force of the tsunami also stripped away nearly all the coastal vegetation as shown in Figure 3.4.

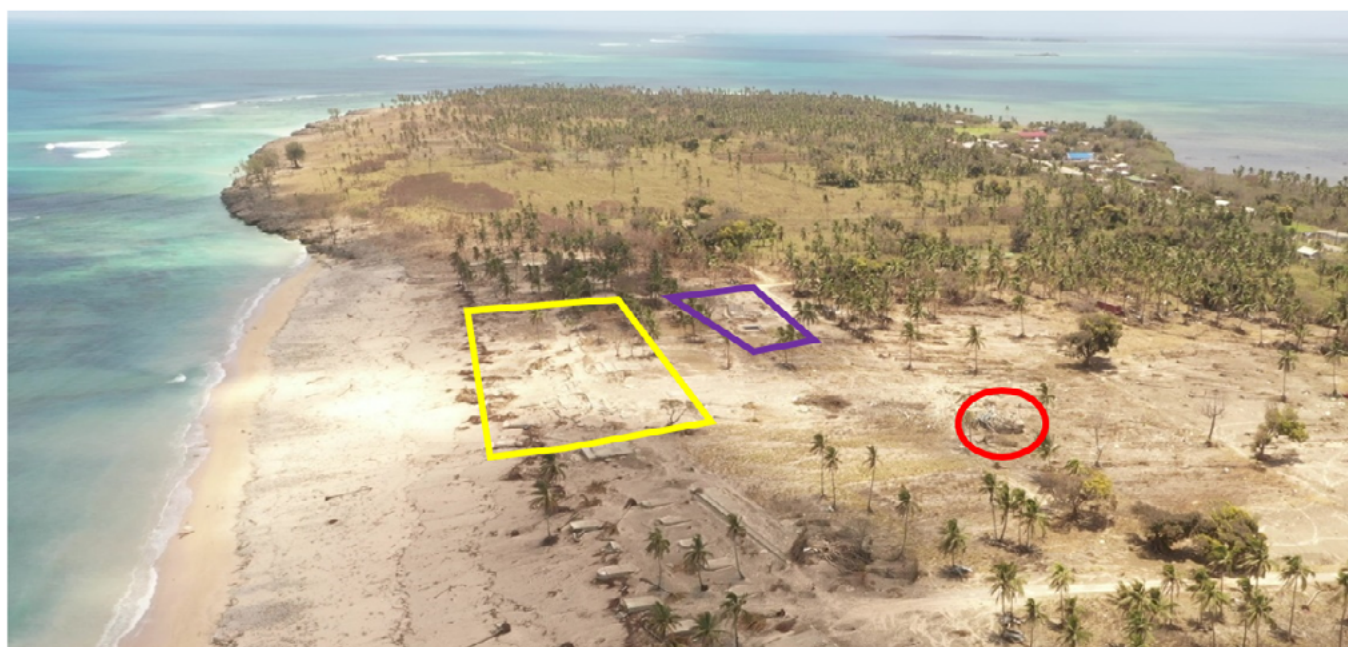
**Figure 3.5** The Ha'atafu section of the Hihifo Peninsula. Yellow is the site of Ha'atafu Beach Resort, Purple Holty's Hideaway and red circle is the 'tsunami rock'. (Photo: TGS)

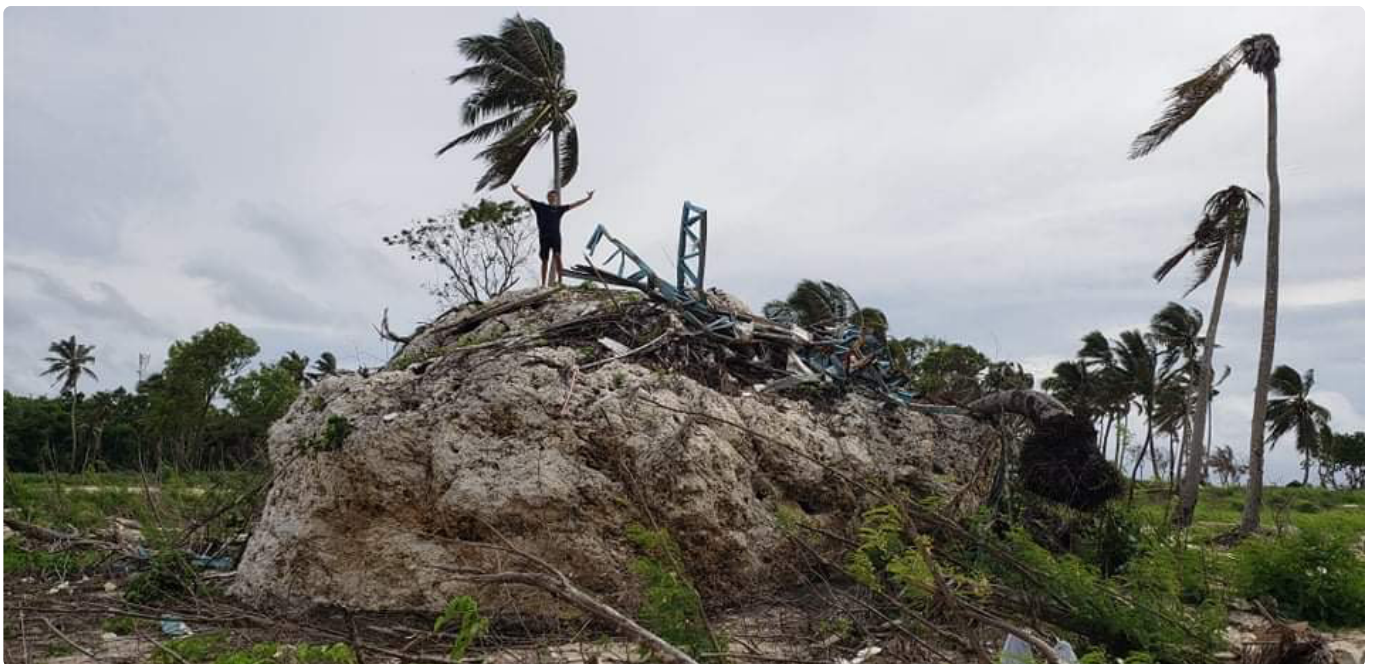
**Figure 3.6** The rock that the witness and family planned to use as a tsunami evacuation point. Fortunately, they did not find the rock during their escape as it was overtopped by the tsunami as indicated by the debris present on top of it. (Photo: Moana Paea)

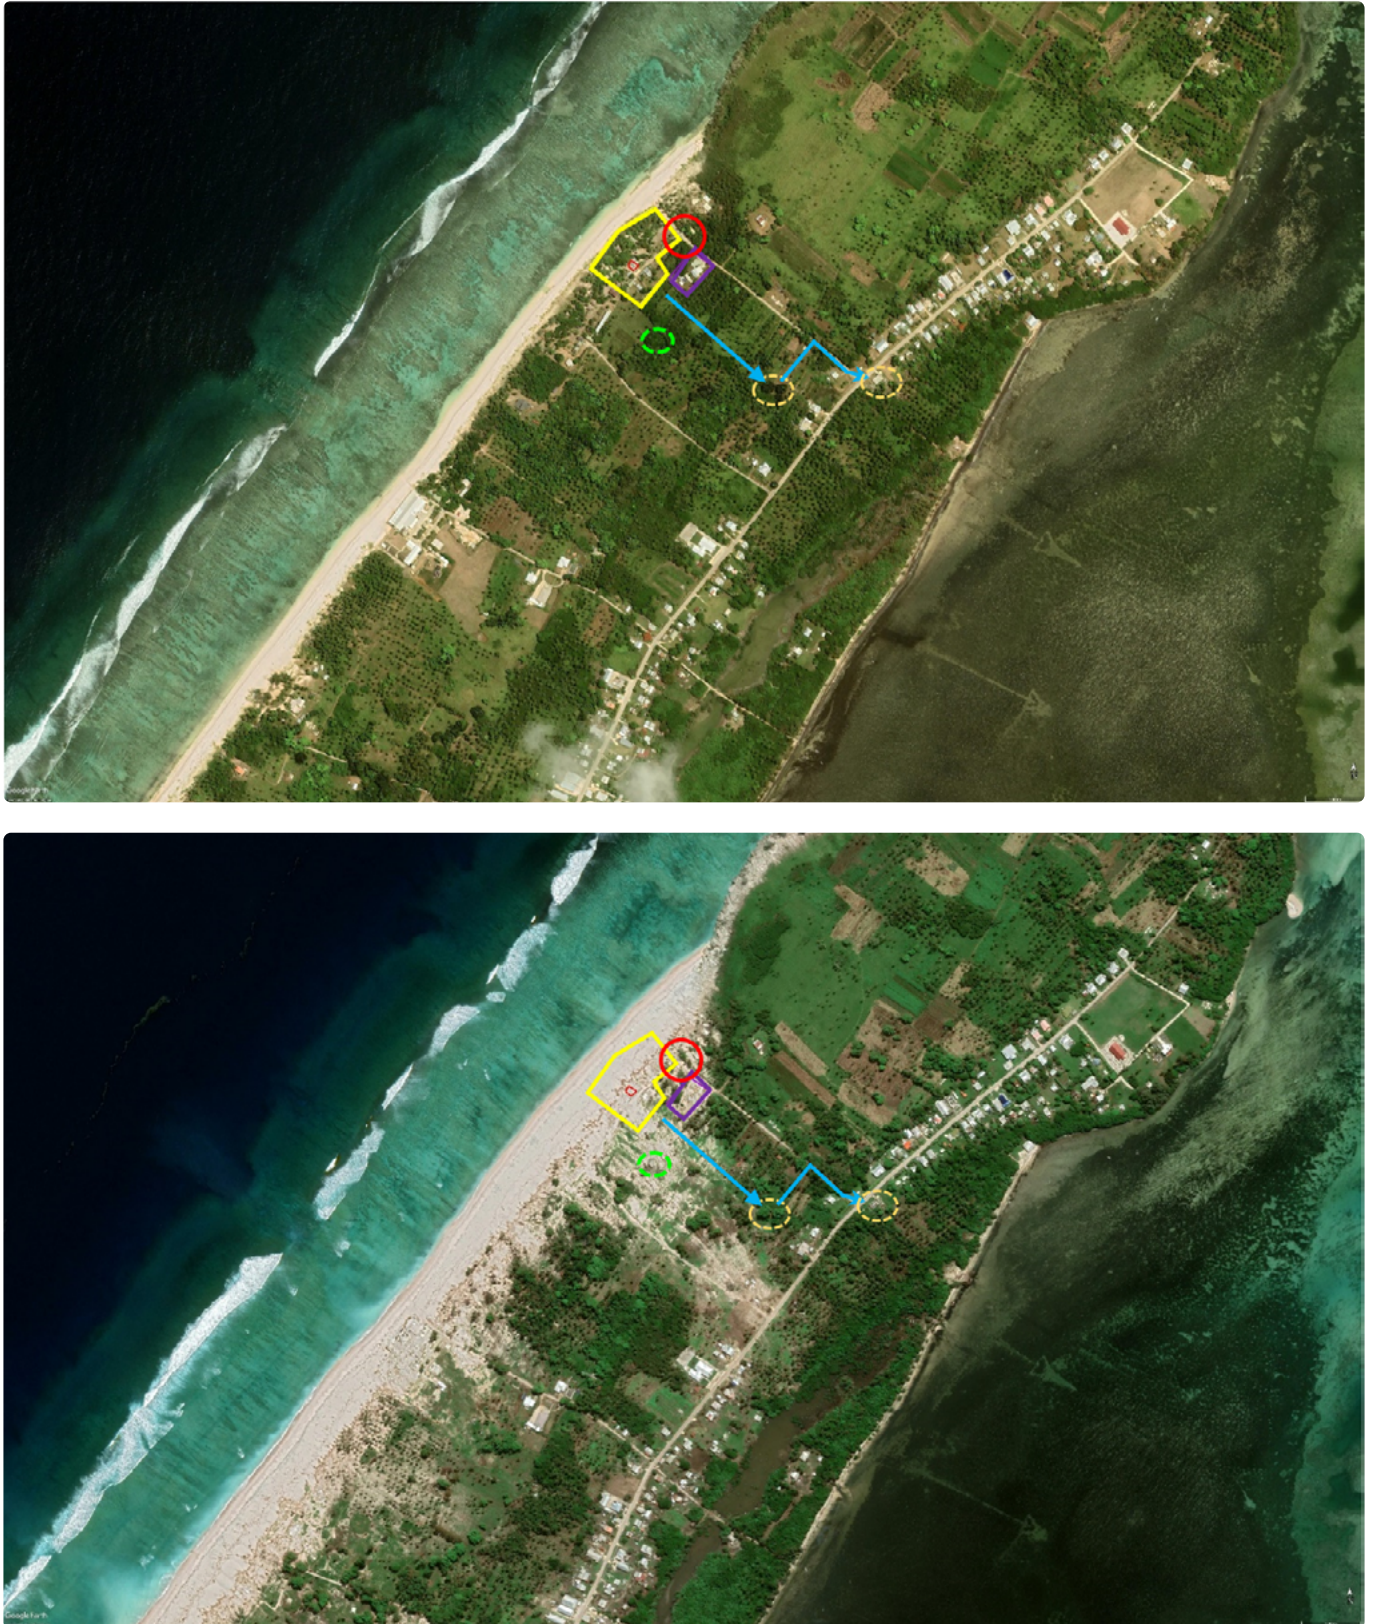
**Figure 3.7** The Ha'atafu-Kanokupolu area before (December 2021, top panel) and after (March 2022 bottom). Red circle indicates the location where the video discussed in the interview was filmed (Figure 3.8). Yellow and purple polygons are the Ha'atafu Beach Resort and Holty's Hideaway respectively. Blue arrow indicates the path run by the eyewitness and family to escape. The pale-yellow ovals along the route are the mango trees they climbed before moving on to the 2-storey house where they climbed up on the roof. The green dashed circle is the large rock shown in Figure 3.6. (Imagery from Google Earth)

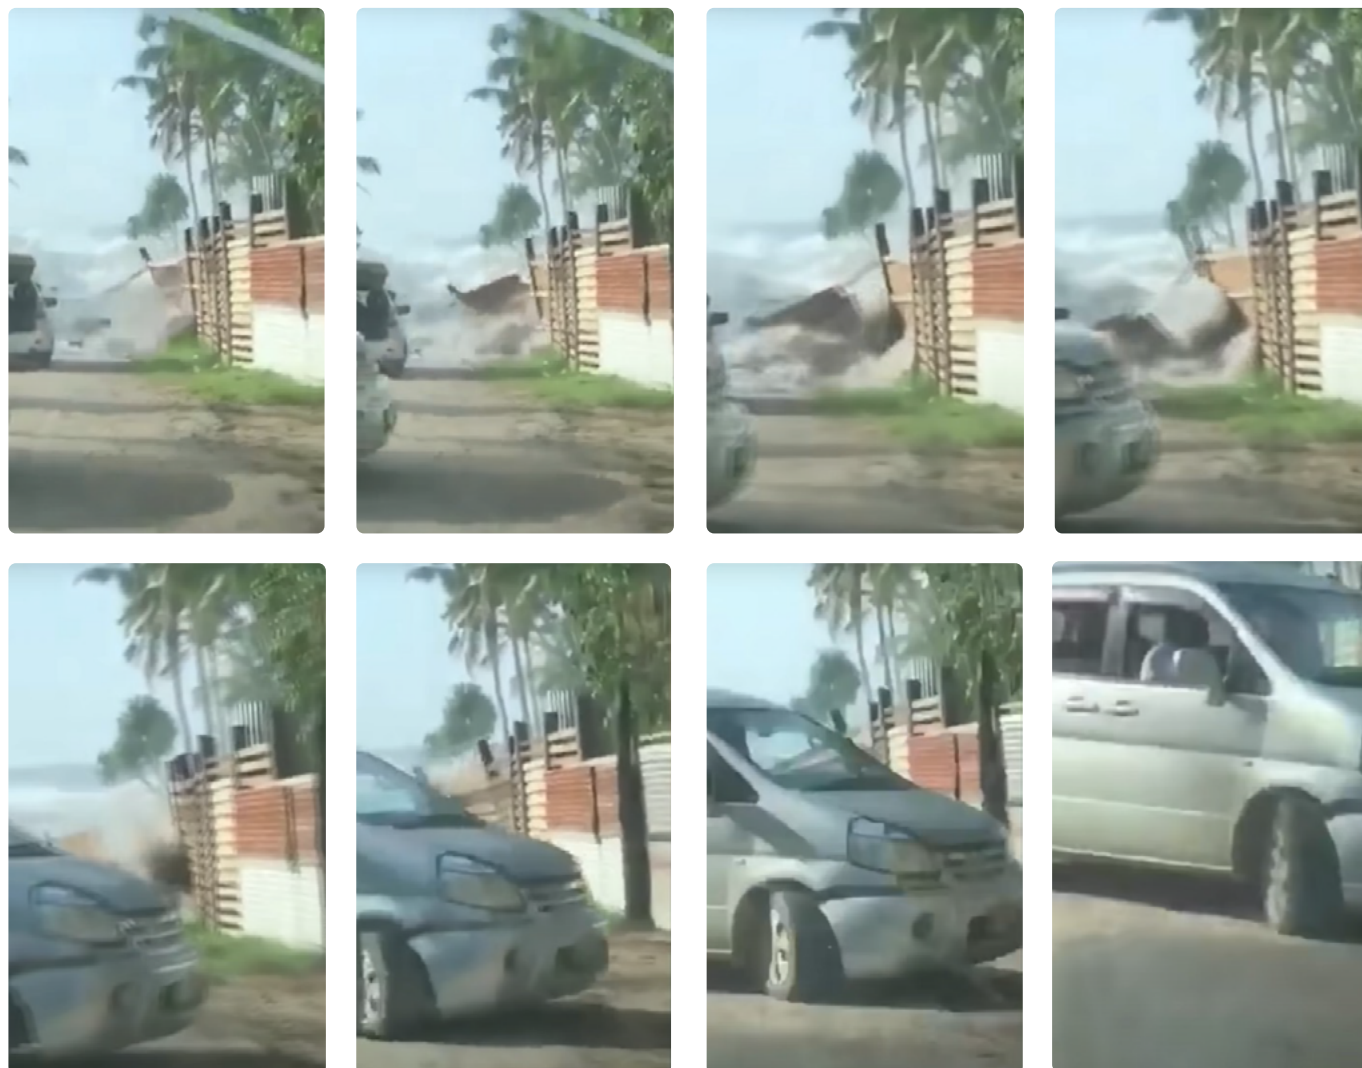
**Figure 3.8** Tsunami wave advancing up the access road just north of the Ha’atafu Beach Resort. View is towards the west with the ocean approximately 150 m away. This scene occurred shortly after Ms. Paea, family and staff evacuated on foot and just before one of the large explosions was heard.

A video circulating on news and social media shows a surge of water coming up a narrow street, ripping down a fence as it advances. This video was recorded at about the same time that the eyewitness reached the car park and saw the cars reversing. Frame grabs from that video are presented in Figure 3.8 below. This is the second wave as described by the eyewitness.

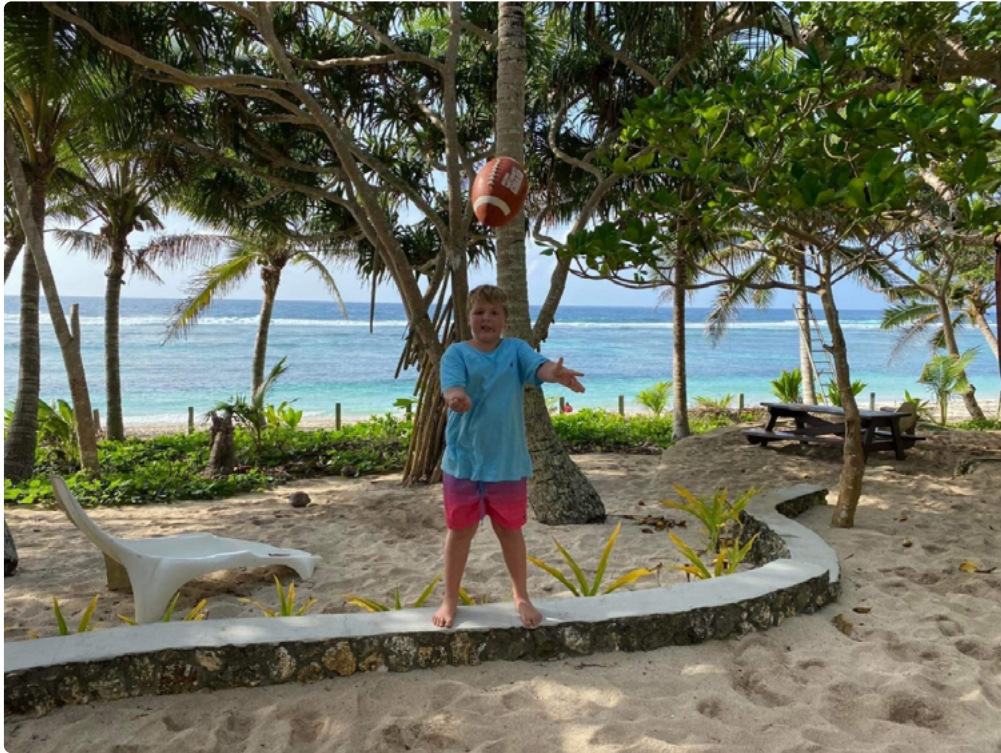
**Figure 3.9** (following pages) Photos provided by Ms. Rachael Moore of the first of the early arrival tsunami waves affecting the Ha'atafu Beach area. The time stamp is taken directly from the photo file metadata.

**4:41:32 PM:** Playing on the upper beach, the sea state appears relatively normal.

The images on the following pages (Figure 3.9) are provided by Ms. Moore and show the transition of the sea state as the first tsunami waves affected the Hihifo Peninsula. The sequence starts at 4:41 pm with the ocean looking relatively normal. 33 minutes later at 5:14 an advancing bore of white water can be seen. Over the next minute, the leading edge of the bore can be seen to just reach the edge of the vegetation as her sons look on (3<sup>rd</sup> and 4<sup>th</sup> images). The final image 2 minutes later shows the agitated nature of the sea.

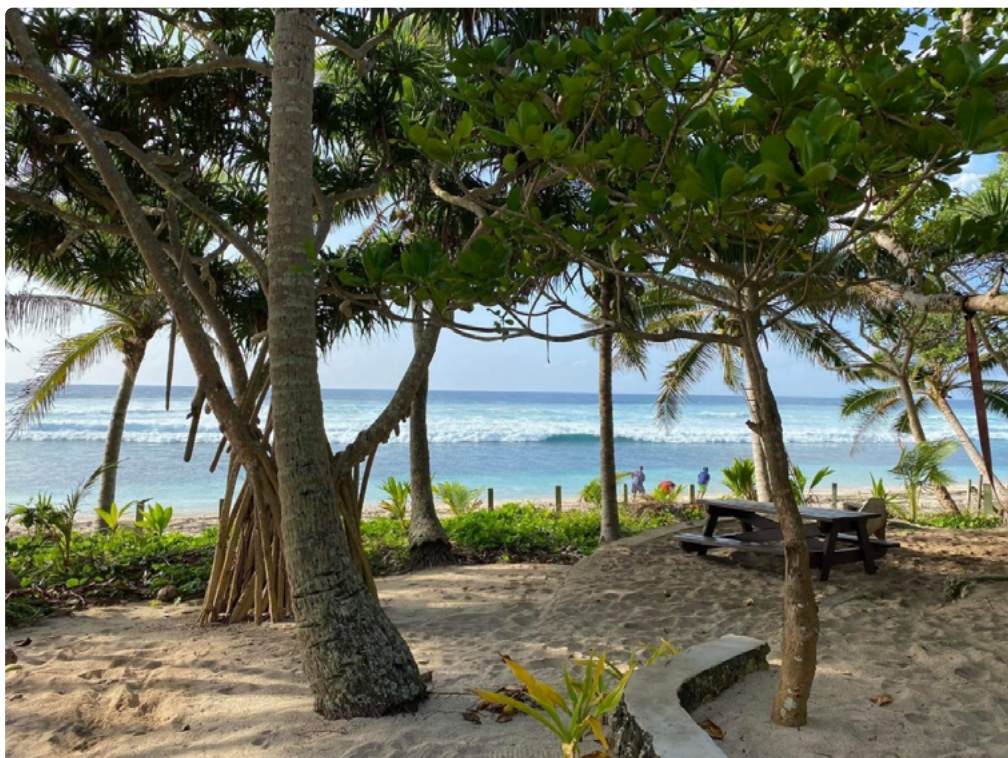
**5:14:32 PM:** A bore can be seen advancing towards the beach between the offshore reef and the beach face.

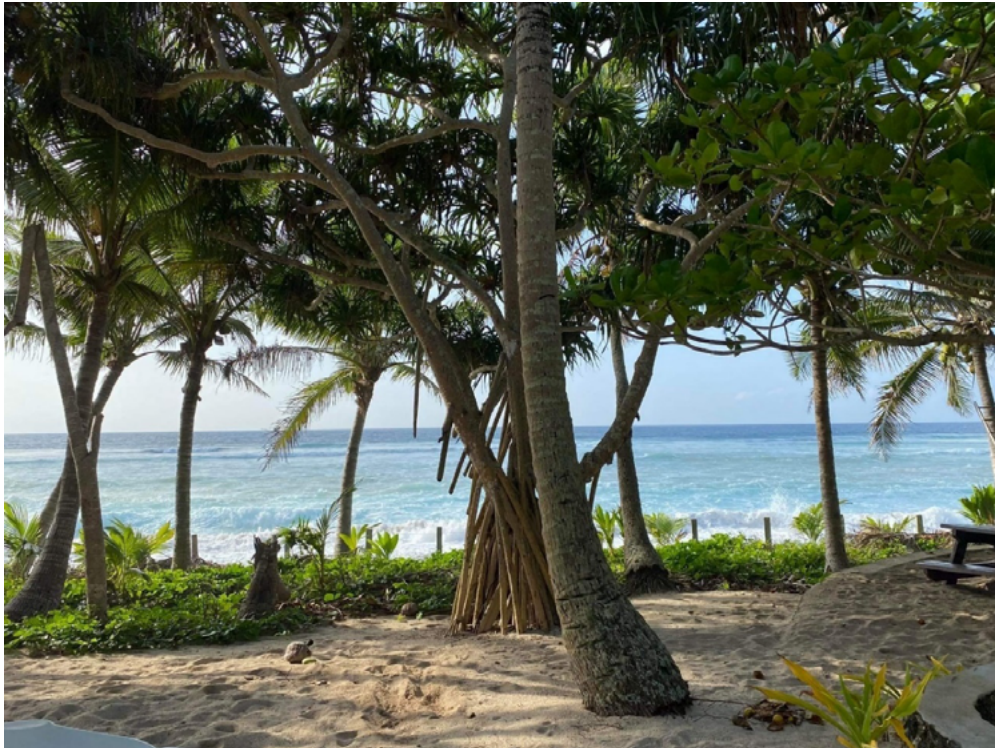
**5:14:57 PM:** The bore has reached the beach

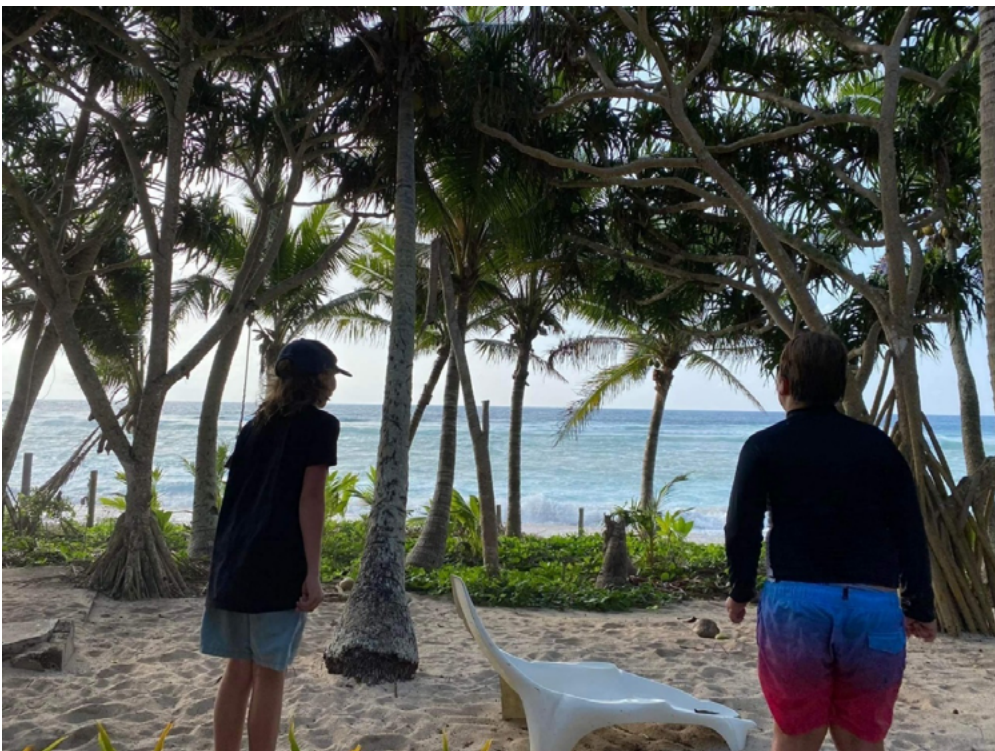
**5:15:11 PM:** The bore interacting with the beach.

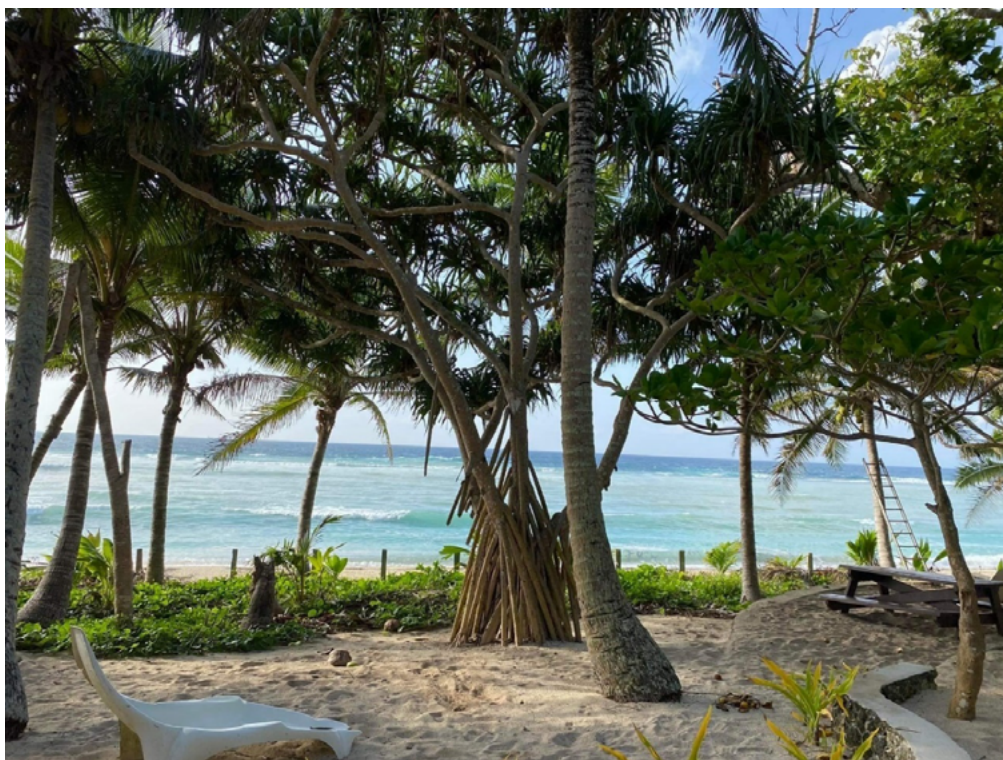
**5:17:38 PM:** A few minutes later, ocean still appears agitated.

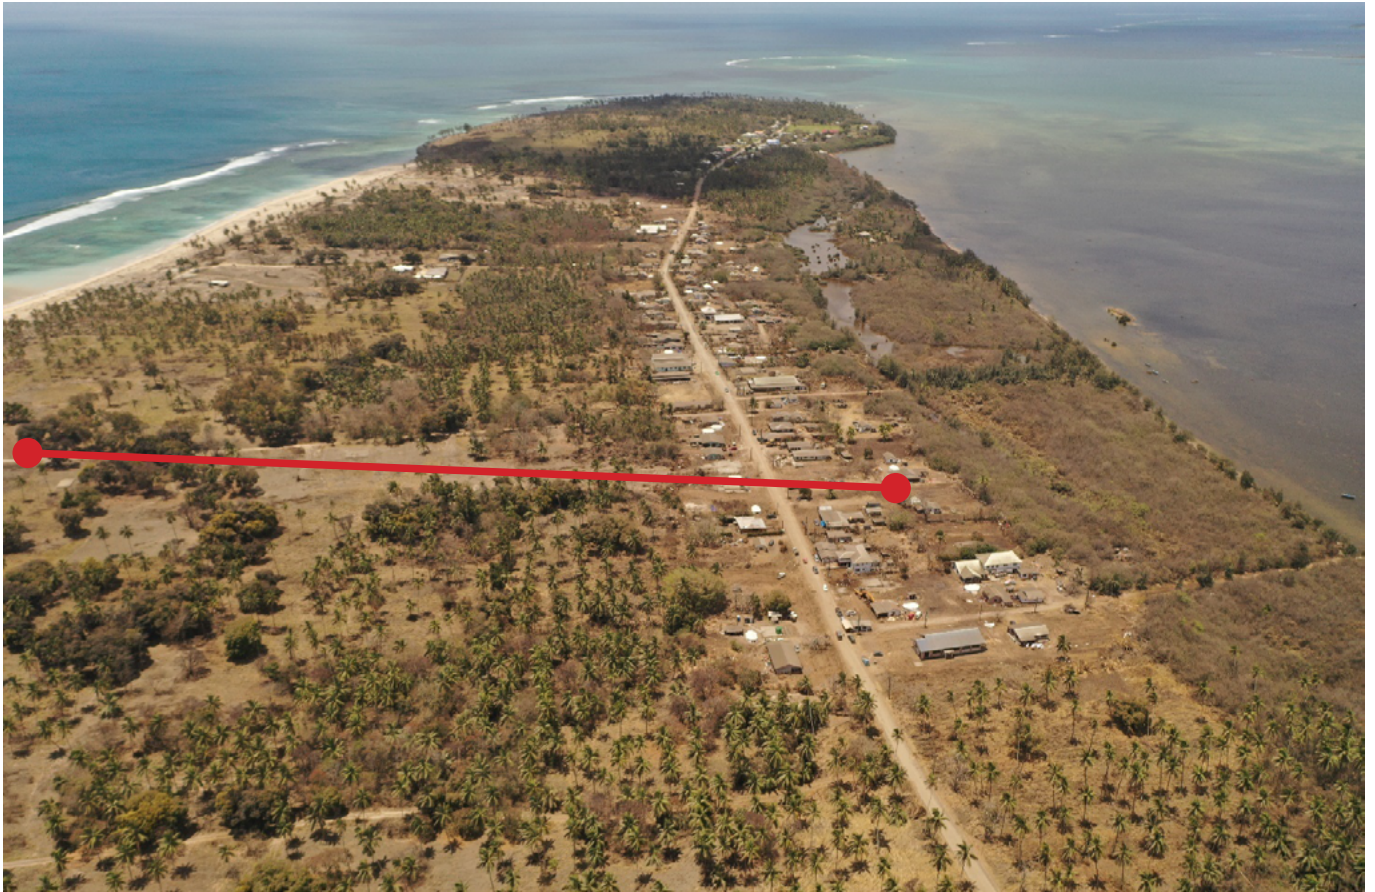
**Figure 3.11** UAV image of Kanokupolu. Red line shows the approximate location of the transect depicted in Figure 3.12. (Photo; TGS)

At Kanokupolu the tsunami overtopped the peninsula flowing across into the lagoon. A weather station positioned on a cell phone tower with base at a ground elevation of approximately 13 m above sea level was destroyed by the tsunami. The station observed the onset of the eruption and reported data until 05:00 UTC (18:00 local time). Three days after the tsunami, a site visit revealed that the tower had been toppled and transported approximately 20 m from its original location, suggesting tsunami flow elevations significantly greater than 13 m above mean sea level. One woman, Angela Glover (51) a British national, was killed in Kanokupolu (Matai Tonga, 2022, Reuters, 2022)

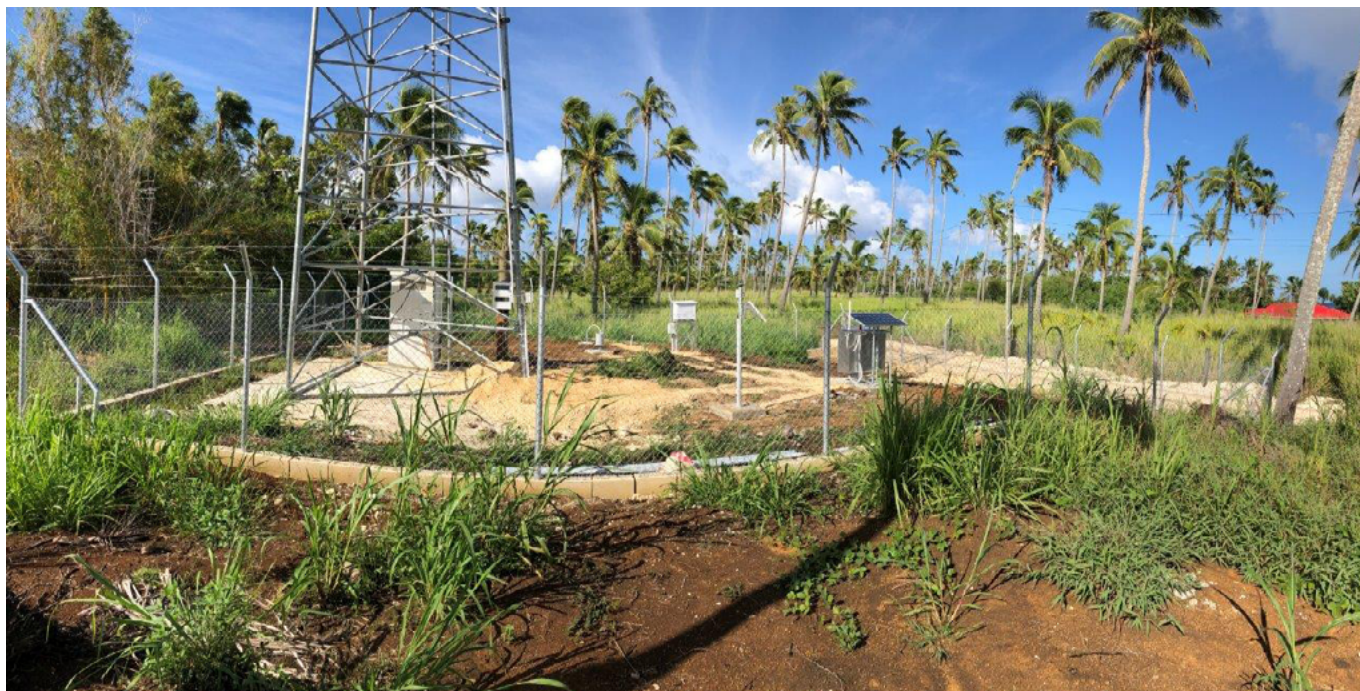
**Figure 3.13** (top) The weather station prior to the tsunami and (bottom) after. (Photos: Shane Cronin and TGS).

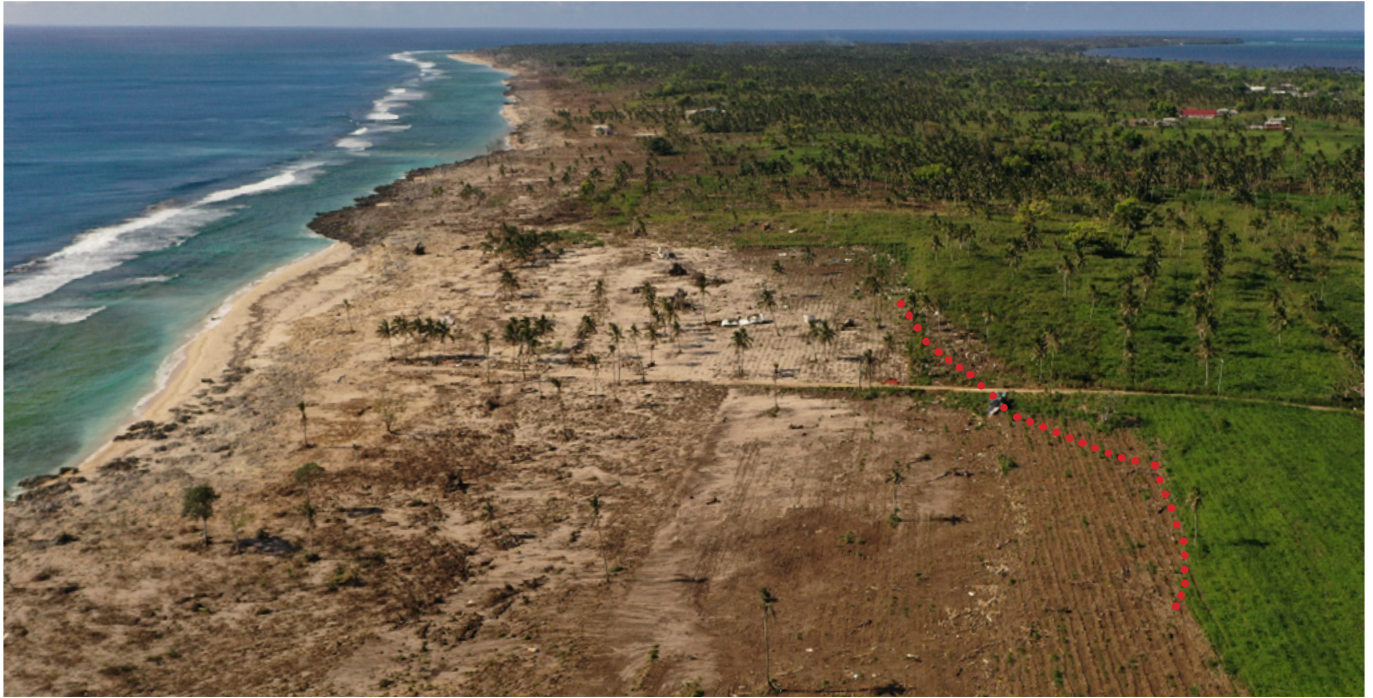
**Figure 3.14** Aerial view of the Utukehe area. The tsunami inundation extent is clearly visible in the agricultural field and indicated with the dashed line. (Photo: Taaniela Kula TGS)

The western peninsula was overtopped from Ha'atafu to approximately 2.5 km south (see Figure 3.1 for inundation extents). South of this, higher and steeper topography prevented the tsunami from overtopping the peninsula and measures of true runup could be obtained, i.e. runup against a steep slope where the point of maximum inundation is also the height of the tsunami runup. An example of this is shown in Figure 3.14 at Utukehe, where a clear demarcation of the inundated area can be seen. with representative transects for Kolovai and Utukehe shown in Figure 3.15. In these areas runup was measured to be 15-16 m above MSL.

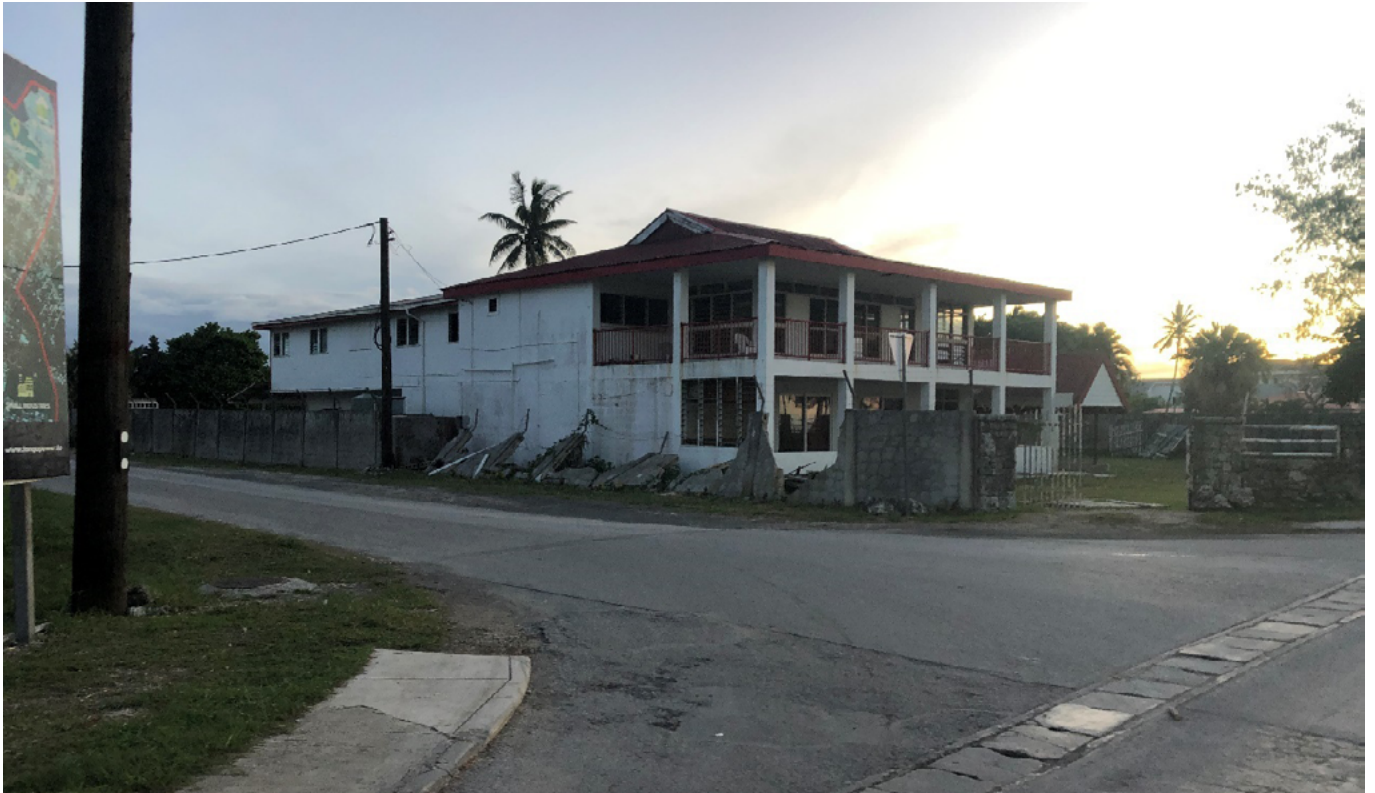
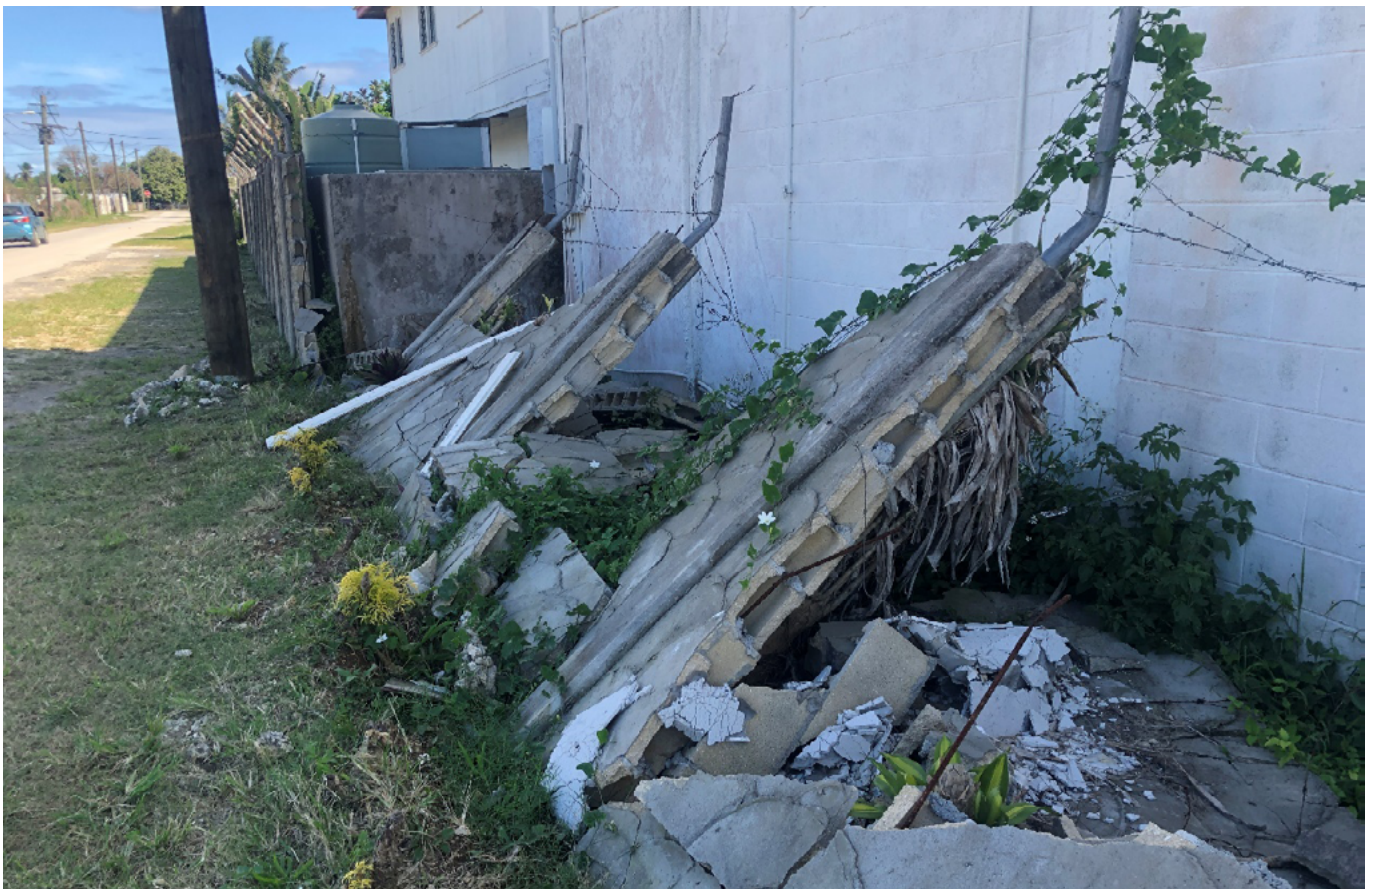
**Figure 3.17** Toppled wall in Nuku'alofa. (Photos: Shane Cronin and TGS).

Buildings in the built-up areas of Nukualofa suffered damage typical for a tsunami of this size, that is, toppled walls made of unreinforced masonry (Figure 3.17) and the lower portions of walls being blown out (Figure 3.17.)
