# Field Survey of Runup and Inundation in Tonga from the January 2022 eruption of the **HUNGA VOLCANO**

# Field Survey of Runup and Inundation in Tonga from the January 2022 eruption of the Hunga Volcano

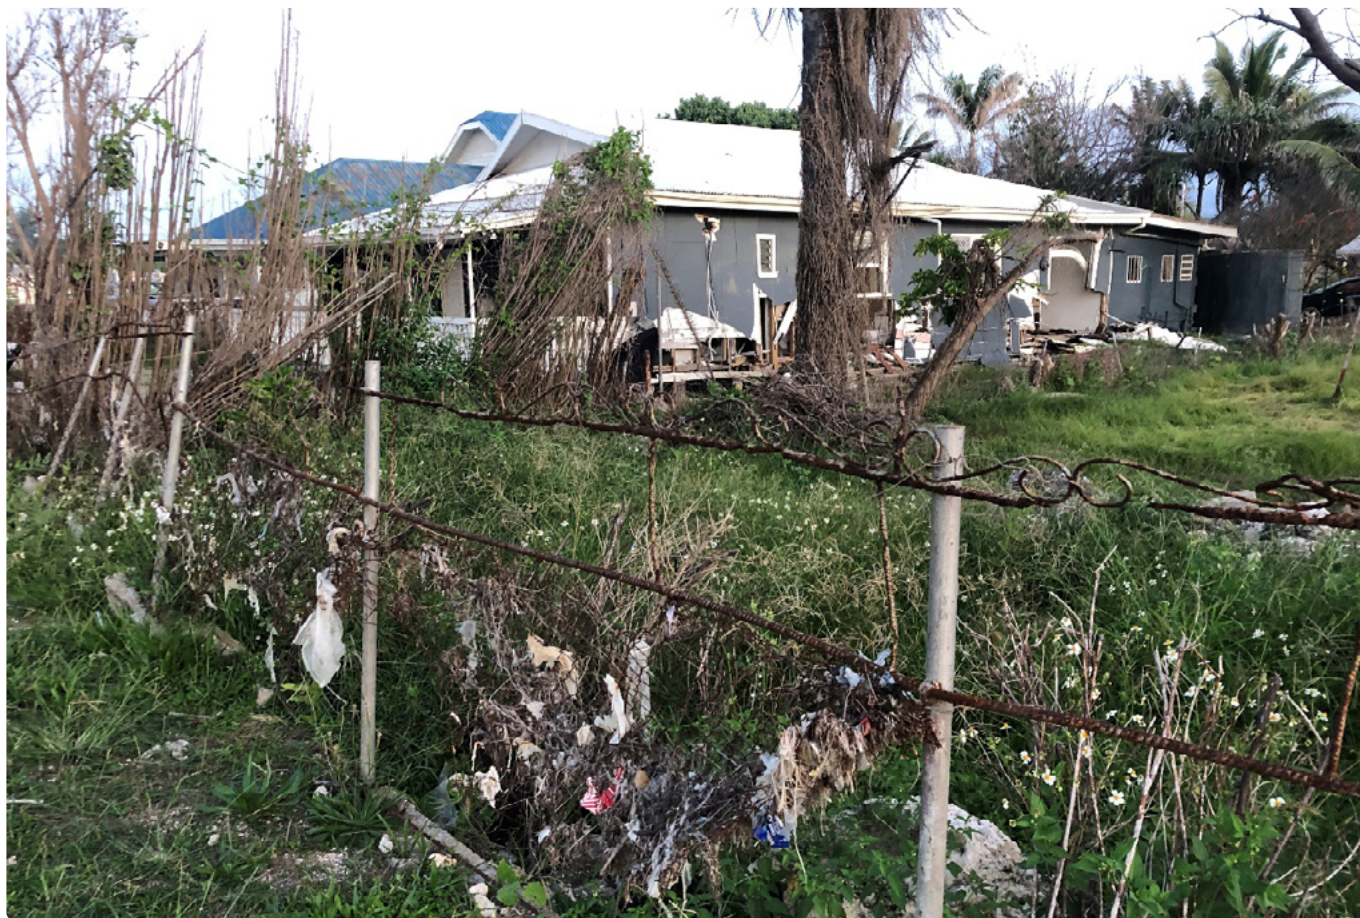
**Figure 3.18** (top) Damaged house with the lower portion of that walls blown out, caused by the tsunami surge. (bottom) A coastal revetment and walkway in Nuku'alofa survived largely intact. (Photos: Shane Cronin and TGS).

Buildings in the built-up areas of Nukualofa suffered damage typical for a tsunami of this size, that is, toppled walls made of unreinforced masonry (Figure 3.17) and the lower portions of walls being blown out (Figure 3.17.)

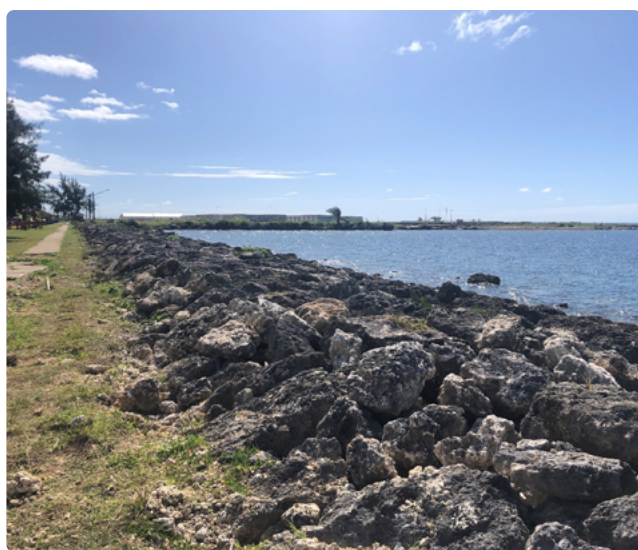
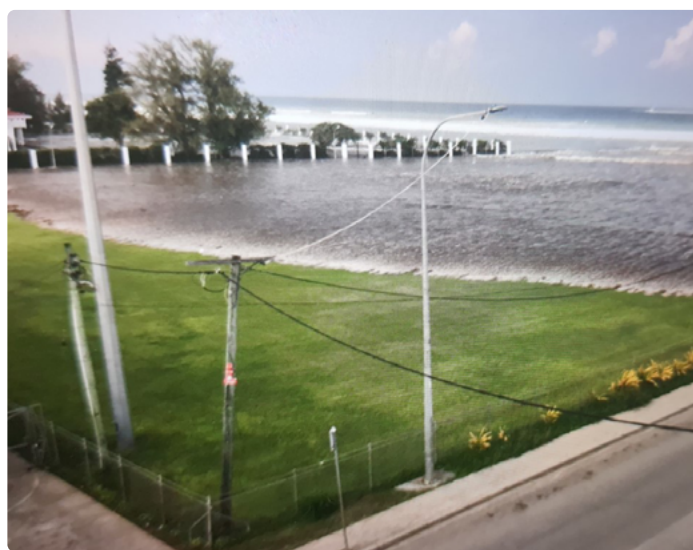
**Figure 3.19** Tsunami surge coming ashore on the grounds of the Royal Palace of Tonga in Nuku'alofa. Photo is taken from the government offices adjacent to the Vuna Wharf.

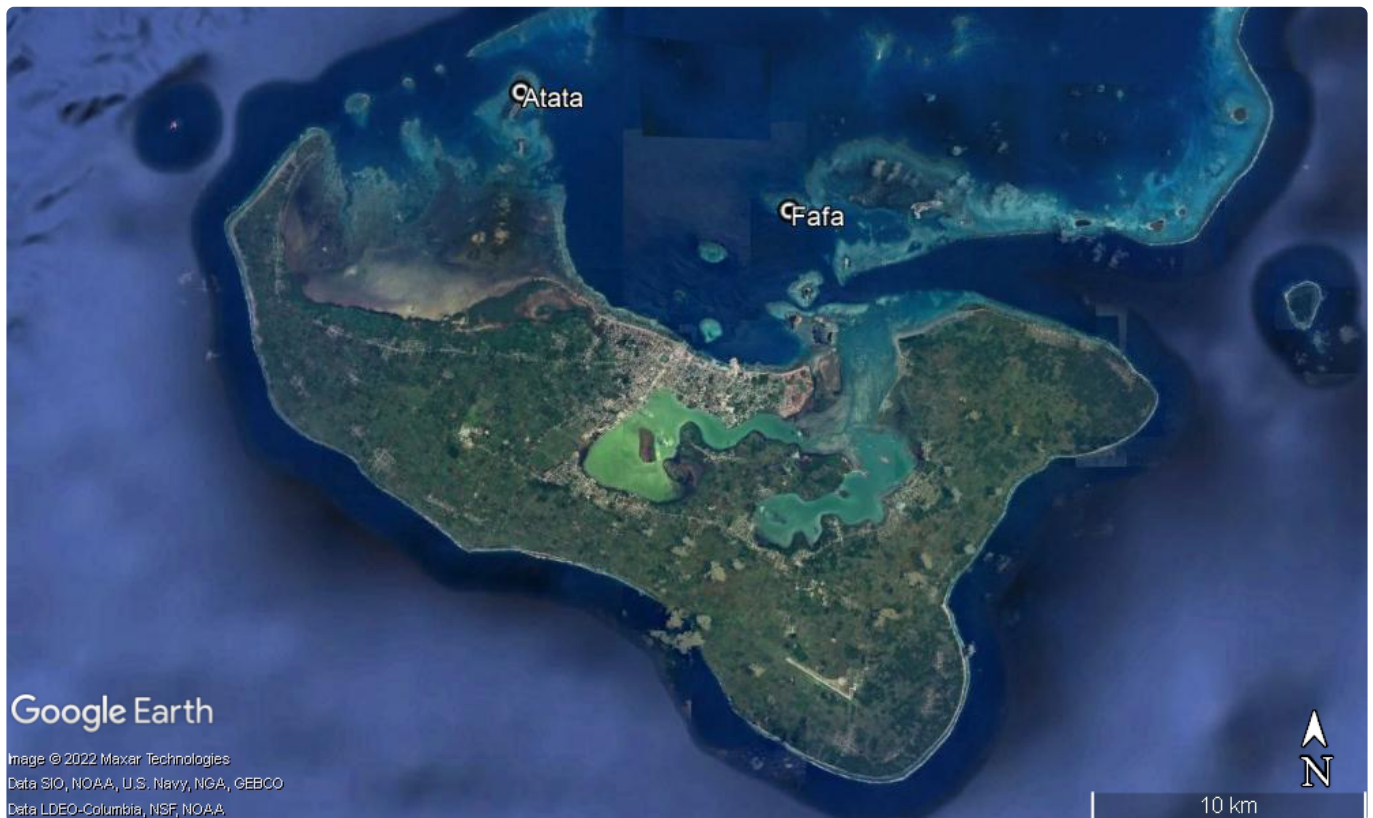
**Figure 3.20** Location of Atata and Fafa, north of Tongatapu.

Atata and Fafa are small islands located off the northern coast of Tongatapu (Figure 3.20). Due to their relatively exposed location, they were strongly affected by the tsunami waves. The low-lying peninsula protruding southward from Atata (Figure 3.21) was completely overtopped with tsunami heights of ~6 m (~4 m flow depth). Runup heights on the higher topography of the island were 6-8 m (Figure 3.22). The island of Fafa was (Figure 3.25) also completely overtopped, also with tsunami heights of 6-8 m flowing over the low-lying topography (Figure 3.26).

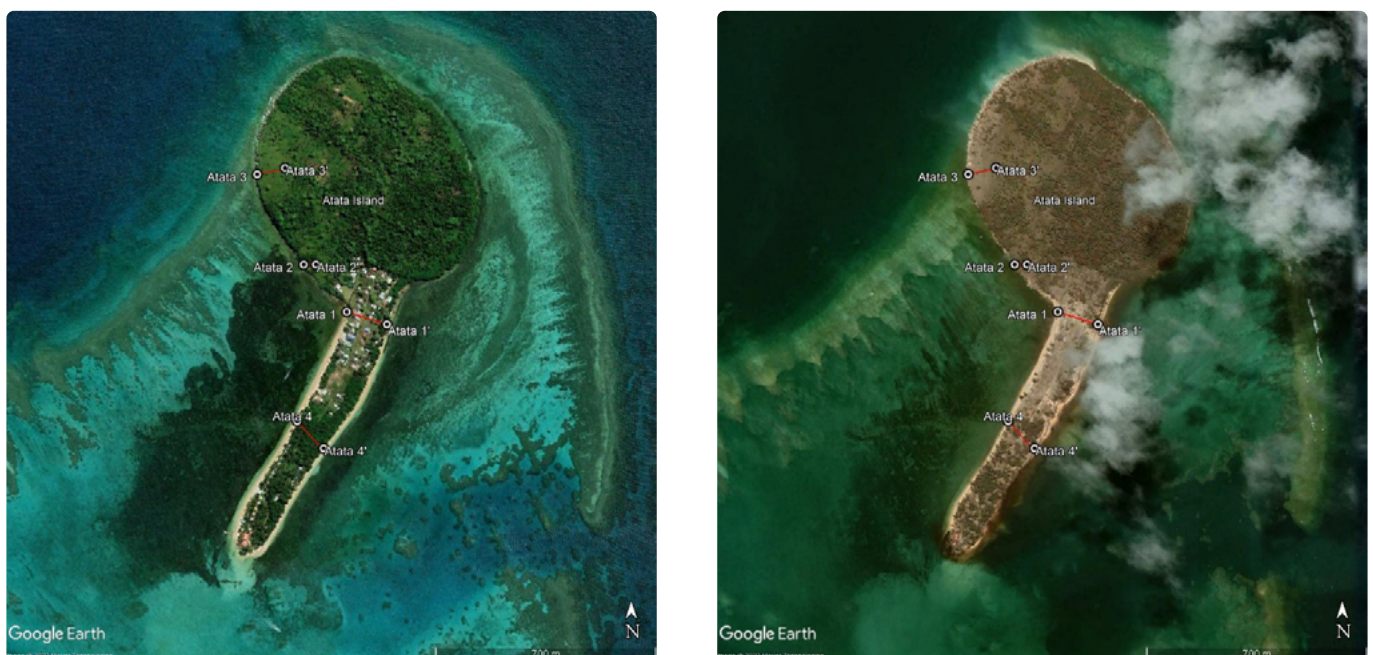
**Figure 3.21** Locations surveyed on Atata. Before tsunami on left, after on right.

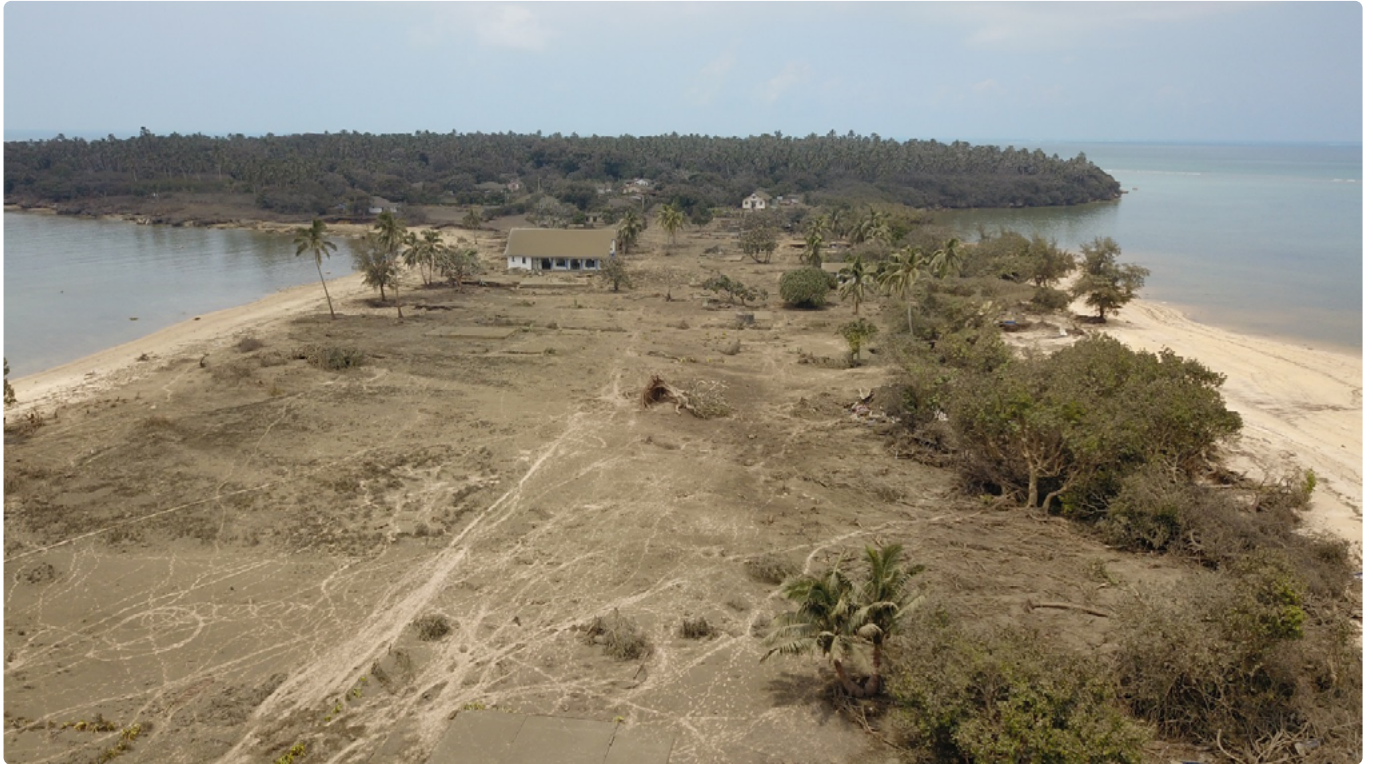
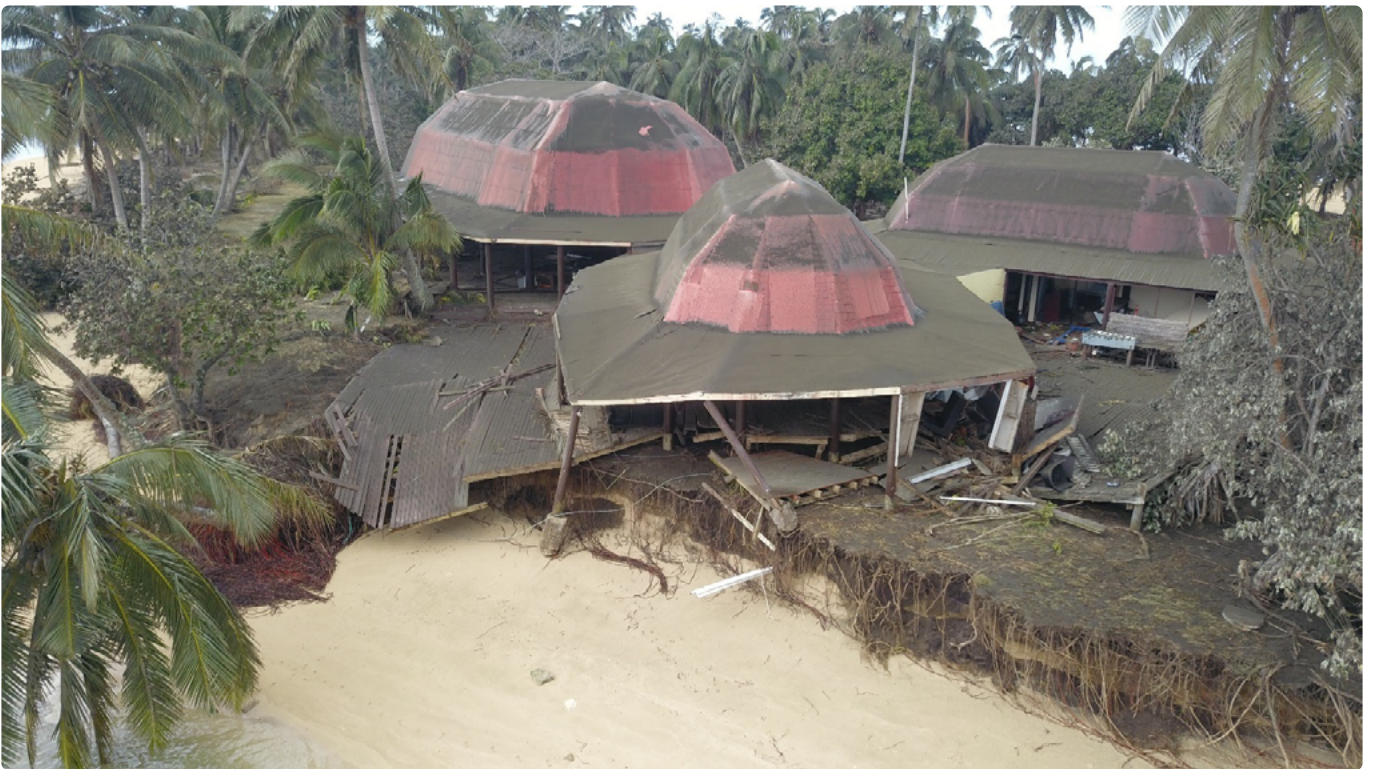
**Figure 3.23** (top) The overtopped spit on Atata and (bottom) damage to structures on the island. (Photos: Taaniela Kula TGS).

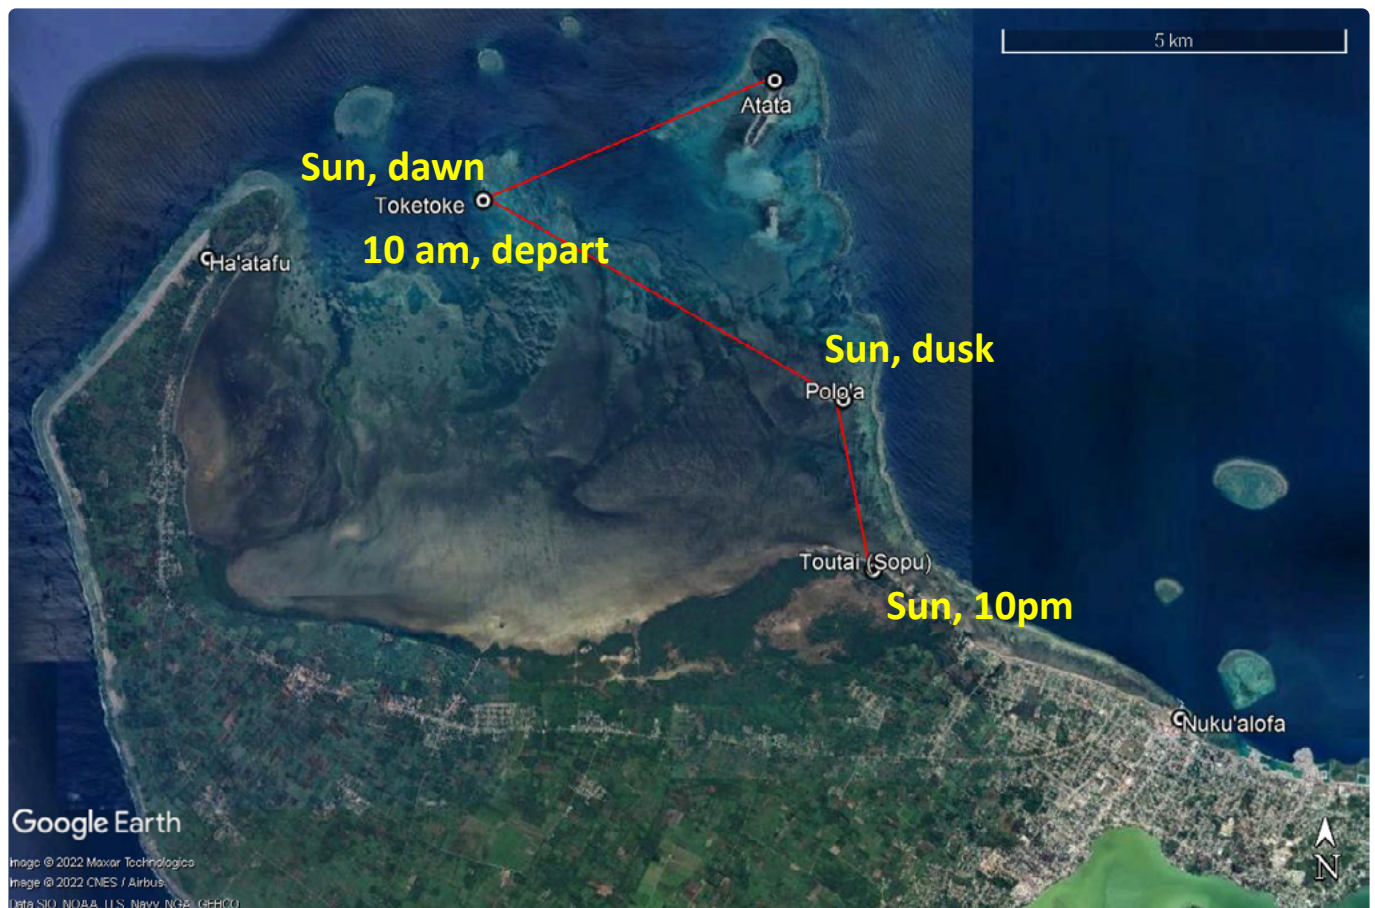
**Figure 3.24** Lisala Folau's path after being washed off Atata by a tsunami wave. He floated and swam for 28 hours before coming ashore at Sopo, west of Nuku'alofa.

Atata Island was the site of another remarkable tale of survival. This one by Lisala Folau a resident of Atata. The tsunami swept Mr. Folau out to sea at approximately 6 pm on Saturday and he was forced to swim and float on debris, before eventually making his way to the main island of Tongatapu at Sopo at 10 pm on Sunday night. Mr. Folau's path is shown in Figure 3.24 and the extended version of his story is reproduced from Facebook posts in Appendix I.

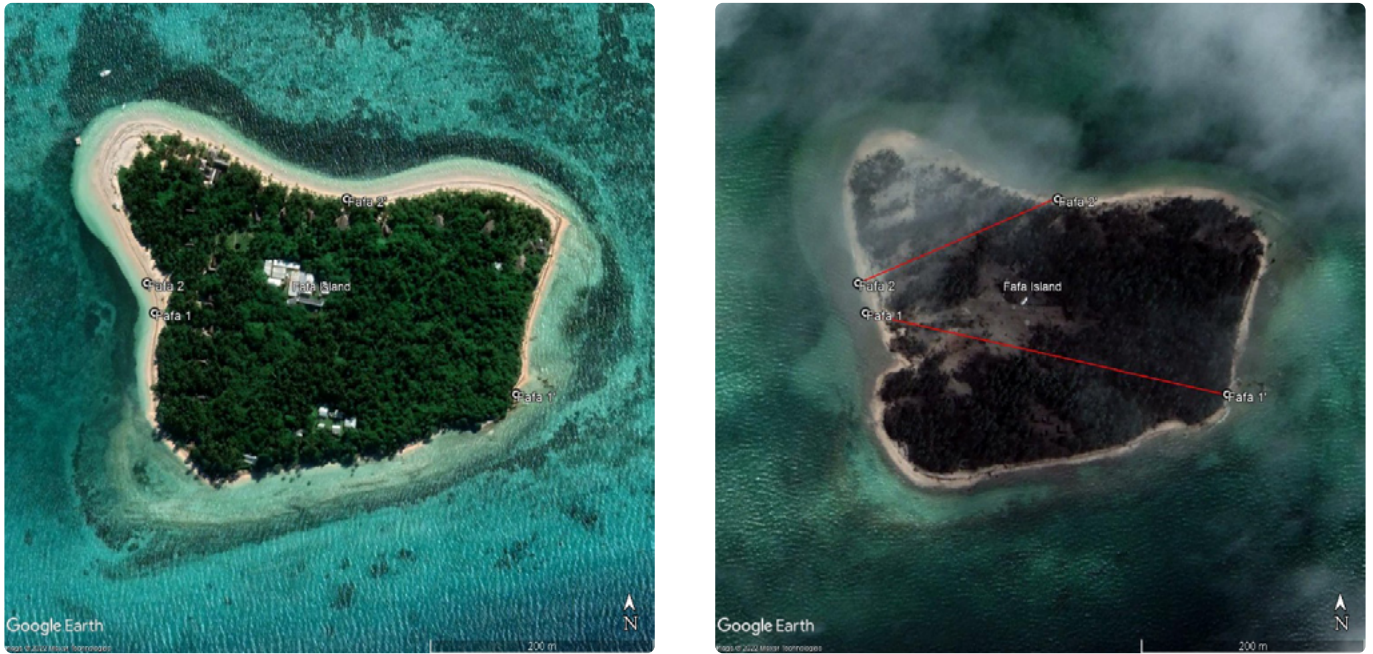
**Figure 3.25** Locations surveyed on Fafa. Before tsunami on left, after on right.

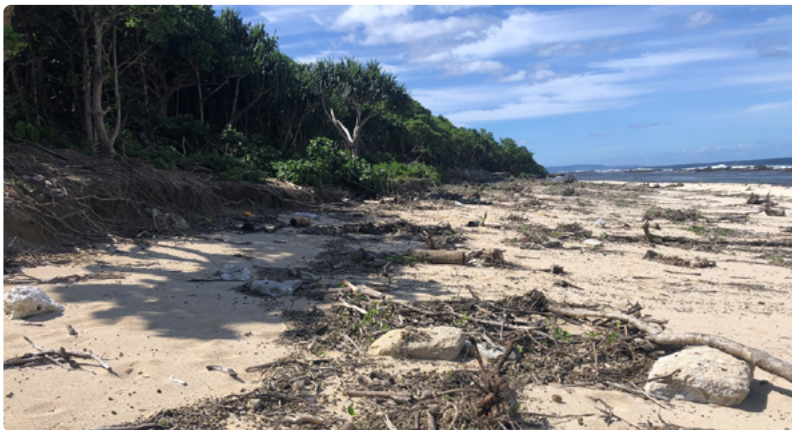
Figure 3.30 (top) Photo of Ahononou and (bottom) transect of topography and tsunami height. (Photos: Shane Cronin and TGS).

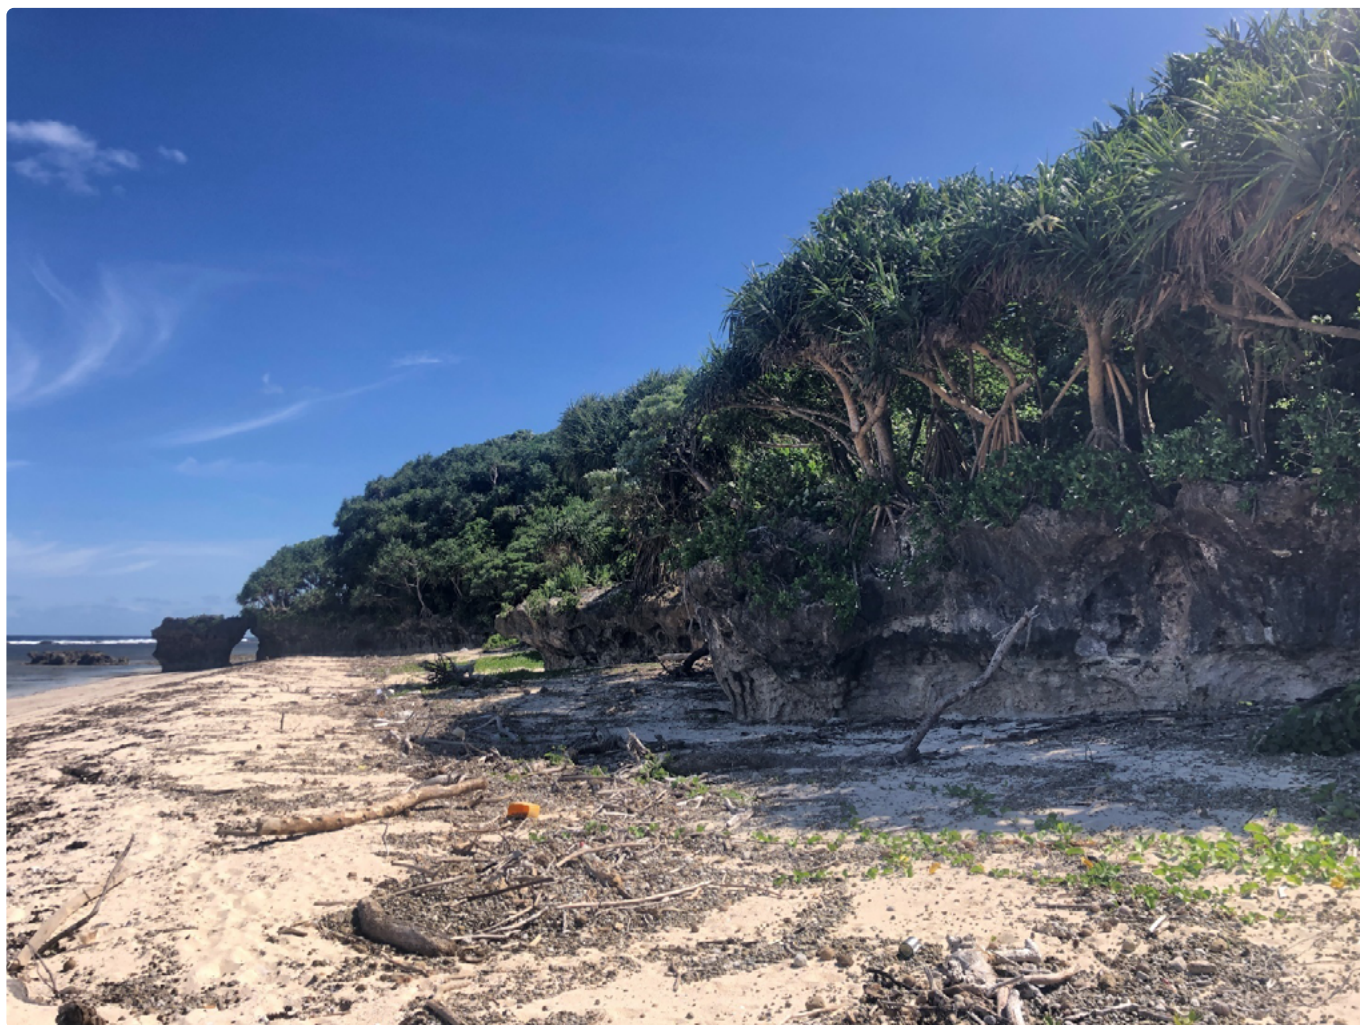
**Figure 3.31** (top) Photo of Katea and (bottom) transect of topography and tsunami height. (Photos: Shane Cronin and TGS).

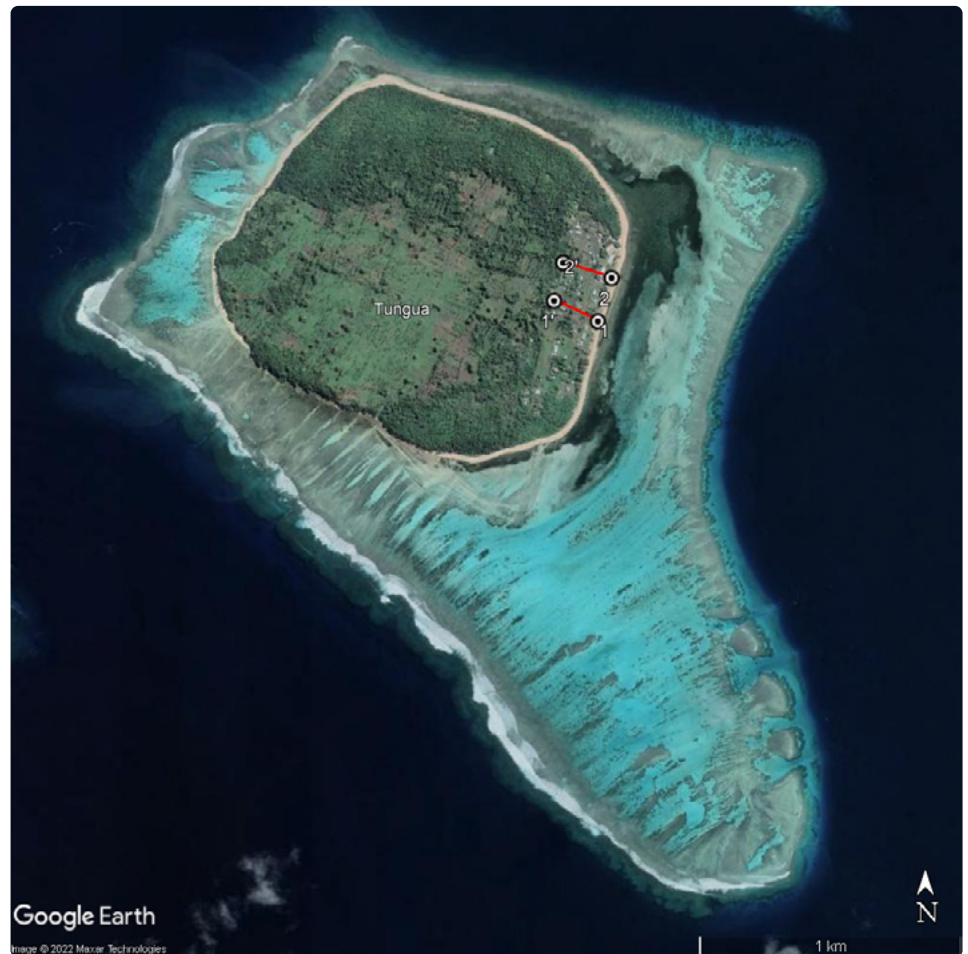
**Figure 3.35** Profiles of measured tsunami height and topography at Tungua.

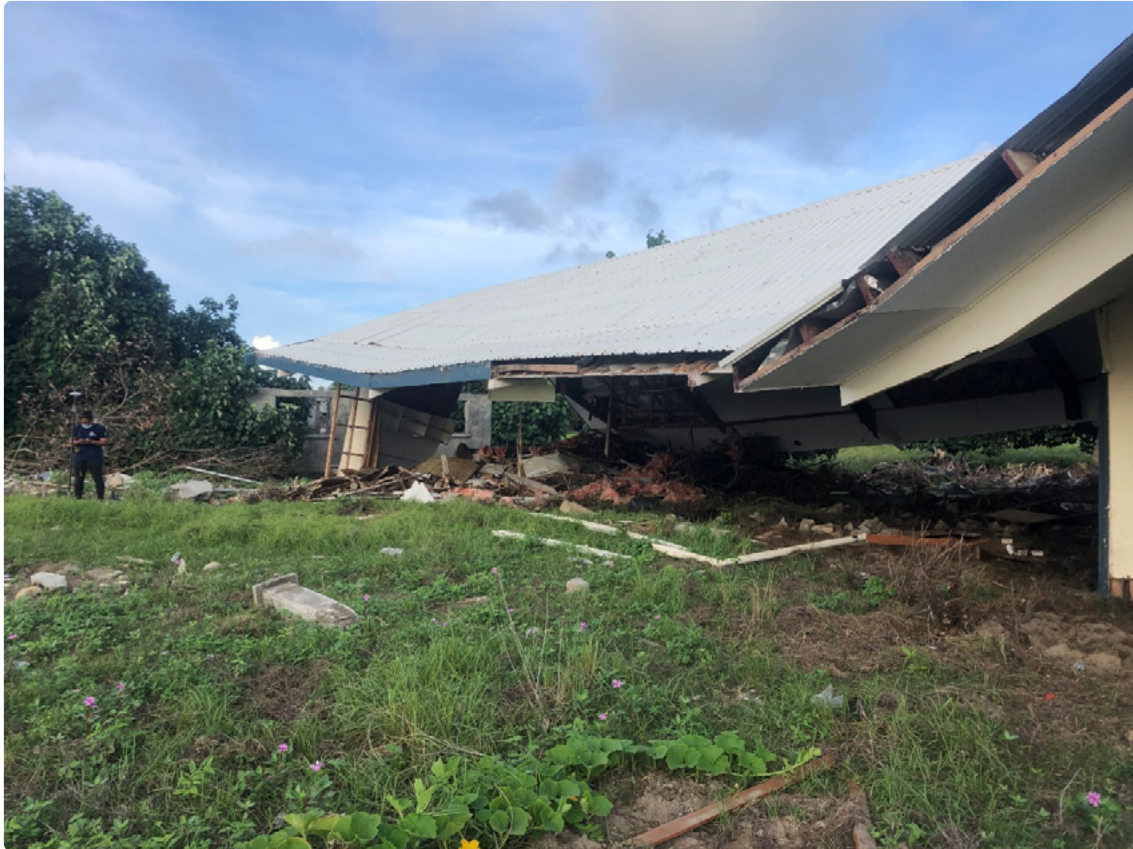
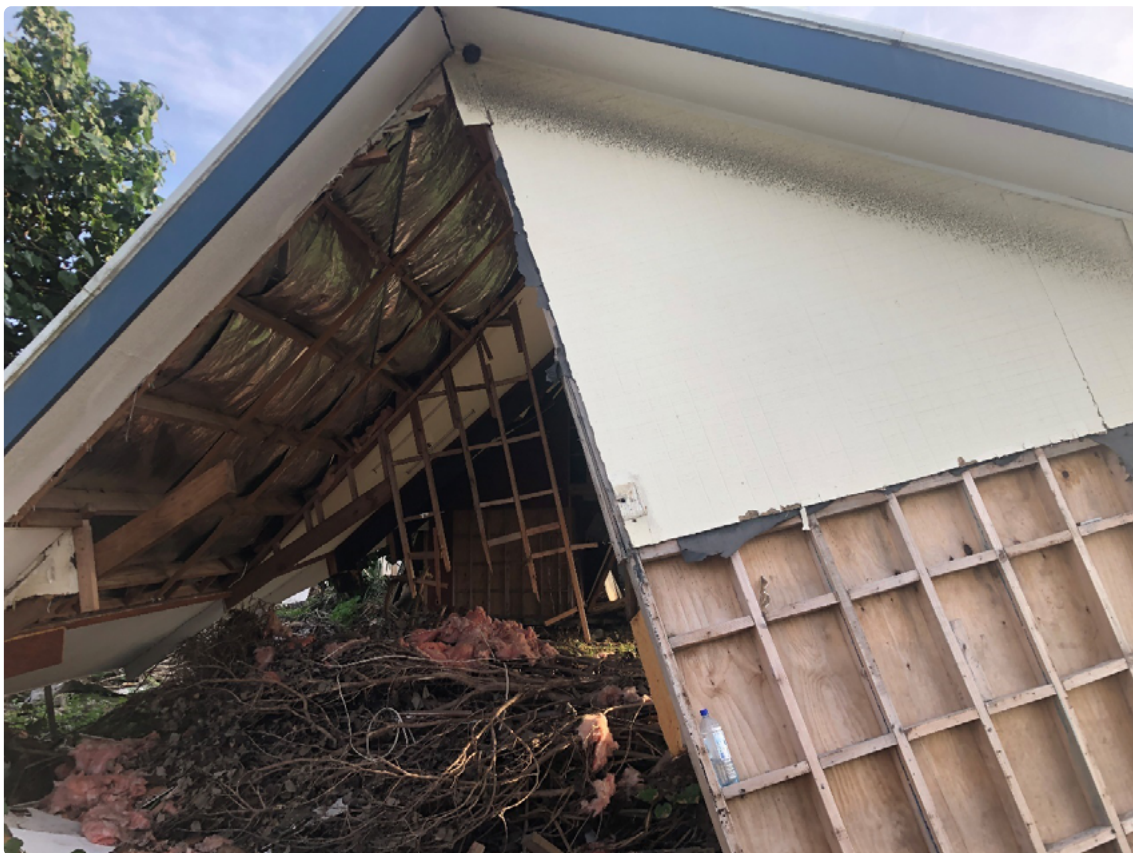
**Figure 3.36** Tsunami damaged structure on Tungua. (Photos: Shane Cronin and TGS).

The village on Tungua is located on the eastern side of the island away from the direction of approach of the tsunami. Furthermore, the island is surrounded by a relatively wide and shallow reef shelf (Figure 3.34) which would have acted to reduce tsunami impacts. Despite these factors, the tsunami inundated over 175 m inland and caused significant damage. Two profiles were measured at Tungua with flow depths of 1-3 m observed along the transect indicating a maximum total tsunami height of ~4 m. Damage on Tungua include a collapsed wood-frame building, concrete structures destroyed, a moved and damaged concrete water tank, damage to a solar panel array and boats damaged and pushed ashore.

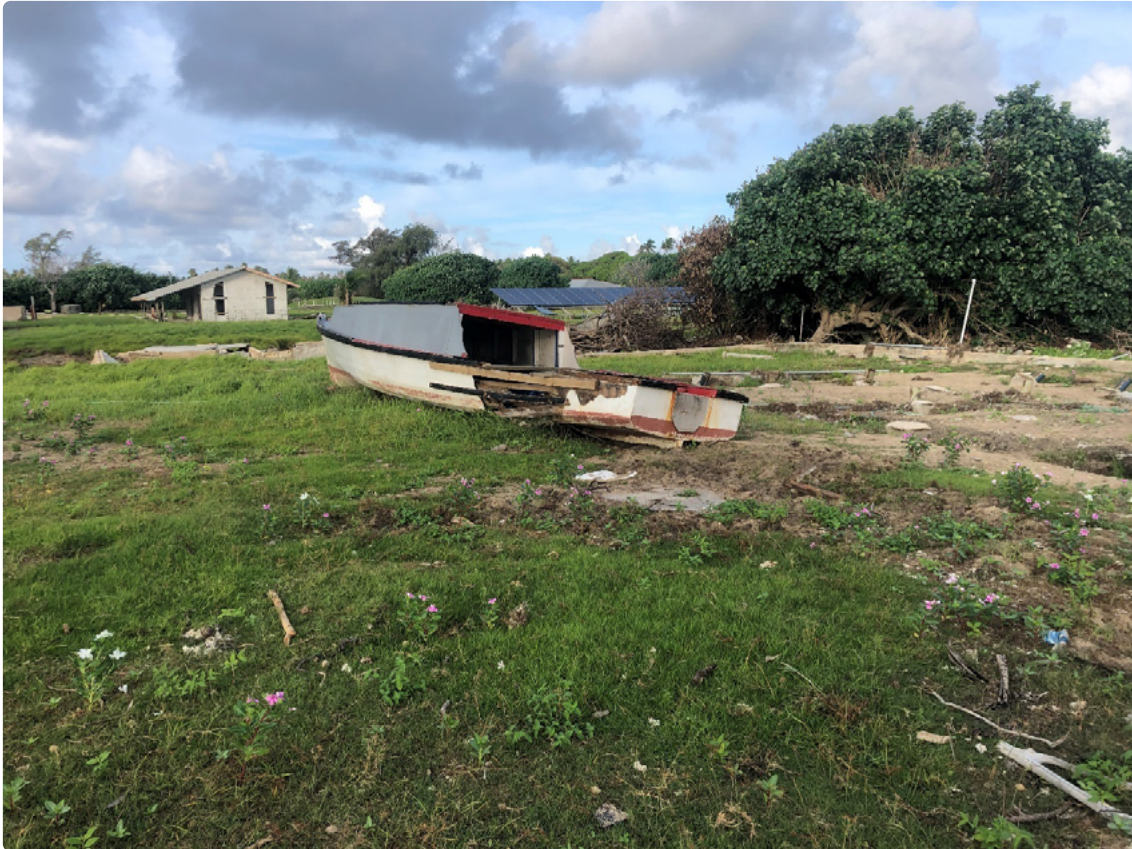
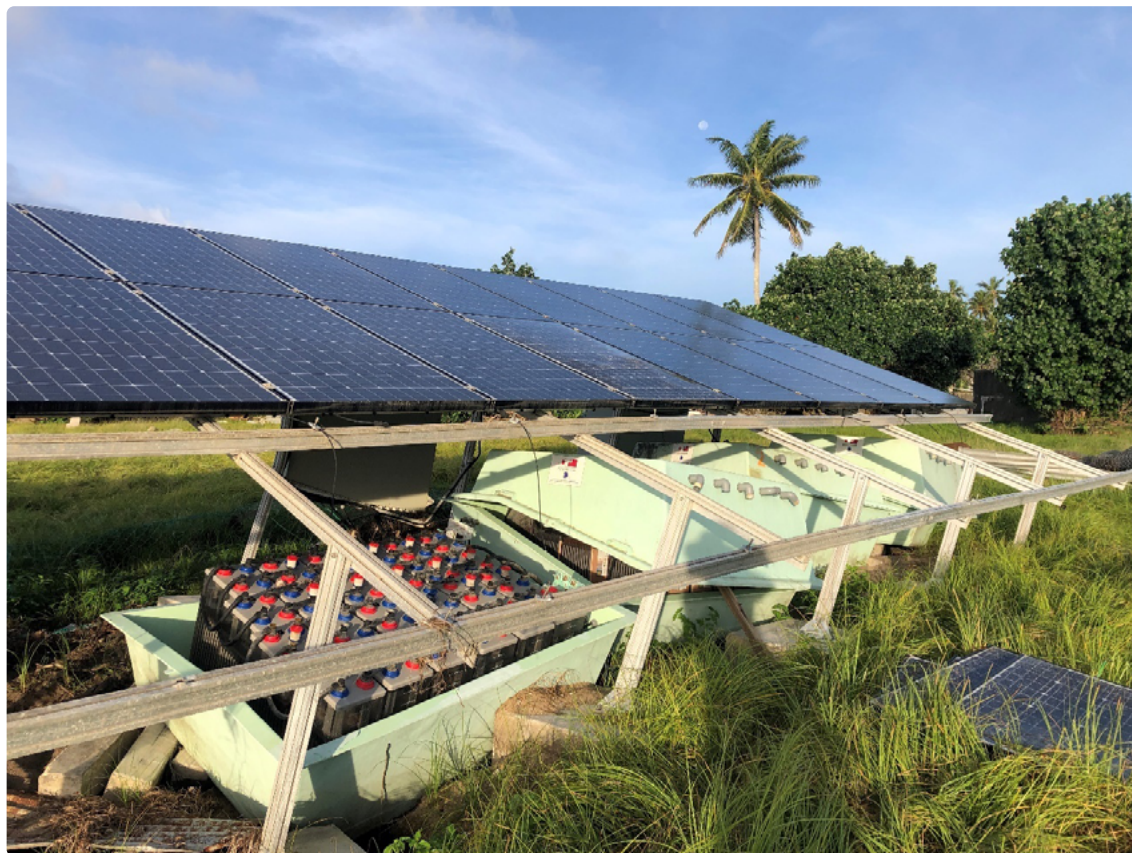
**Figure 3.37** Tsunami damage on Tungua. (Photos: Shane Cronin and TGS).

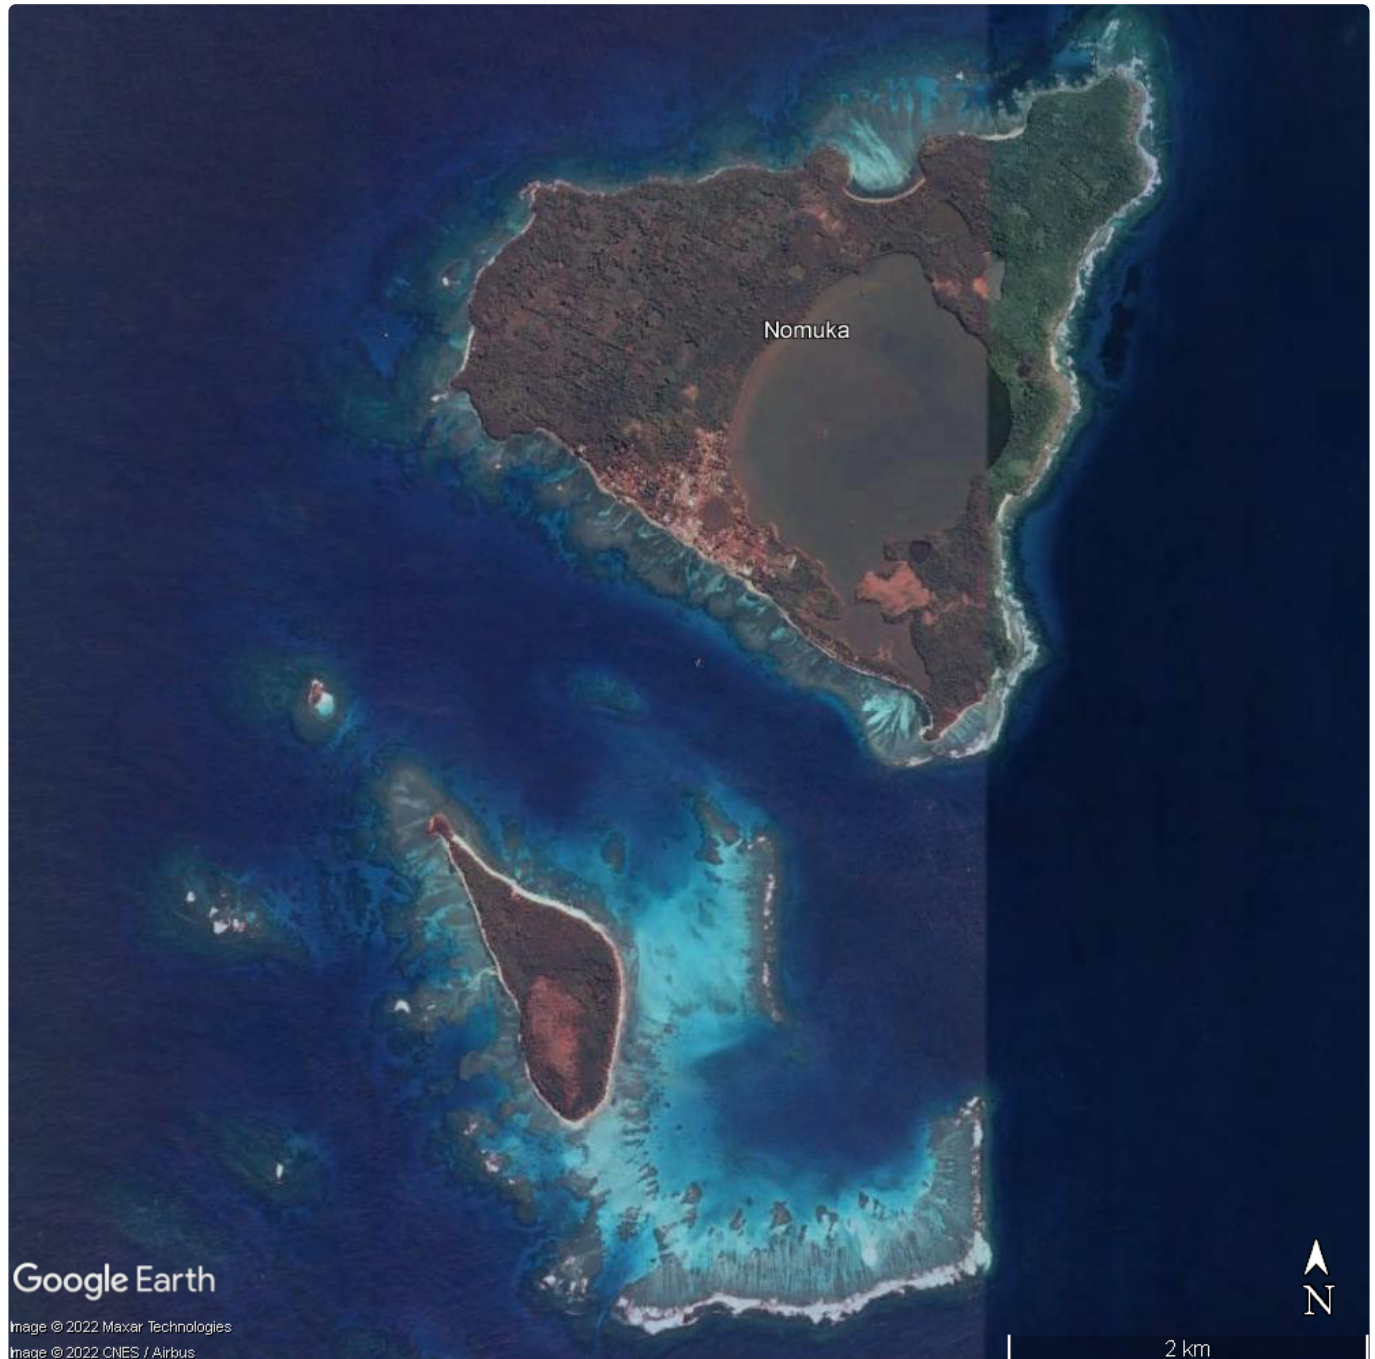
**Figure 3.38** Nomuka and Nomuka Iki islands. The location of Nomuka Iki sheltered the village on Nomuka from the full brunt of the tsunami. (Google Earth)

Nomuka and Nomuka Iki are located approximately 65 km northeast of Hunga Volcano. Although the tsunami strongly affected Nomuka, the presence of Nomuka Iki likely protected the village on Nomuka from the full force of the tsunami (Figure 3.38).

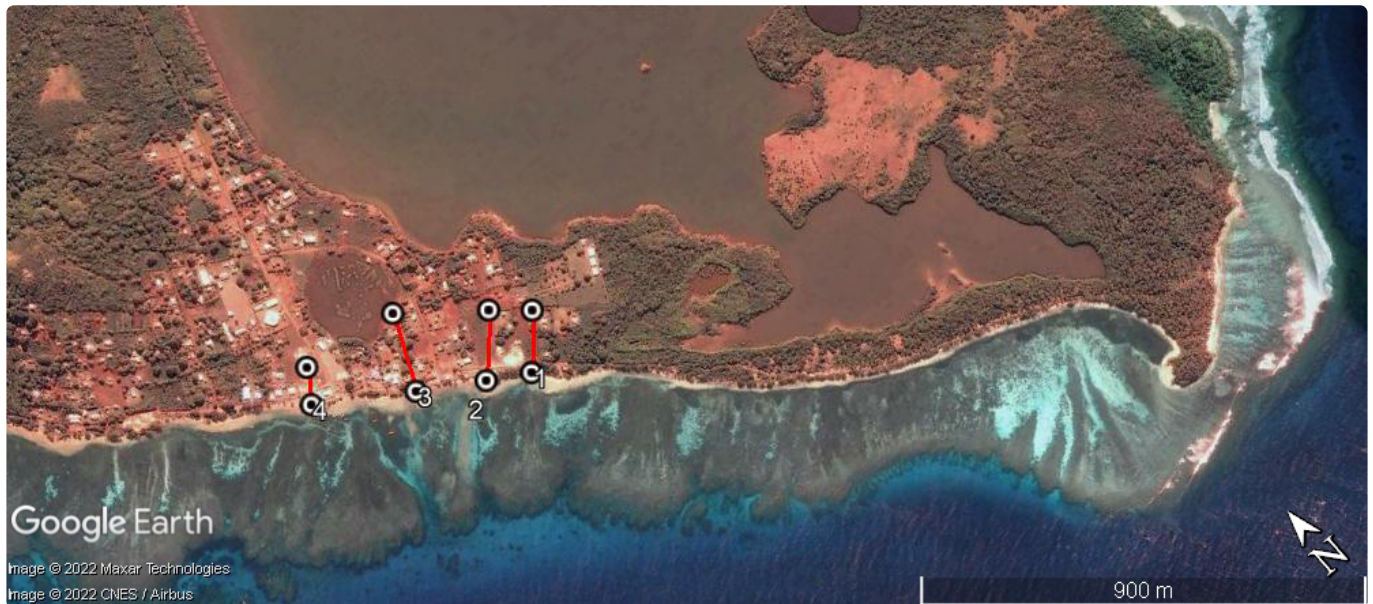
Figure 3.39 Locations surveyed in Nomuka Village. (Google Earth)

In the village on Nomuka (Figure 3.39), tsunami flow traces were measured at up to 10 m near the shoreline on Profile 1 with tsunami heights more typically of the order of 4-6 m on the other three profiles (Figure 3.40). On Profile 3, the tsunami surge crossed over the land area and flowed into the small pond and surged across to the other side. Inundation distances ranged from 80 to more than 150 m. There was significant damage to some structures and several boats and vehicles were entrained in the surge and destroyed (Figure 3.41). The tsunami flow caused significant scour and erosion around building foundations (

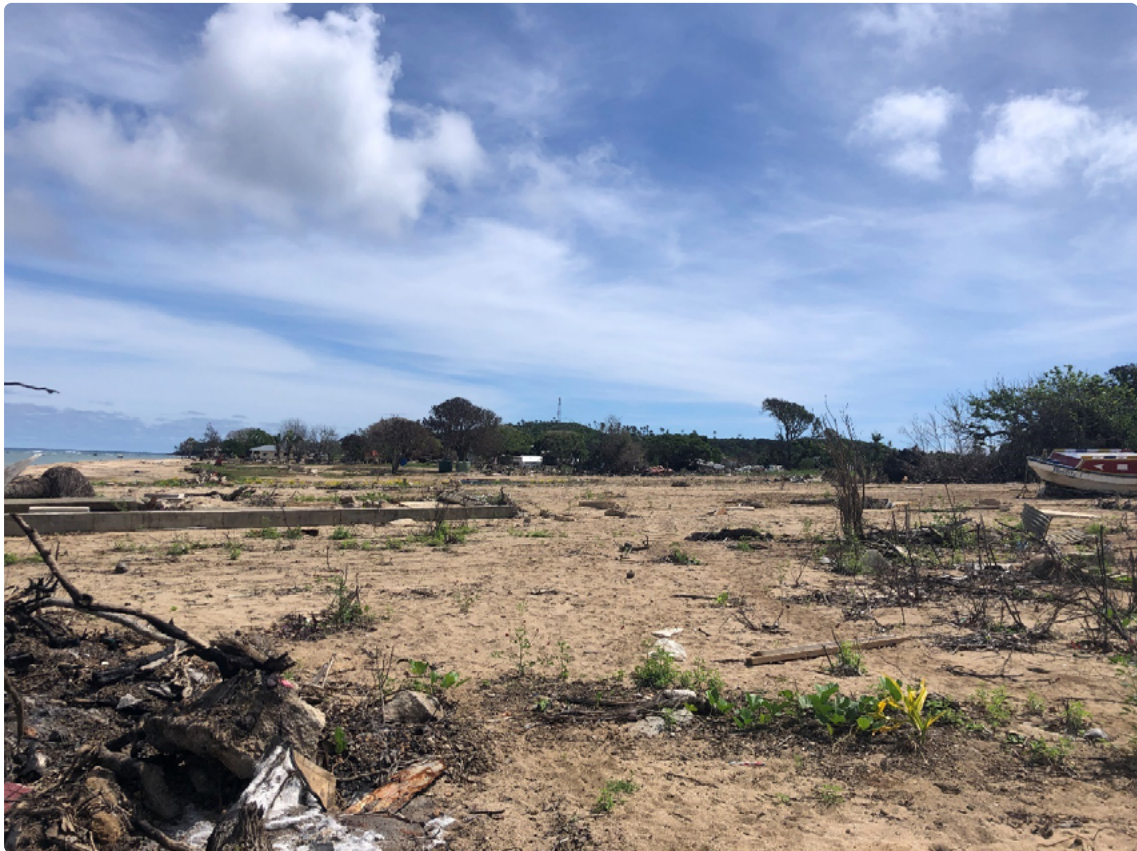
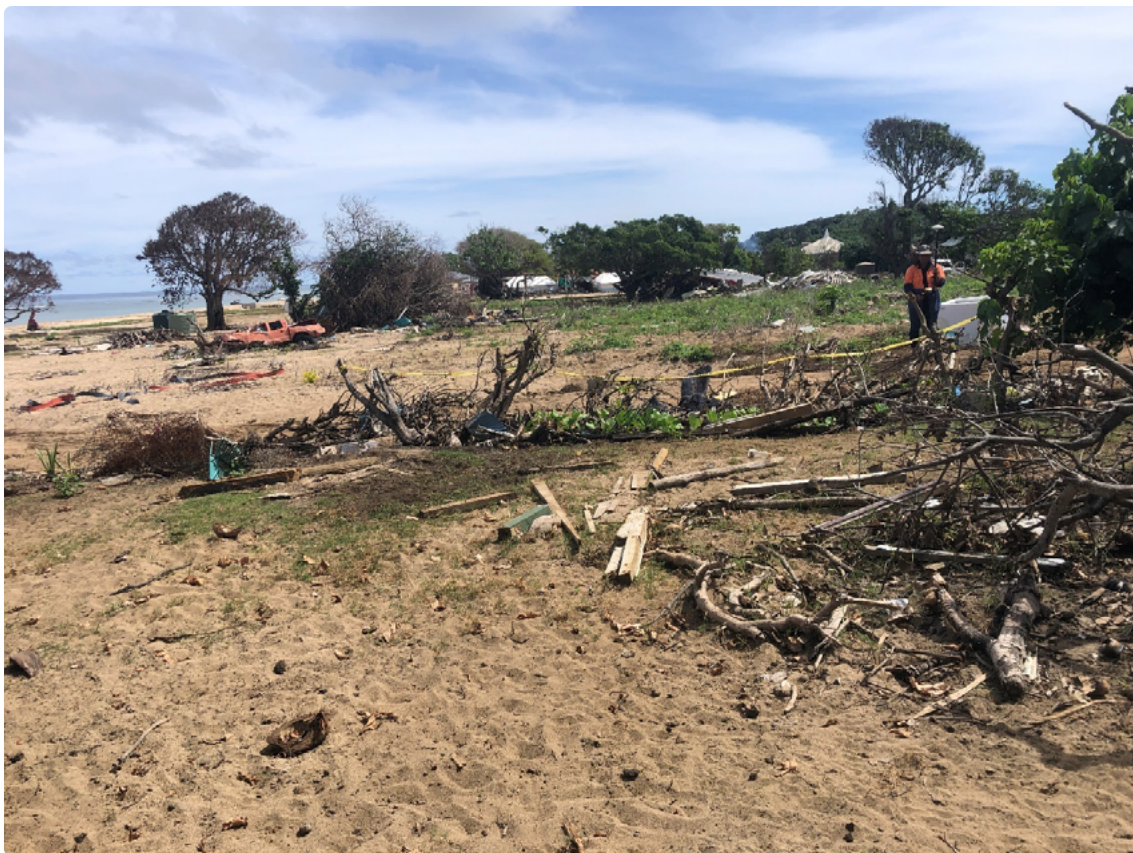
**Figure 3.41** (top) Damaged boat (bottom) the inundated area. (Photos: Shane Cronin and TGS).

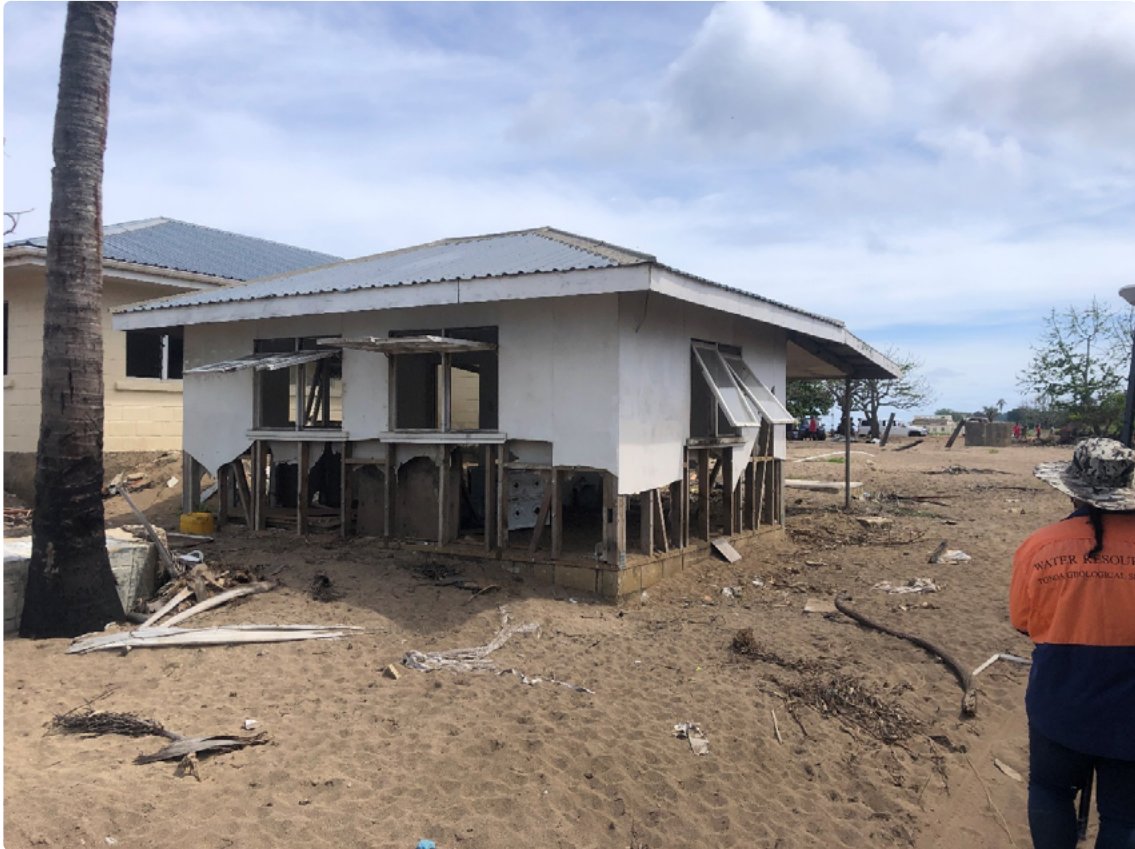
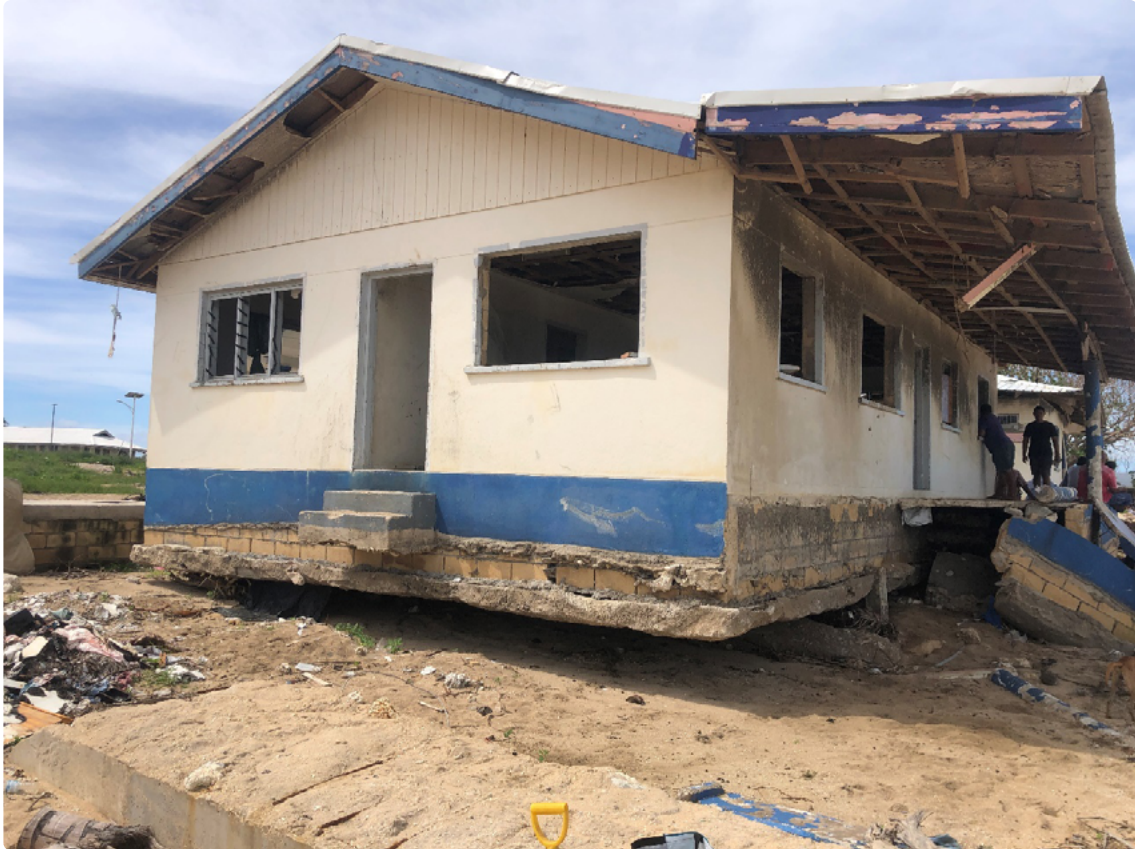
**Figure 3.42** (top) Tsunami flow caused the damage to the lower portion of the walls and (bottom) scour around a building foundation. (Photos: Shane Cronin and TGS).
