# Field Survey of Runup and Inundation in Tonga from the January 2022 eruption of the **HUNGA VOLCANO**

# Field Survey of Runup and Inundation in Tonga from the January 2022 eruption of the Hunga Volcano

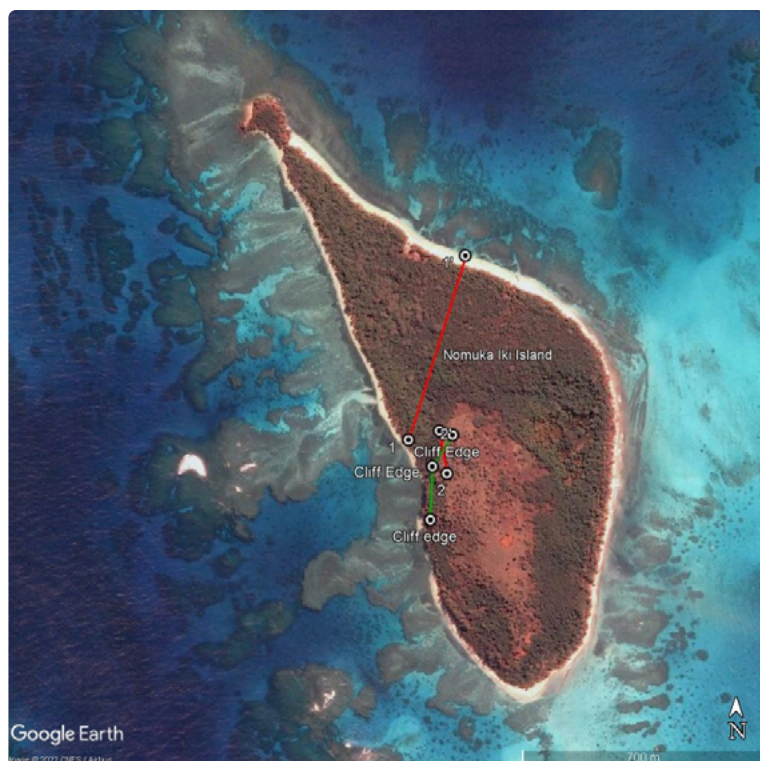
**Figure 3.43** Locations of the profiles surveyed on Nomuka Iki. Profile 1 crossed the northern section of the island from southwest to northeast. Profile 2 ran towards the south from the flat area up onto a topographic high. The green line indicates the location of the cliff face along which runup was measured. Red arrow indicates the direction of tsunami approach. Inset photo shows Nomuka after the tsunami with the forest stripped away from the low-lying land area. (Google Earth and Taaniela Kula TGS)

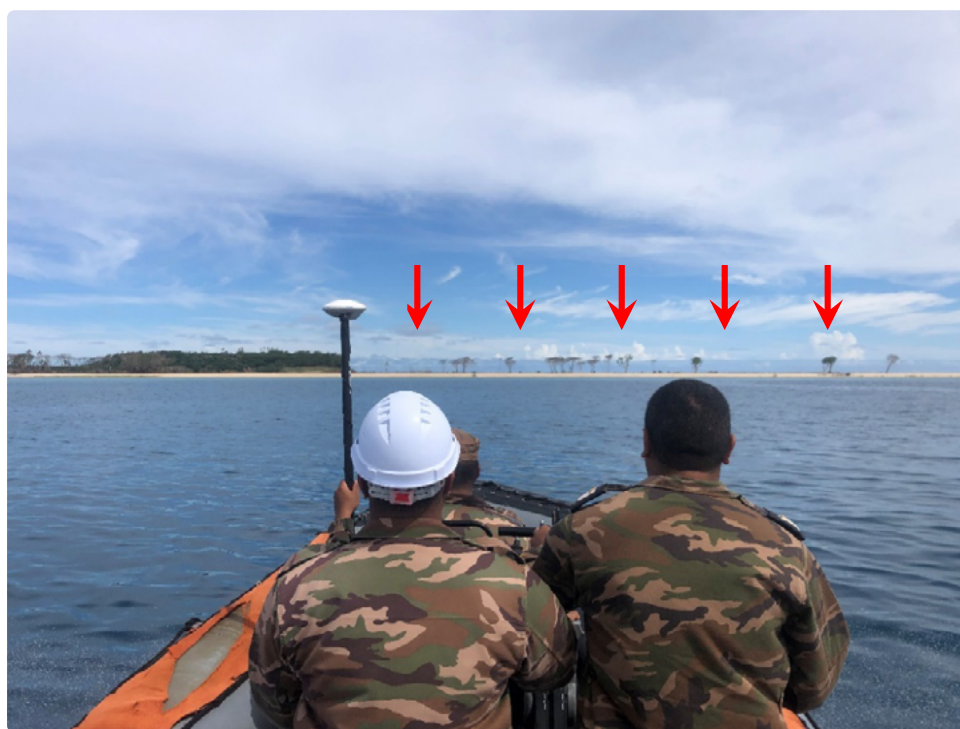
**Figure 3.44** View of Nomuka Iki from offshore. Note the broad flat coastal area with few trees (red arrows) on the right and the elevated area on the left. (Photos: Shane Cronin and TGS).

In contrast to Nomuka, Nomuka-Iki was affected by a much larger tsunami surge. The tsunami flowed across a broad flat area destroying a coastal forest with flow depths greater than 12 m. Measured runup was up to 20m along the face of a small hill located on the island (see Figure 3.44).

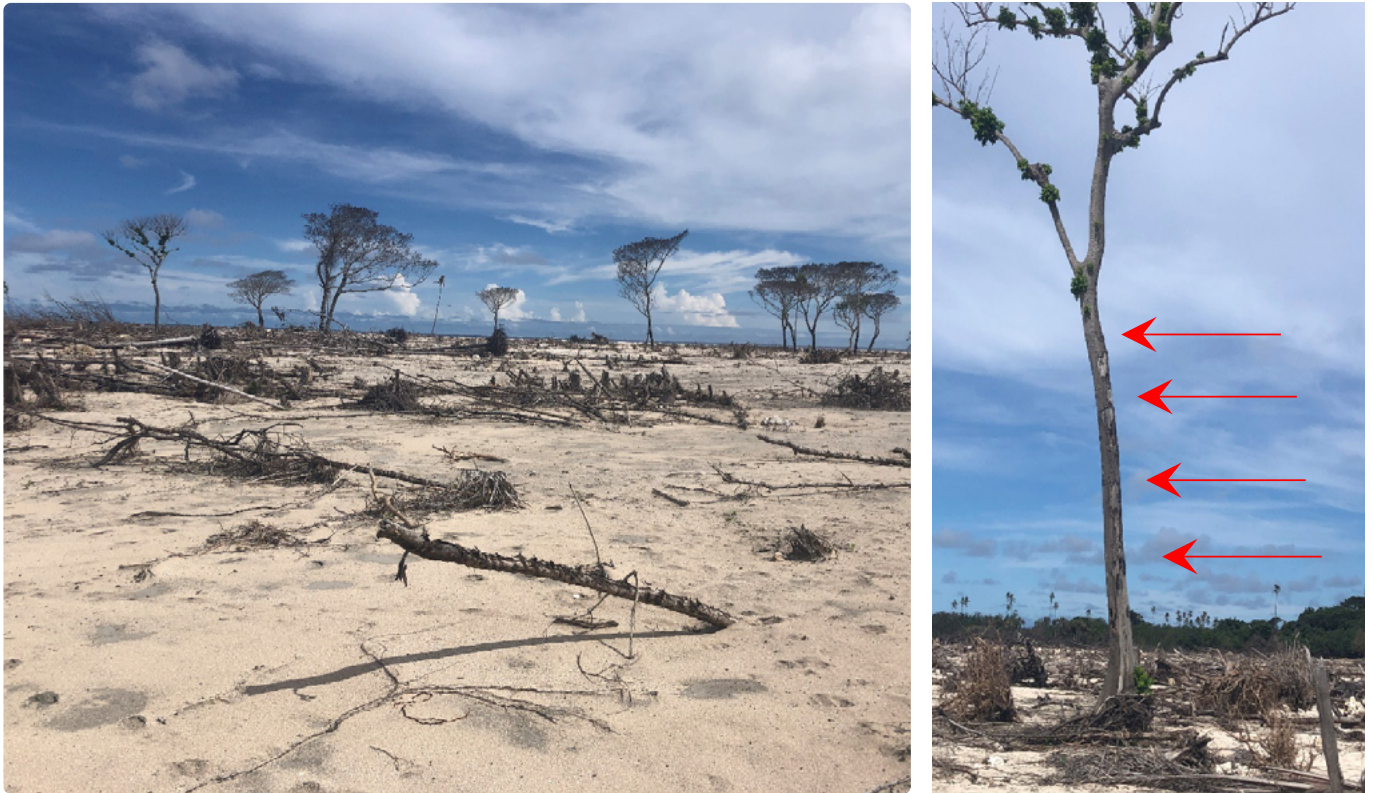
**Figure 3.45** Tsunami over wash on Nomuka Iki stripped the coastal forest. Inset image shows impact scars on the tree trunk used to quantify the tsunami flow depth. (Photos: Shane Cronin and TGS).

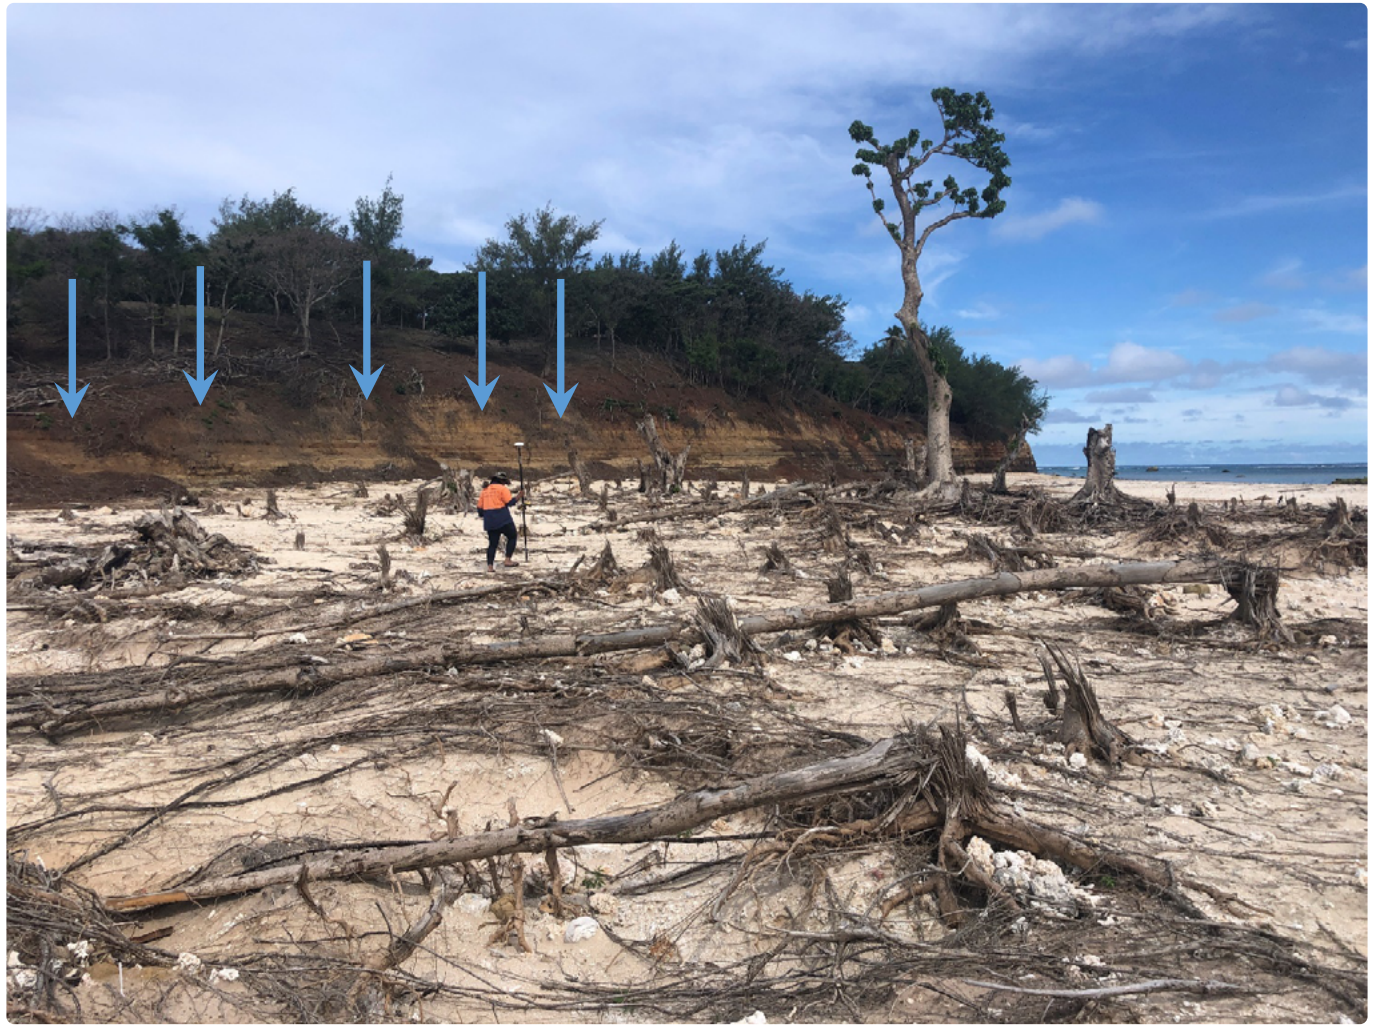
**Figure 3.47** (top) The hillside on Nomuka Iki where the runup heights (bottom panel) were measured. Blue arrows indicate approximate tsunami runup height. (Photos: Shane Cronin and TGS).

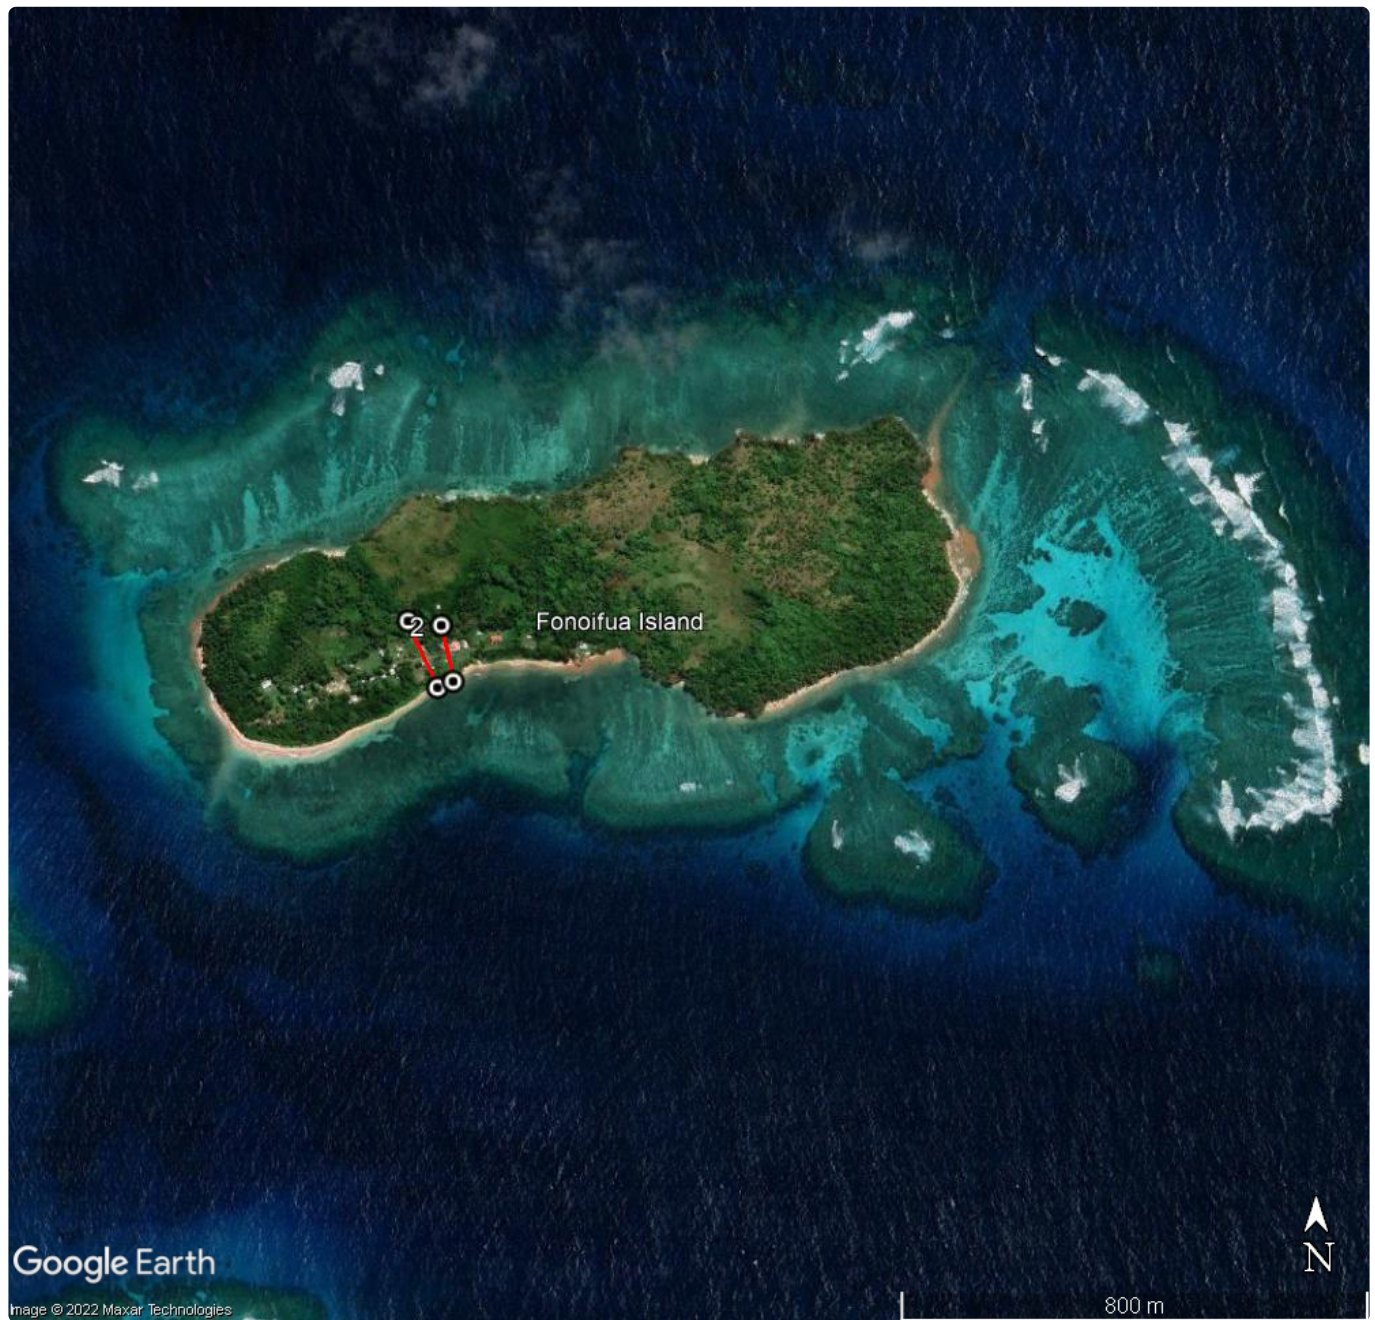
**Figure 3.48** Locations surveyed on Fonoifua Island. (Google Earth)

Two transects were surveyed on Fonoifua. Peak tsunami runup heights were measured at 2.9 m and 4.9 m on each transect.

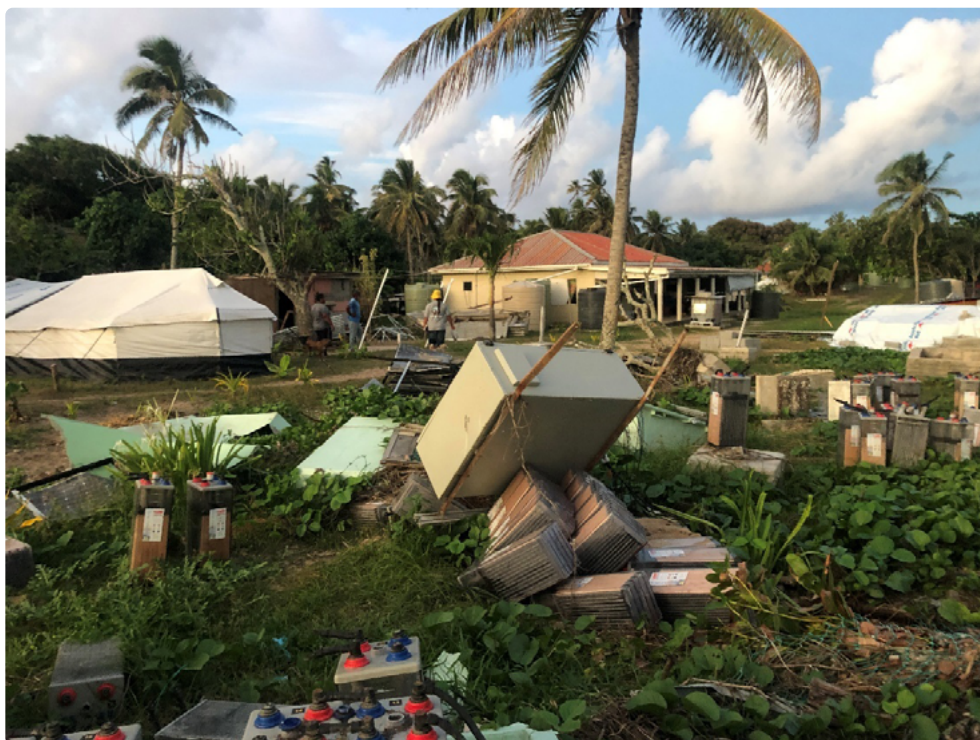
**Figure 3.50** Tsunami damage on Fonoifua. (Photos: Shane Cronin and TGS).

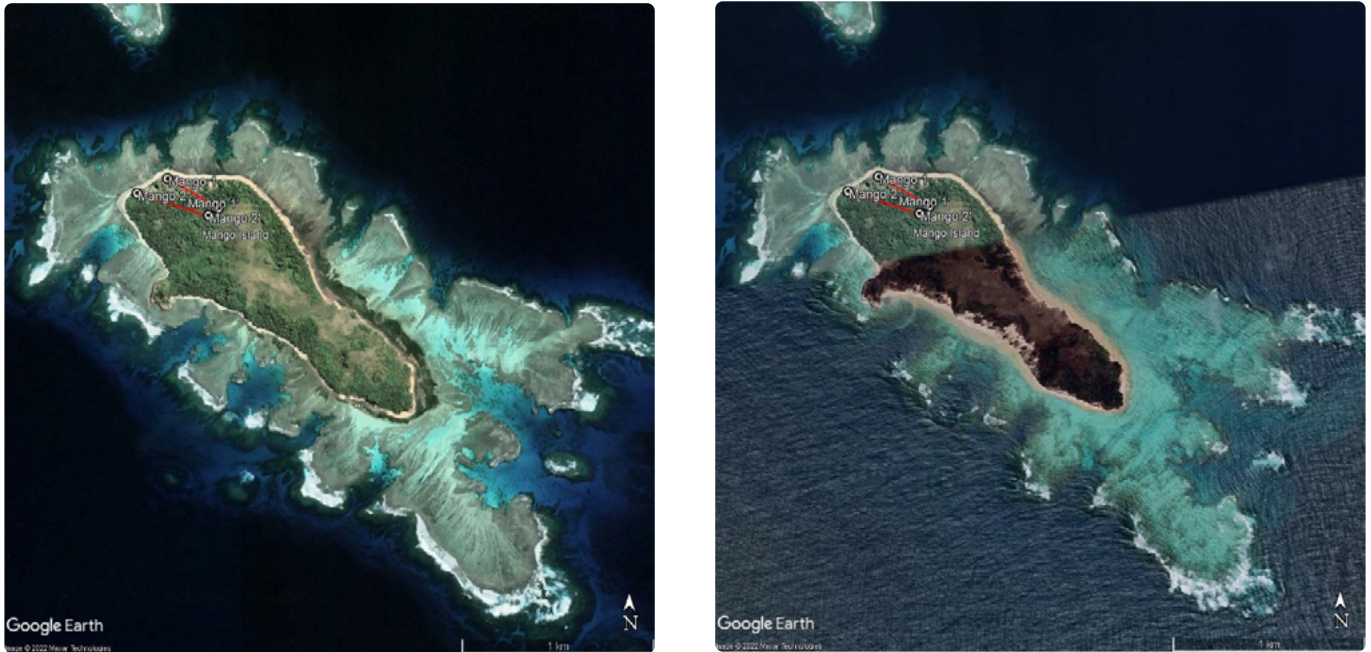
**Figure 3.51** Locations surveyed on Mango Island. Images from before the tsunami (left) and after (right). Red arrow indicates the direction of tsunami approach. The heavily damaged village on the north coast is circled in red and shown in more detail in Figure 3.53. Google Earth.

Mango Island was heavily damaged by the tsunami with measured tsunami heights of just under 10 m from two transects taken in the village at the northern end of the island (Figure 3.51 and Figure 3.52). With the tsunami approach from the west, the village on the north coast was not protected as the wave wrapped around the island. It is also possible that the high tide allowed for stronger refraction and some amplification over the offshore reef platform on the north-western side of the island. News accounts report that all of the residents from Mango were evacuated to Tongatapu after spending the night outdoors. A detailed account of their ordeal was described in news reports (Matai Tonga, 2022b) and is reproduced in Appendix J.

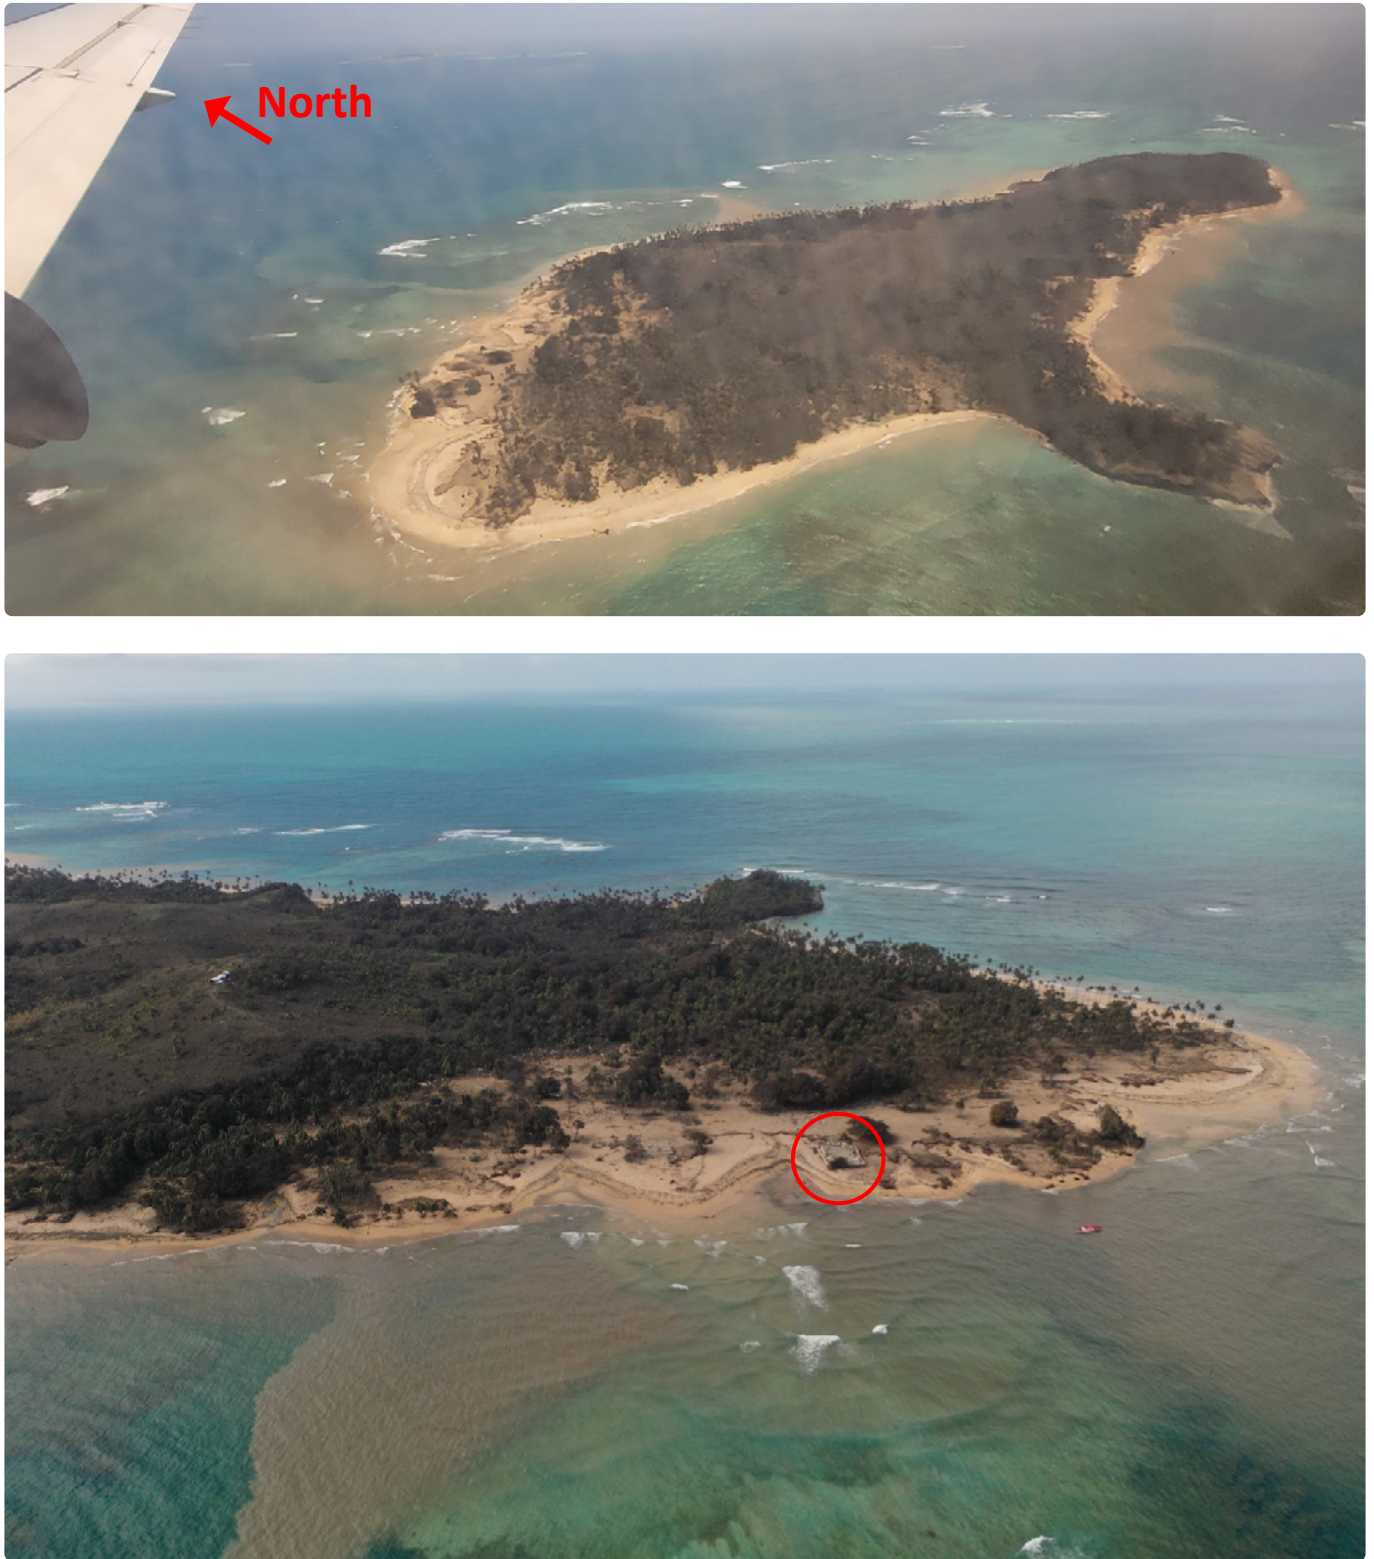
**Figure 3.53** Aerial view of the damage to the Mango Village. The remains of the structure circled in red (lower panel) is shown at ground level in Figure 3.54. (Photos: Taaniela Kula TGS).

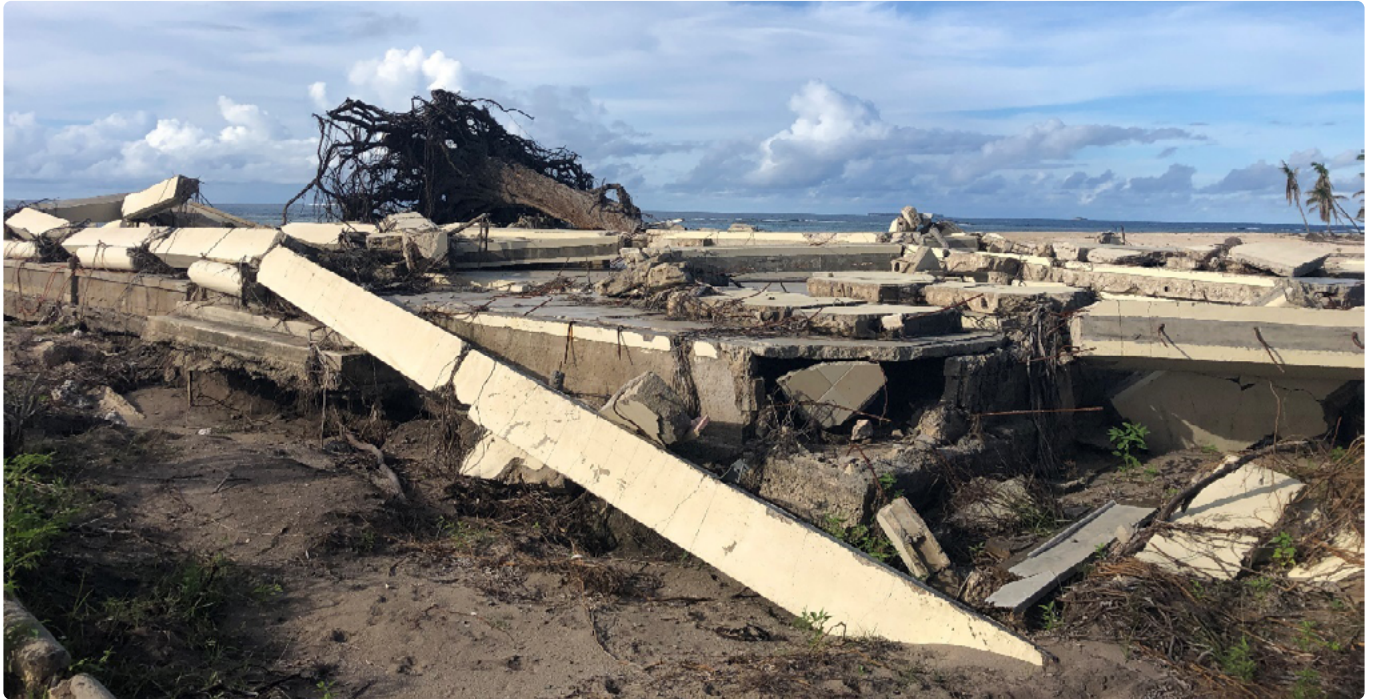
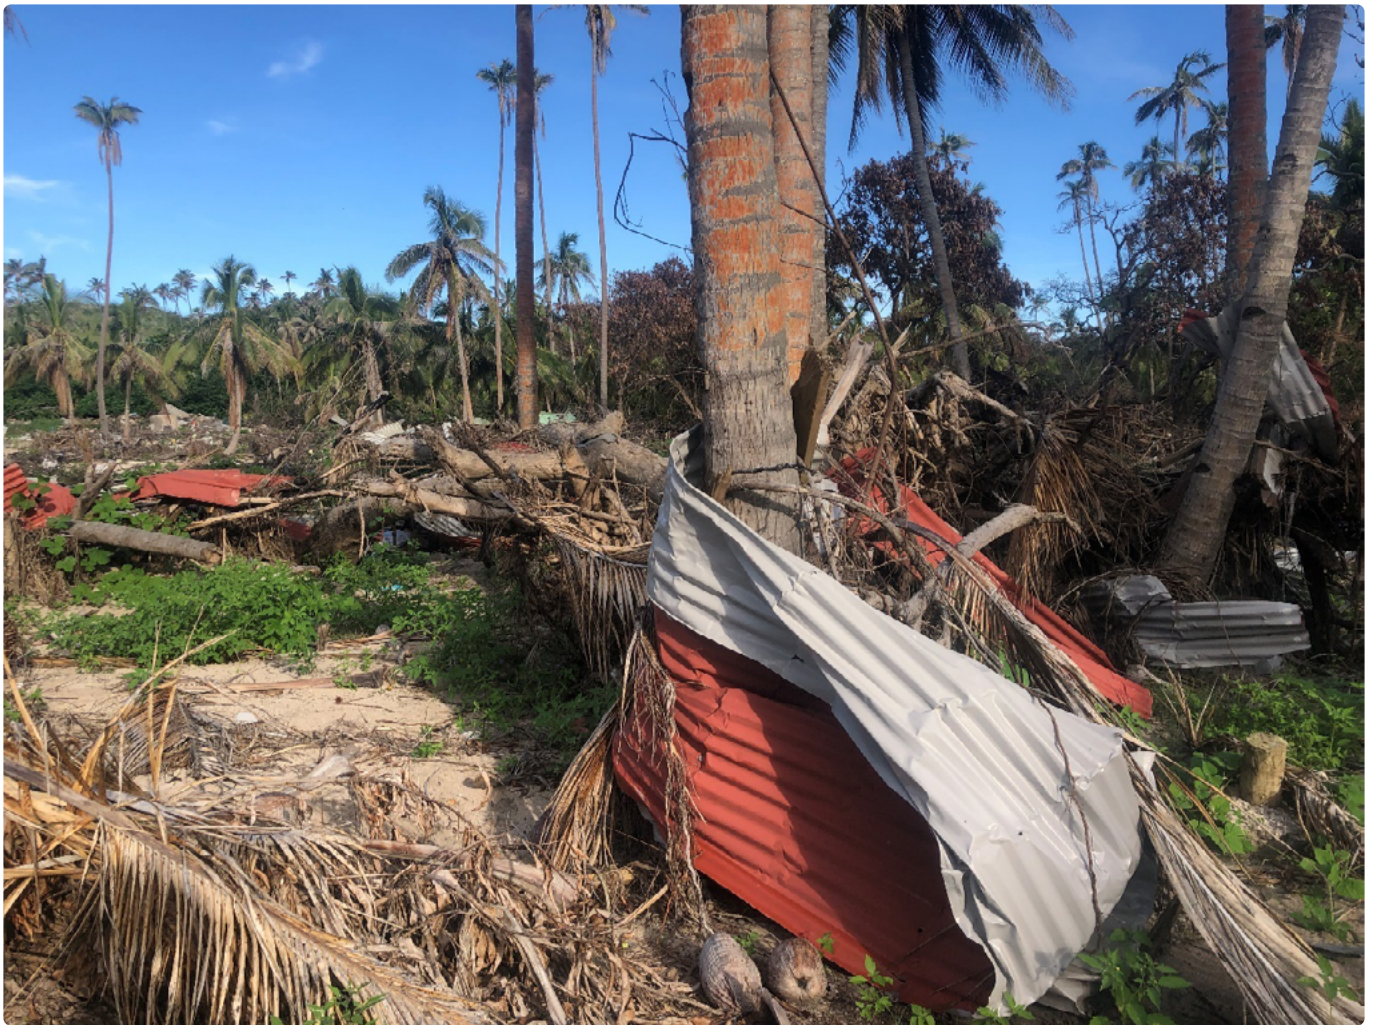
**Figure 3.54** Tsunami damage on Mango Island. (Photos: Shane Cronin and TGS).

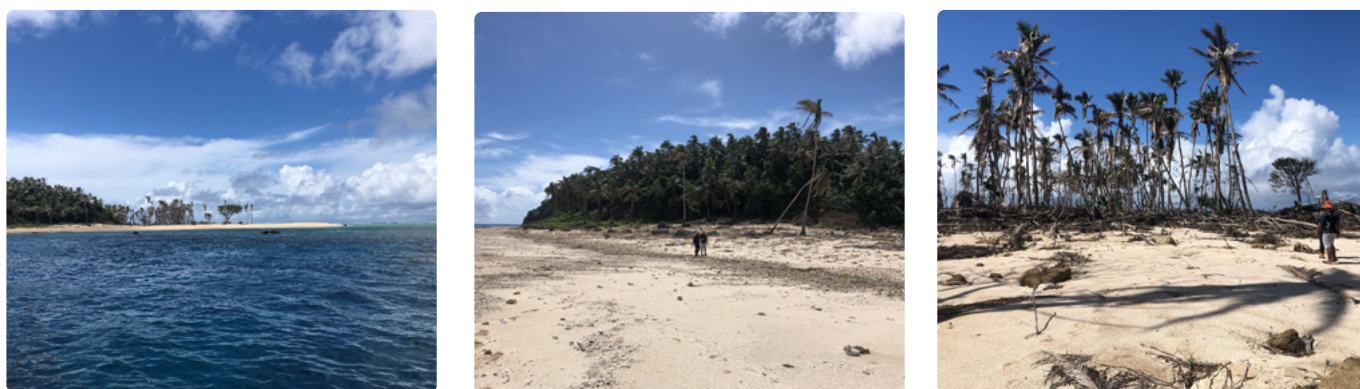
Tonumea Island (Figure 3.55) was strongly affected by the tsunami. Runup heights more than 10 m were measured on the steep face of a hill in the centre of the island (Figure 3.56, Figure 3.57). The tsunami completely washed over the low-lying fringe of land on the southern side of the island with flow depths of 6-8 m, toppling most of the trees and stripping away large areas of beach. Although not surveyed, aerial imagery from Google Earth suggests that similar effect occurred on the northern part of the island.

**Figure 3.56** Photos from Tonumea Island. (Photos: Shane Cronin and TGS).

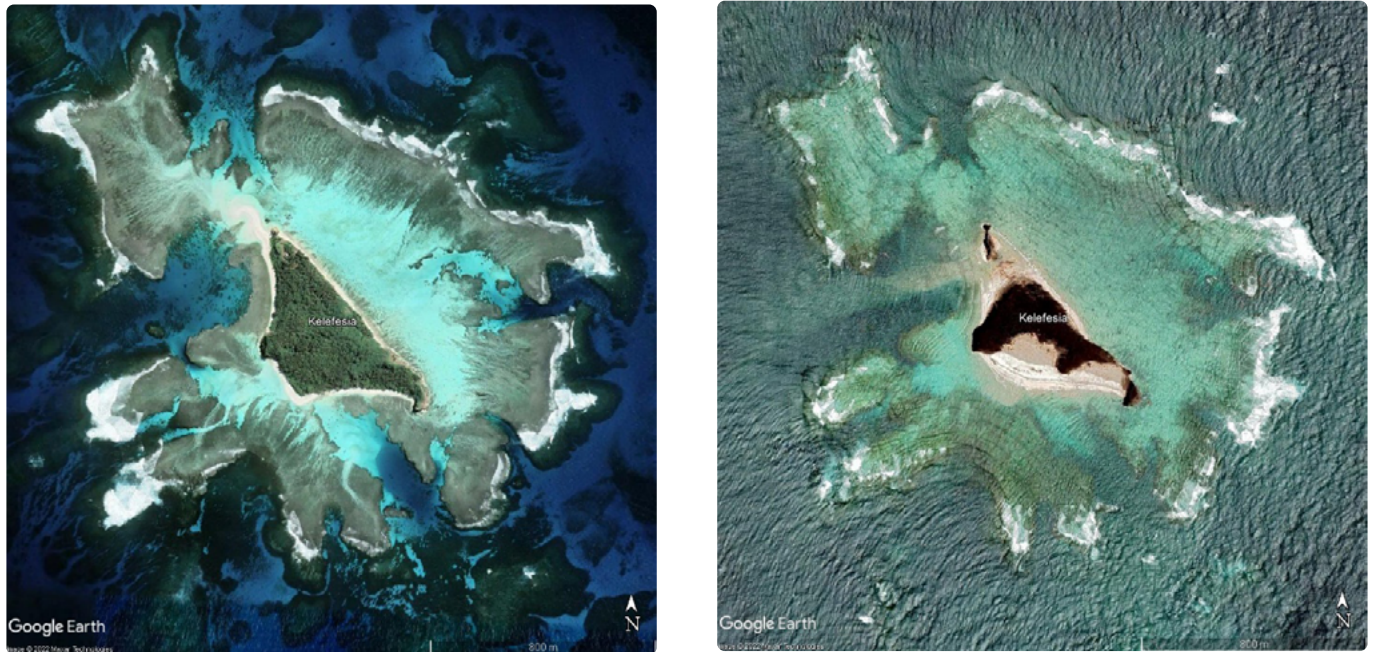
Due to time constraints, the survey team was not able stop at Kelelesia island. However Aerial imagery from Google Earth (Figure 3.58) shows that the island was heavily eroded and was changed significantly by the tsunami.

**Figure 3.58** Google earth imagery of Kelelesia from before and after the tsunami. (Google Earth)
