Tsunami Runup and Inundation in Tonga from the January 2022 Eruption of Hunga Volcano

Keywords: Tsunamis, volcanic hazard and risk, field survey, eyewitness.

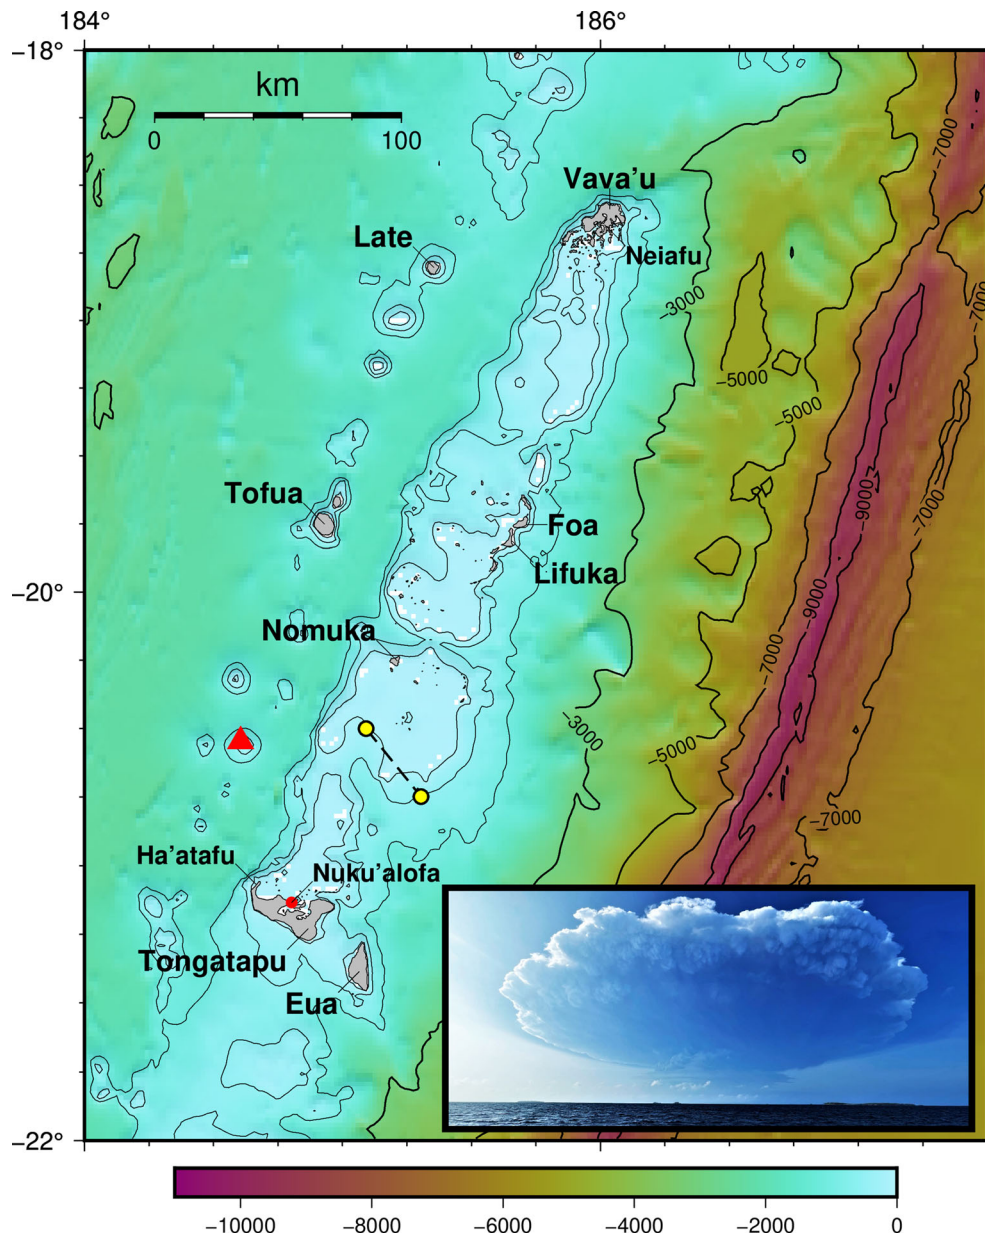
Figure 1

The bathymetry surrounding the major islands of The Kingdom of Tonga. Red triangle shows the location of Hunga Volcano. Yellow dots are the location of the Tongan Navy vessel on January 15th. Inset shows the eruption rising to its climax at 5.24 pm (0424 UTC) January 15th as seen from ~ 5 km northeast of Nuku'alofa (Photo: Branko Sugar); the upper plume is already > 100 km wide

At the time of the eruption on January 15, the Tongan Navy vessel Ngahau Siliva was *en route* from Mango to Nuku’alofa after delivering water and supplies to the island which had been affected by ash fall from the eruption of the previous day. At 0411 UTC, approximately 2 h after departing Mango, the crew heard one large explosion from the volcano. At 0425 UTC (17:25 local) they saw two large wave crests, estimated at 9–10 m amplitude off the star-board (right) side of the vessel in a direction roughly south of west (Fig. 13l and Supplementary Material Video 1). The position of the vessel at the time of this observation (Fig. 1c) shows an area of shallow

bathymetry (< 100 m depth) in the direction of the waves. By 0450 UTC they reported complete darkness with heavy ashfall and pumice falling from the sky. At 0525 UTC, located 36 km southeast of their previous position (Fig. 1), the boat’s engines failed due to the ash, and they drifted for several hours while repairs were made. During this time crewmembers reported feeling as if they were riding on the waves but were unable to count a specific number of crests. After restarting the engines at 1000 UTC (11 pm), the vessel changed course and headed north to Vava’u to await further orders.

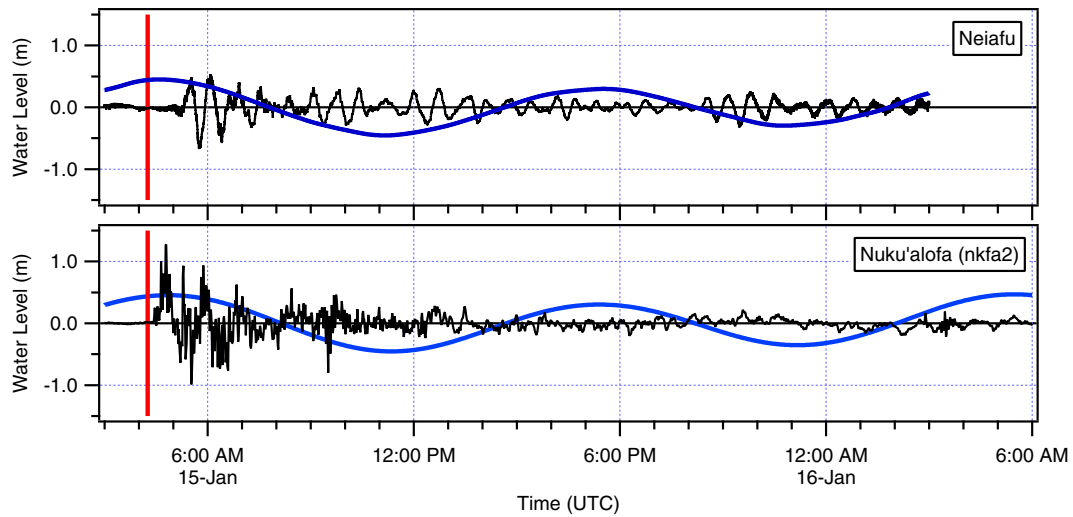
Figure 4

The detided (black) water level and the predicted tide (blue) at Neiafu (top) and Nuku'alofa (bottom). Vertical red line indicates the time of the large explosion from the erupting volcano (0415 UTC)

The Neiafu and Nuku'alofa (nkfa2) data sets were detided using a predicted tidal curve derived from tidal constituents at their respective stations (Fig. 4). The figures show that the main tsunami of January 15th occurred during the high tide period on Tongatapu and shortly after high tide at Neiafu. At Neiafu tsunami amplitudes were generally smaller than the tide range, while at Nuku'alofa the tsunami amplitudes are more than twice the tide range. The plots also show the rapid onset of tsunami activity at Tongatapu and the ~ 1.5 h travel time to Neiafu. Also, at Neiafu we see that the tsunami signal is more periodic in nature, suggestive of resonance in the complex bathymetry and dendritic channel

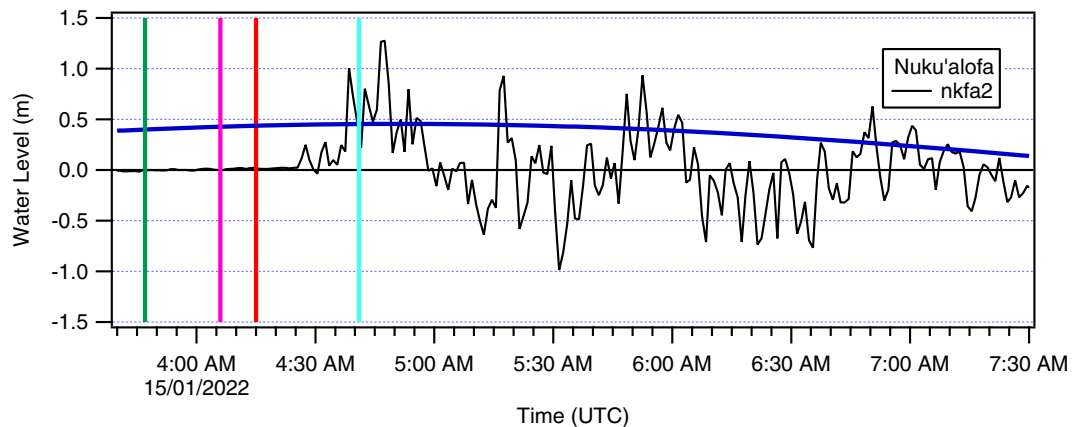
Detail of the first 3.5 h of tsunami activity at Nuku'alofa. Vertical lines indicate key times; green (0347) the start of the surface eruption, pink (0406) eruption plume visible on satellite imagery, red (0415) the time of a large explosion and cyan (0441) the ~ 26 -min tsunami arrival time for the large eruption from Hunga to Vuna Wharf

characteristic of southern Vava'u, where the tide gauge is located. Figure 5 shows the first ~ 3.5 h of the de-tided tsunami record at Nuku'alofa (nkfa2). In this plot the vertical red line is the time of the large magnitude explosion of the eruption sequence (USGS, 2022), which occurred at 0415 UTC. Tsunami activity is present on the gauge at ~ 0425 UTC, just 10 min after the explosion—which is too early for water waves generated by it. The implications of this timing are considered further in the Discussion section below.

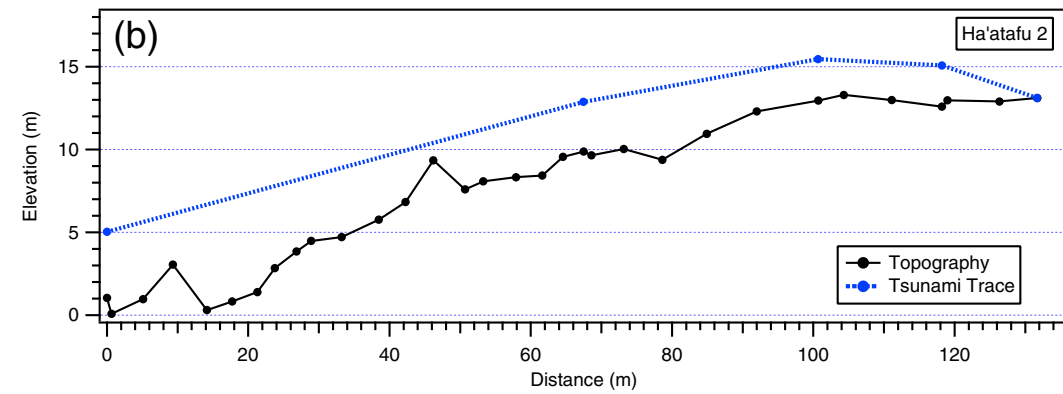
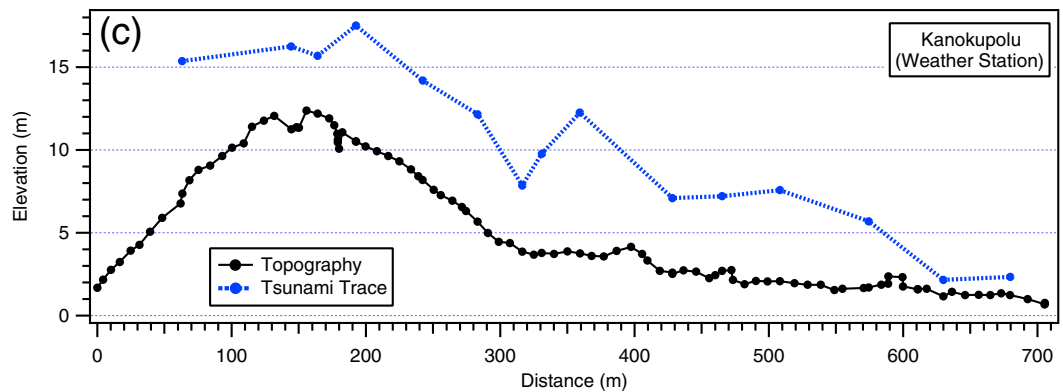
◀Figure 7

a Locations surveyed along the western coast of Tongatapu. Yellow shaded area indicated extents of inundation. Green triangle indicates the location of the Tongan Meteorological Service weather station. The start and endpoints of each transect are indicated with the red dots. Left plot shows maximum tsunami trace height, maximum runup height and maximum inundation distance along each transect. **b, c** Detailed transects from Ha'atafu and Kanokupolu

Some of the most extreme tsunami effects occurred in the Kolovai District of western Tongatapu where tsunami surges overtopped the narrow Hihifo Peninsula causing near total destruction along the shoreline and inundating over distances of up to 1 km (Fig. 7). At Kanokupolu, a weather station co-located on a cellular phone tower situated at approx. + 13 m elevation was toppled by the tsunami, ripped from its foundations and transported more than 200 m from its original location. The weather station collected data at 10 min intervals and this data was uploaded every hour on the hour via satellite telemetry. The station made its final transmission at 0500 UTC (18:00 local) and was therefore destroyed some time after (Fig. S1).

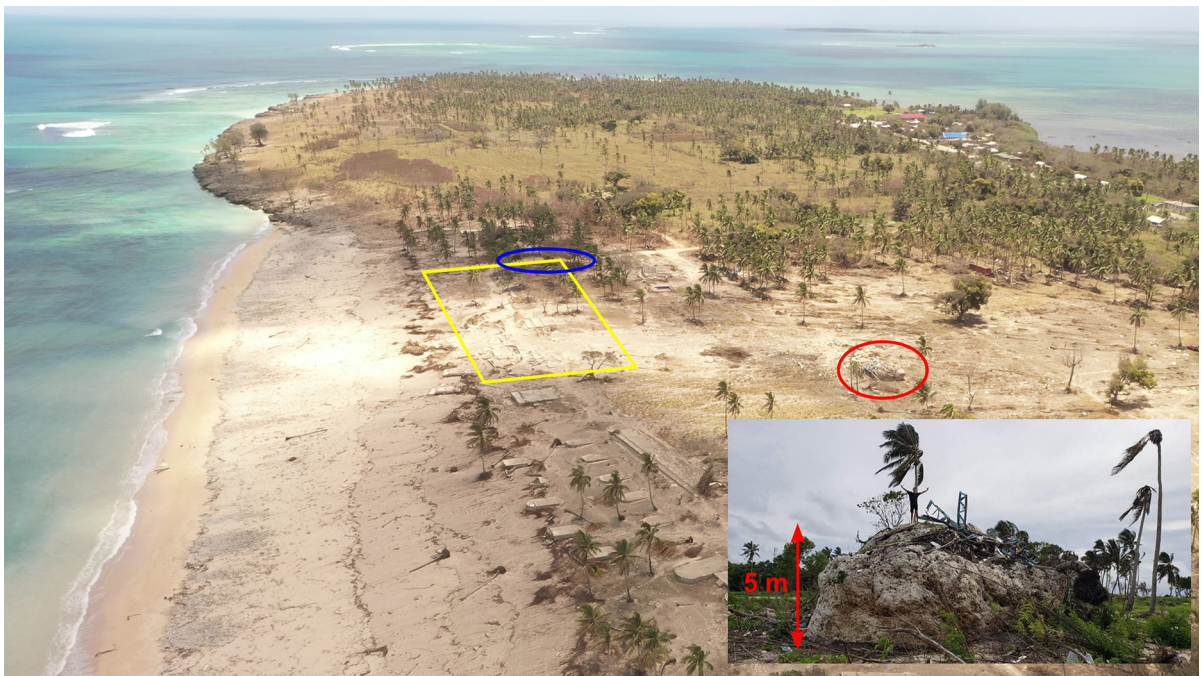
Figure 8

View to the north along the the Ha'atafu section of the Hihifo Peninsula. Yellow rectangle indicates the site of Ha'atafu Beach Resort. Blue ellipse is the location of the car videos mentioned in the Ha'atafu Timeline section. The red ellipse is the location of the 'tsunami rock', shown in the inset after the tsunami and covered with debris indicating that it had been overtopped by the waves

Ha'atafu was the scene of remarkable tales of survival (Fig. 8). Moana Paea, proprietor of the Ha'atafu Beach Resort described hearing a commotion from the beach area as the first surges rose above the high tide level, reaching the beachside boundary of the resort. At the same time, Australian High Commissioner Rachael Moore, who was at the resort with her family, observed and photographed these early surges indicating a time of ~ 0415 UTC (17:15 local) for the first significant waves. Videos shared on social media also show local residents who had been spending the day on the beach, returning to their cars after being chased off the beach by the first surges. Ms. Paea and her staff began alerting other guests to leave the resort, all of whom went to the carpark and began to leave by vehicle. A second video obtained from social media shows the vehicles evacuating as a tsunami surge rushes up the road adjacent to the resort, toppling a fence as it progresses inland and narrowly missing a car full of people that had been parked on the waterfront. As this was going on Ms. Paea, her family and staff, noting the vehicular congestion, fled on foot in search of a large 'tsunami

surges completely overtopped the rock leaving it covered with debris (Fig. 8).

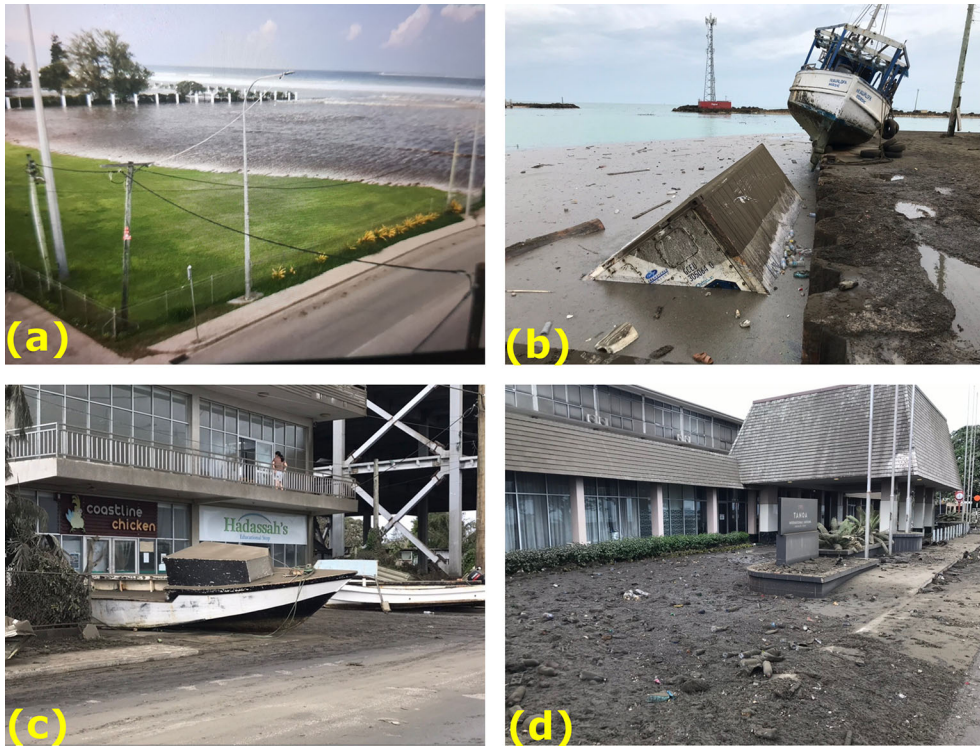
Figure 10

Scenes from Nuku'alofa **a** tsunami surge coming ashore on the grounds of the Royal Palace at 17:47 local time **b, c** smaller vessels floated on to the wharf or across the street **d** inundation at the Tanoa Hotel along the waterfront

Tsunami heights along northern coast of Tongatapu in the vicinity of Nuku'alofa were generally in the range of 2–4 m with inundation distances of 100 to > 300 m (Fig. 9). East of the entrance to Fanga'uta Lagoon inundation distances dropped of significantly however measured maximum tsunami trace heights remained consistent with sites to the west. While there was no major structural damage to the port facilities, several small boats were floated out of the basin and were deposited on dry land and several shipping containers and boats washed back and forth within the port basin. The waterfront roadway in the port area was covered with debris and the entire area was affected by a thick layer of volcanic ash (Fig. 10).

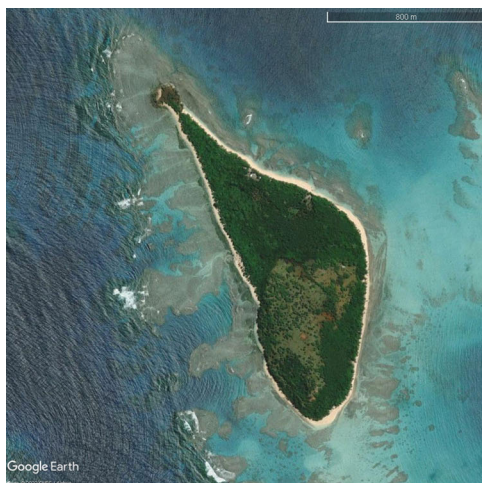
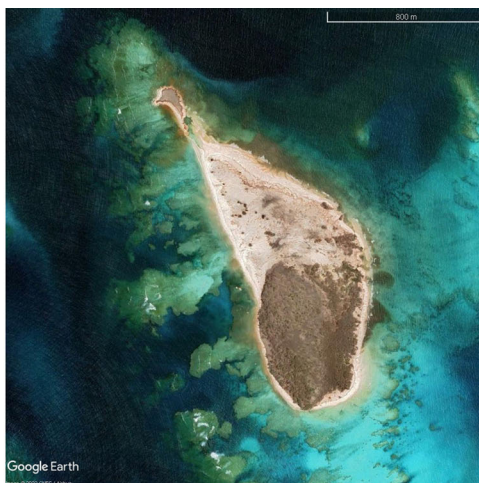
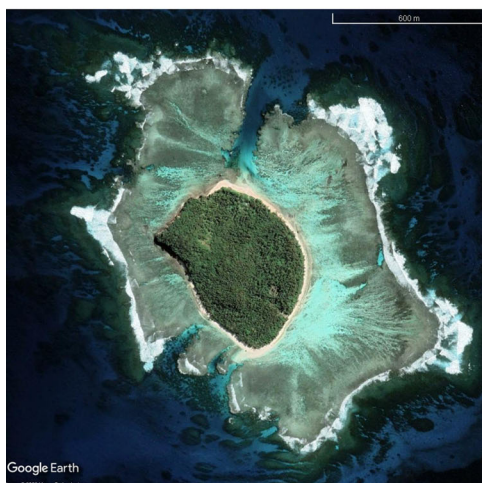
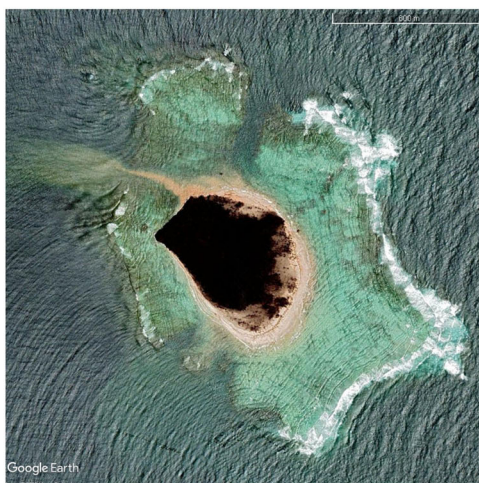
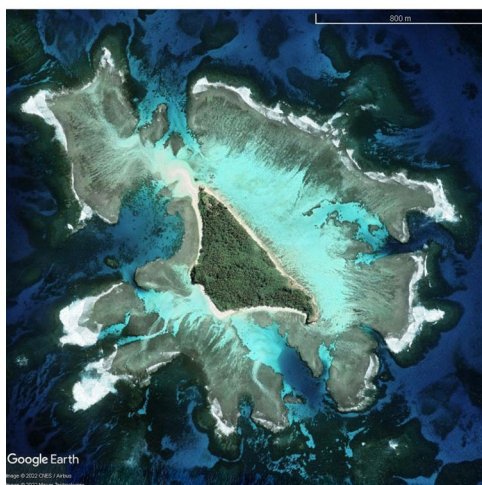
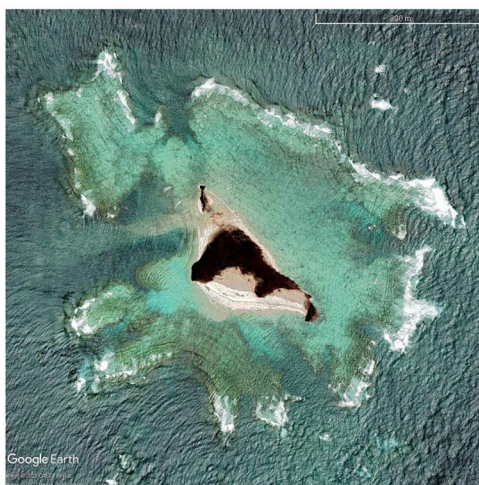
◀Figure 11

Before and after images of Nomuka iki (top) Tonumea (middle) and Kelelesia (bottom) showing large scale morphological change due to tsunami over wash. (Imagery from Google Earth, Maxar Technologies)

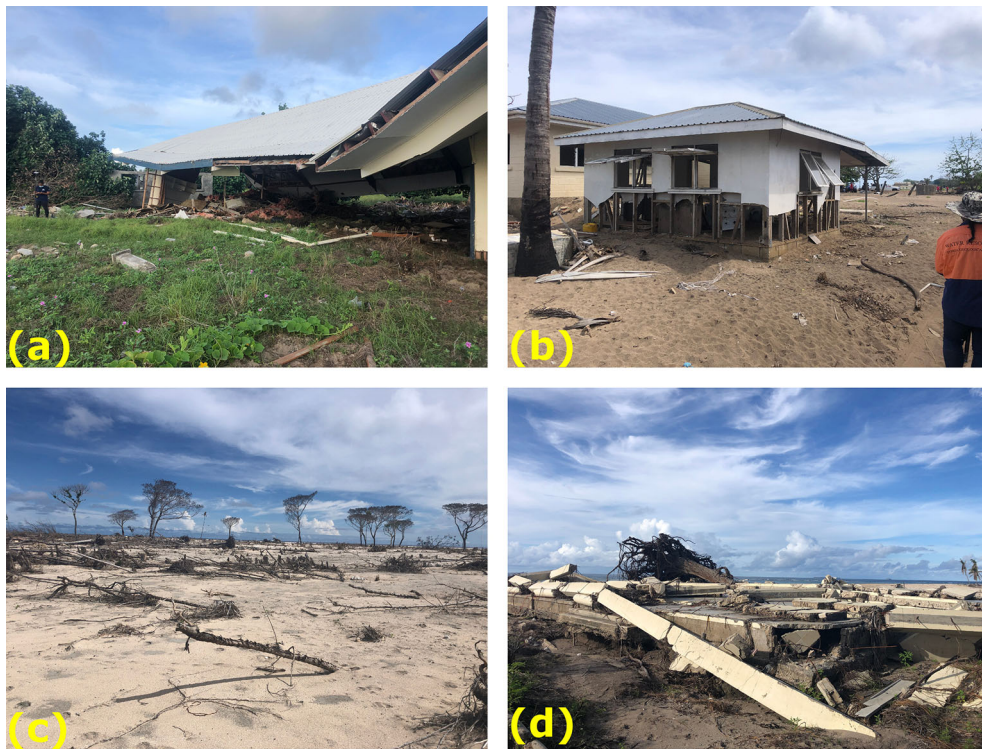
Figure 12
Tsunami damage on Tungua **a** Nomuka **b**, Nomuka Iki **c** and Mango **d**

The survey team visited several islands north of Tongatapu (see Fig. 6). While all the islands visited were affected by the tsunami, the most severe effects and largest tsunami heights were observed on Nomuka-Iki, Mango and Tonumea Islands. Each of these islands, as well as Kelelesia (which was observed only from a boat 1 km offshore), were completely over washed by the tsunami surge. The extreme inundation resulted in drastic changes to the coastal morphology and shape of these islands (Fig. 11), effects that at first glance seem more extreme and erosive in nature than those described by Kench et al. (2006) on Maldivian atolls after the 2004 Indian Ocean tsunami. At just under 5 m, the maximum measured tsunami heights on Tungua were smaller relative to the other islands, however these measurements were taken at the village on the eastern side of the island which faces away from the direction of tsunami approach and was protected by a large shallow reef. Nevertheless, there was severe damage to modern buildings and robust structures, such as a solar power installation (Fig. 12a). On Nomuka, tsunami heights in the village were in

excess of 8 m with ~ 6 m runup and > 100 m of inundation (Fig. 12b). Nomuka-iki, a small island located 2 km to the southwest, partly protected Nomuka, and was hit much harder, with complete over wash of the lower lying part of the island and measured runup of up to 20 m along the western face of a topographic high on the southern half of the island. The low-lying forest on the northern half of the island was stripped virtually clear to the subsoil (Fig. 12c), reminiscent of the destruction seen on Painatan Islands in Western Java following the 2018 tsunami generated from the eruption and subsequent flank collapse of Anak Krakatau (Borrero et al., 2020). There were tsunami heights of the order of 5 m on Fonoifua with damage to several buildings and the solar power facility. Finally, the village on the northern coast of Mango Island was totally destroyed by tsunami runup exceeding 7 m and maximum measured tsunami trace heights of nearly 10 m (Fig. 12d). In early-October 2022, a survey team visited Tofua and measured tsunami runup of > 20 m on the southwest coast and 14–16 m on the east side of the island. At these sites the
