KURIL ISLANDS, 15 November 2006, 11:14 UTC, $M_W=8.1$

Kuril Island Tsunami Impact in Crescent City, California 15 November 2006

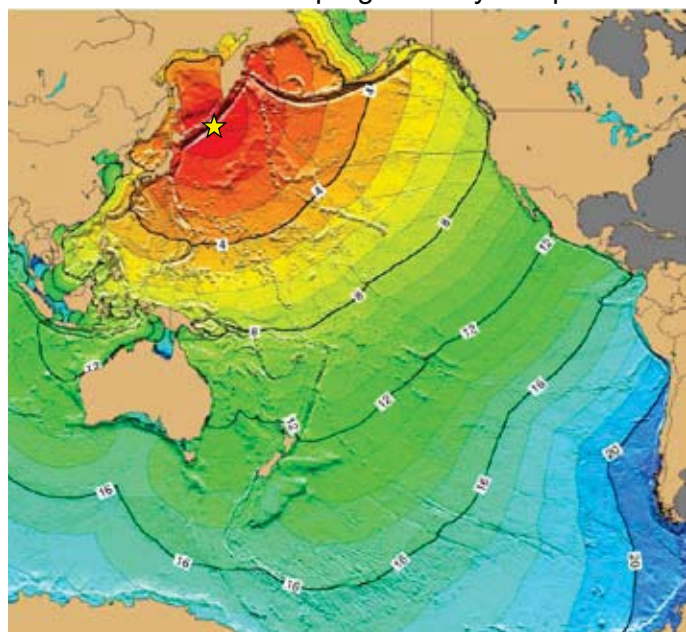
Tsunami travel time chart showing the theoretical time it takes to cross the Pacific from the tsunami source (assumed to be the earthquake epicentre). Color change every hour.

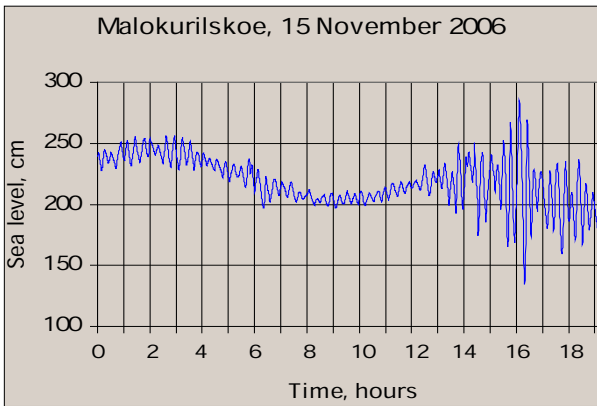
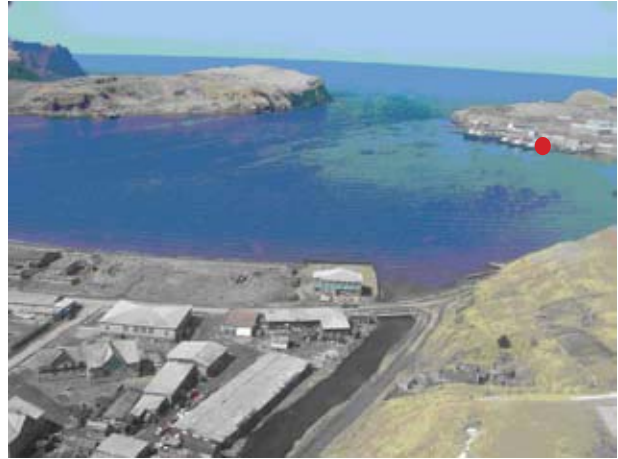
Sea level record from Malokurilskoe, Shikotan Island (left) along with an aerial view (right) of the harbor. Red dot indicates the location of the analogue gauge in the harbor. Graph indicates maximum peak-to-trough wave height in centimeters over time. Both courtesy of Tatiana Ivelskaya, Sakhalin Tsunami Warning Center.

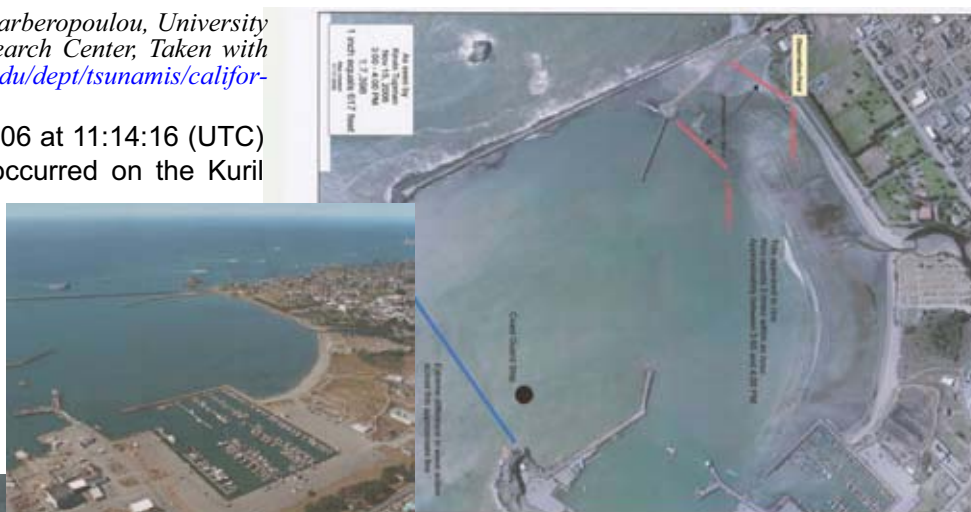
Left: Aerial photograph of the Crescent City Harbor. Photo provided by Harbor Master Richard Young (taken by Rick Hiser). Right: GIS measurement of inundation distance between high and low water levels during the tsunami. Information provided by Mr. Kevin Tupman.

Public works technician Kevin Tupman came to north harbor around 2:40 pm. He also observed the changes in water level due to the tsunami. Mr. Tupman estimated the distance from the low water mark to the high water mark was some 850 ft. He was at the north harbor from 3 until 4 pm and he saw three full wave cycles, which confirms Mrs. Burke's observation.

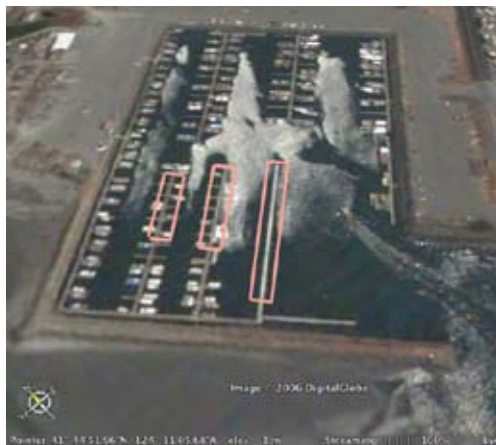
vessels berthed at Dock H were severed. Dock H had three boats, including the biggest boat in the harbor, 'Delana'. The 'Delana' was connected directly to the piling, while the other two vessels were connected to the exposed dock. The dock could not resist the strong current and the pull coming from the boats and failed.

Aerial view showing the areas where major damage occurred to the docks of Crescent City Harbor. URL:http://www.usc.edu/dept/tsunamis/california/Kuril_2006 Permission granted to download from the USC Tsunami Research Center website. Photo credit to Professor Lori Dengler.

Other witnesses described the tsunami in the harbor as 'flowing like a river'. It caused a whirlpool effect and it was flowing in clockwise direction. Dock H was the first dock in the flow direction and could not resist the flow.

After the Dock H, it was just a matter of time before Dock G failed. The loose boats carried pieces of Dock H when they crashed into Dock G and later into Dock F. A large portion of Dock F was also damaged, but it did not move around as did Docks G and H.

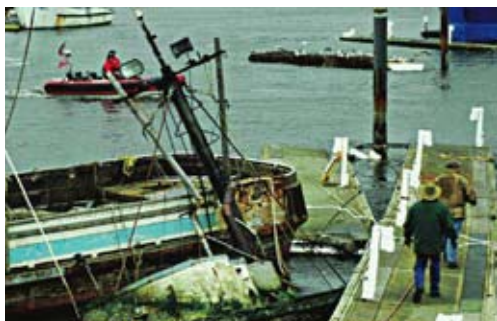
Boats damage in Crescent City Harbor. Photo provided by Professor Lori Dengler, Humboldt State University.

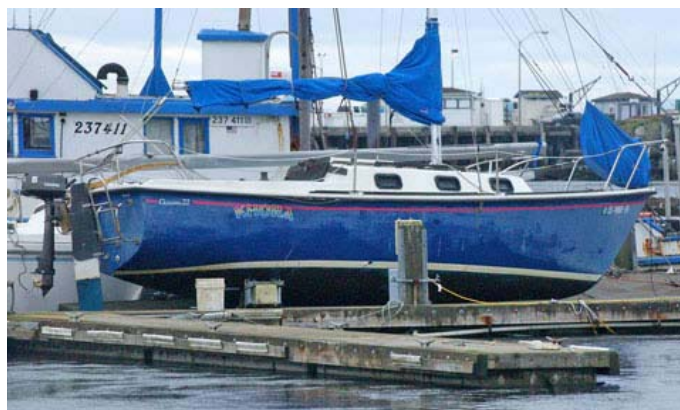
Boat lifted out of the water onto a pier. Photo provided by Professor Lori Dengler, Humboldt State University.

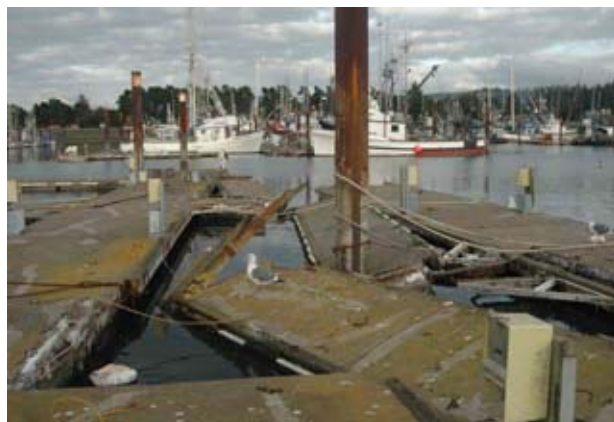
Pier damage photo taken by Emergency Services Coordinator Allen Winoogradov following the tsunami in Crescent City.
