2nd Field Survey Report for Palu Tsunami 2018

Taro Arikawa¹, Abdul Muhari², Yoshihiro Okumura³, Yuji Dohi⁴, Bagus Afriyanto²,
Karina Aprilia Sujatmiko⁵

Possible subsidence areas or tsunami source areas along the coast

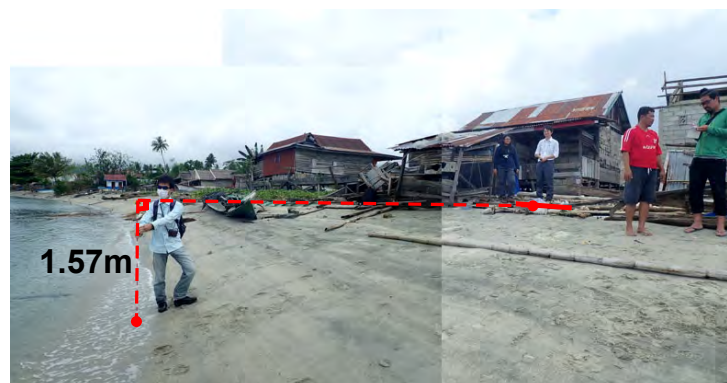
ID1

Tsunami Height and Behavior at Point A

- Run up height is 1.57m
- After the earthquake, the sea level fell down and seemed to hit in the offing, after that the tsunami headed for the shore

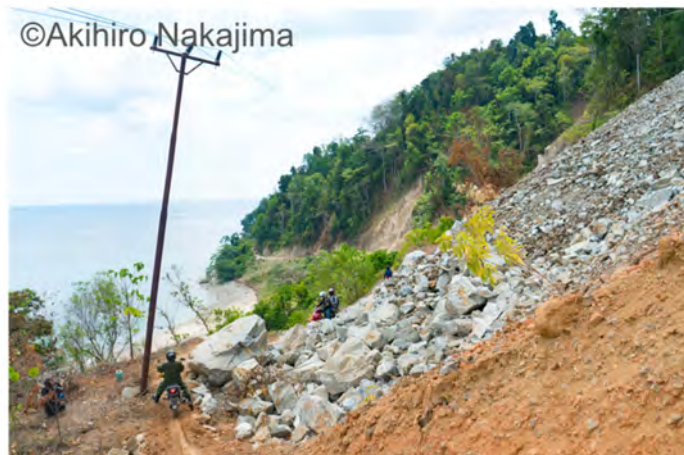
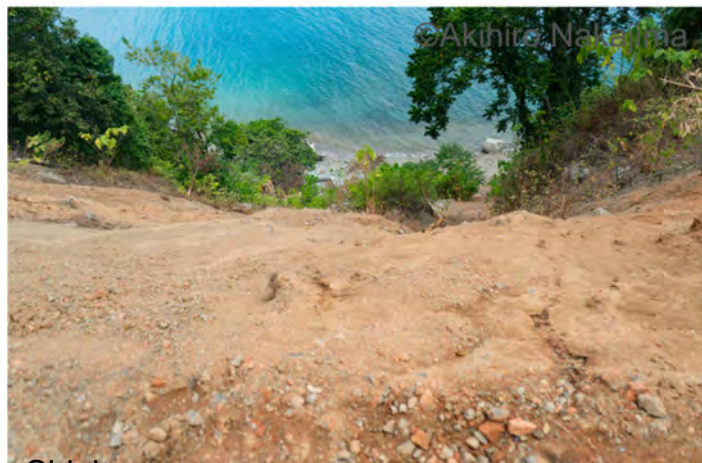
State of Landslide at Point B

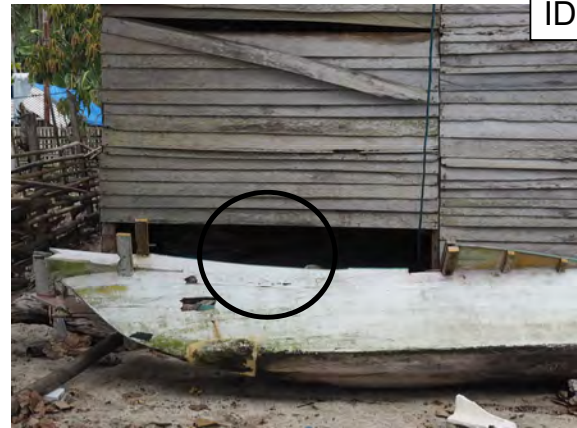
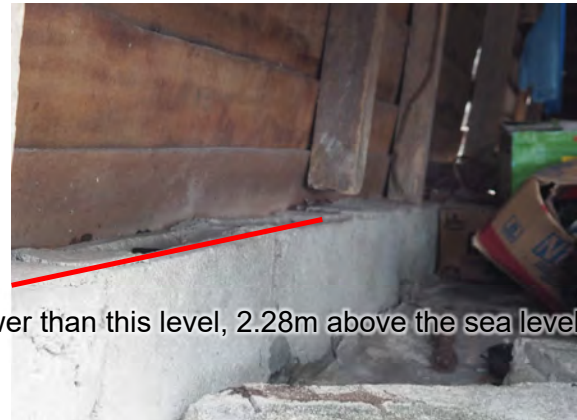
ID2

The height of the tsunami around the point B

There was no water marks inside a wooden building.
At least, a tsunami height is lower than the upper of the concrete block of the foundation.

Lower than this level, 2.28m above the sea level

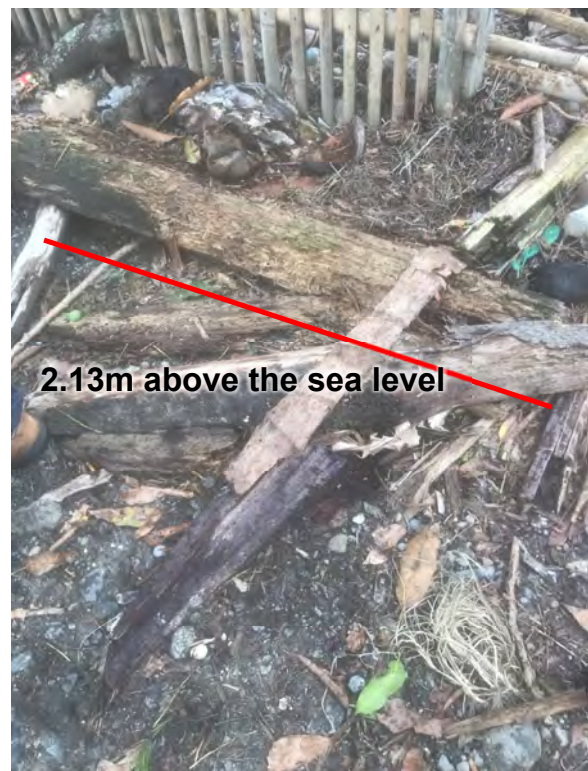
ID3

2.13m above the sea level

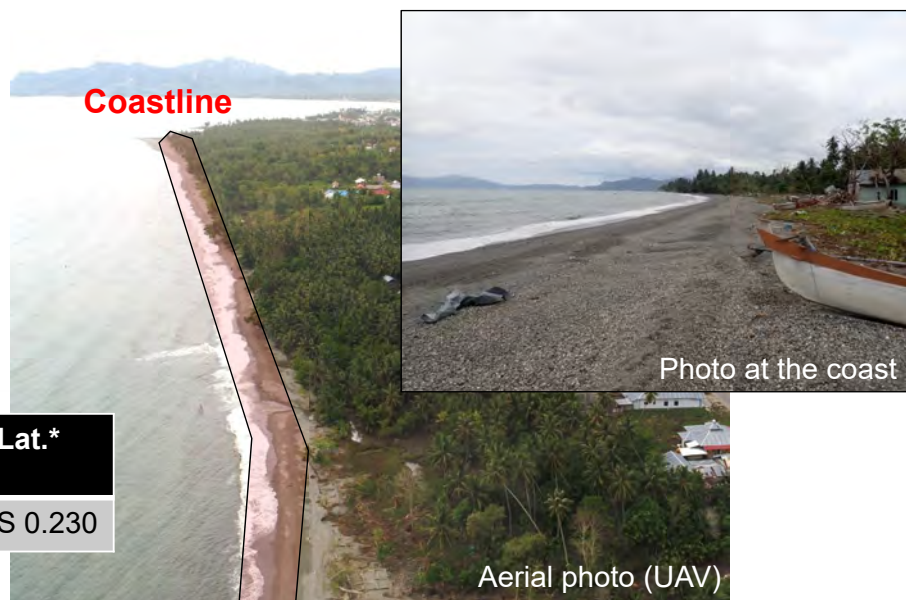
The slope seen at the coast can be considered to be the subsidence?

This subsidence indicates the possibility of the tsunami source resulted from the land slide under the sea?

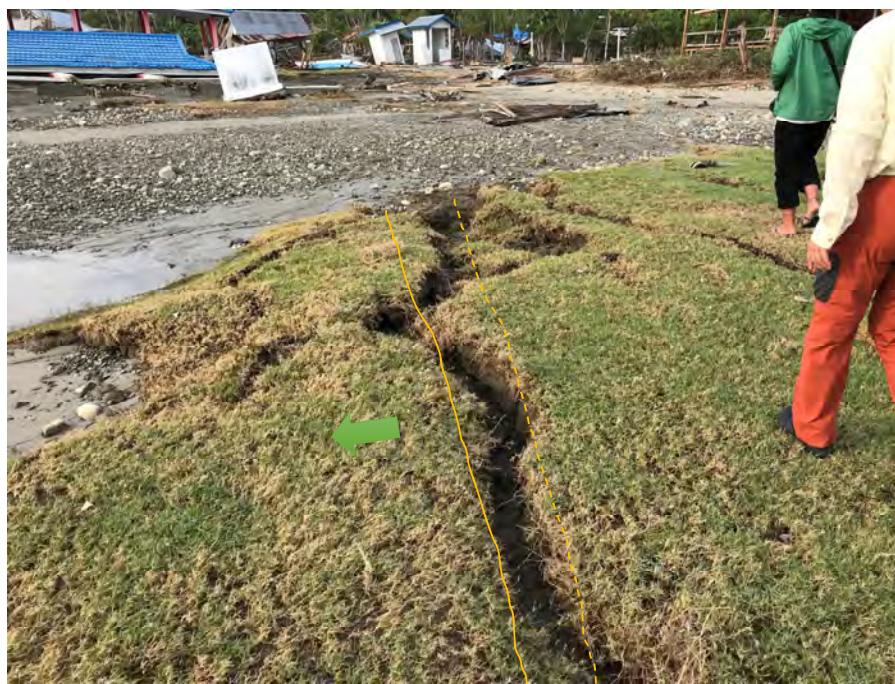
ID14

Scene of crack at point C

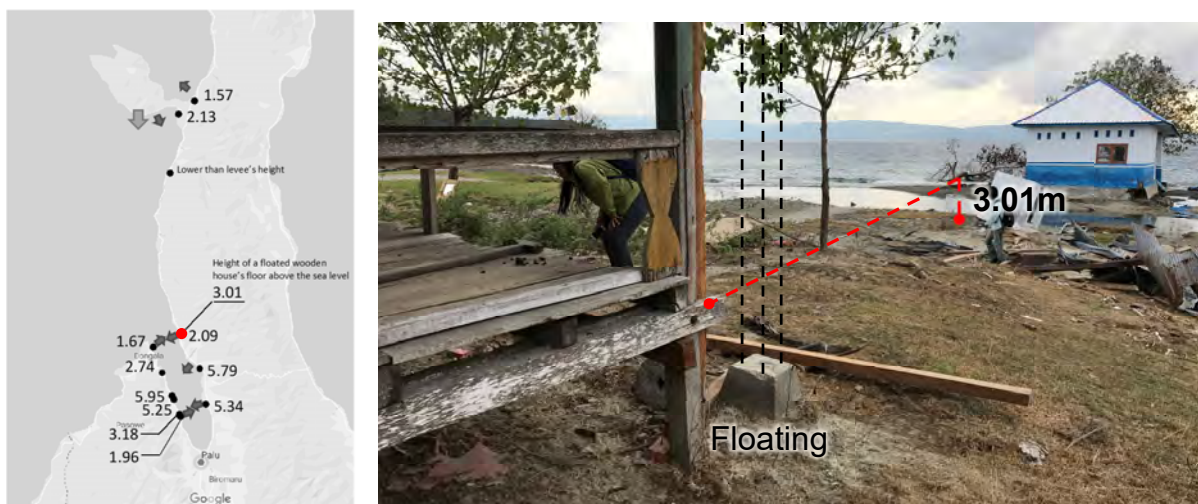
Tsunami Height at Point C

At least 3.01m height of tsunami arrived at this area because of a floating wooden building. Flow depth is 2.09m here.

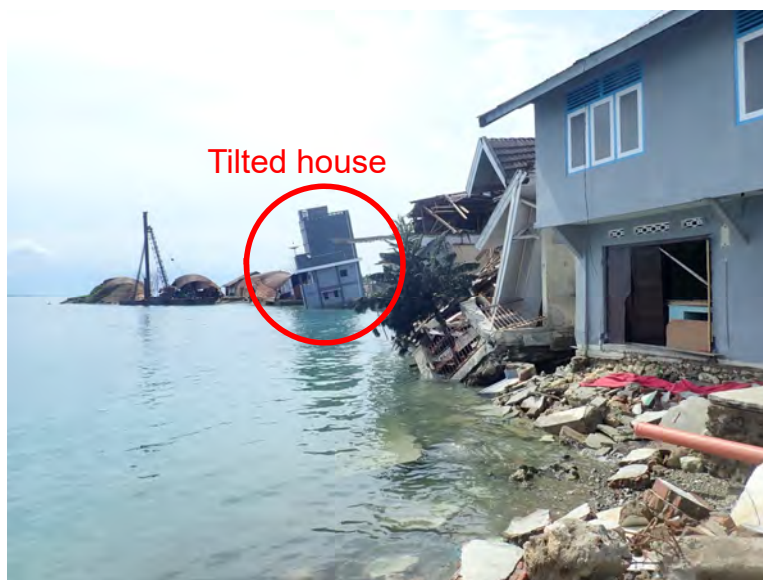
Point D

The tilted house can be seen.

Additionally, some houses sank into the sea after the earthquake, base on the testimony by the diver who dived into the sea around here on the day after the earthquake.

These phenomena indicates the possibility of the submarine landslides here.

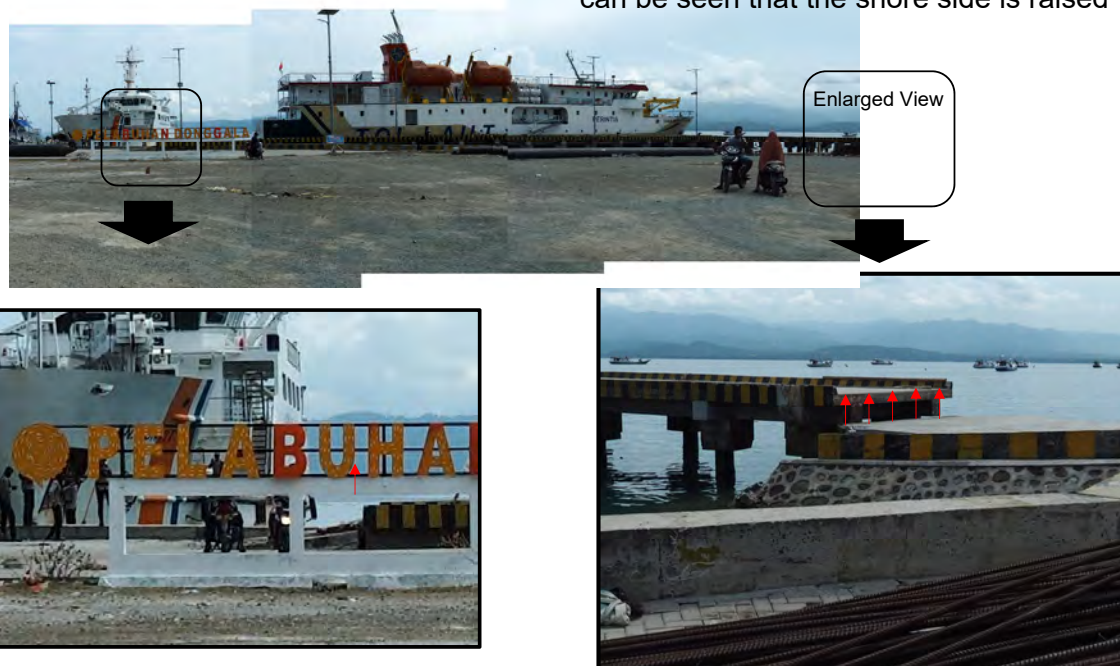
ID6

Scene of step at the pier due to subsidence of the ground at point D

Due to the bottom of the offshore side of the pile of the pier might be subsidence, it can be seen that the shore side is raised

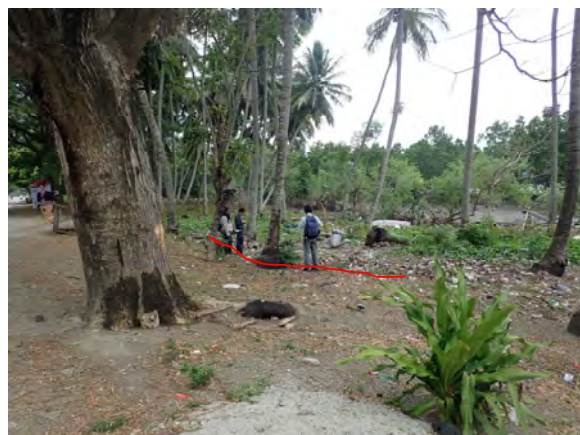
Tsunami Height and Behavior near by Point D

- There was no evidence of the subsidence here.
- The tsunami arrived in 10 minutes after the earthquake

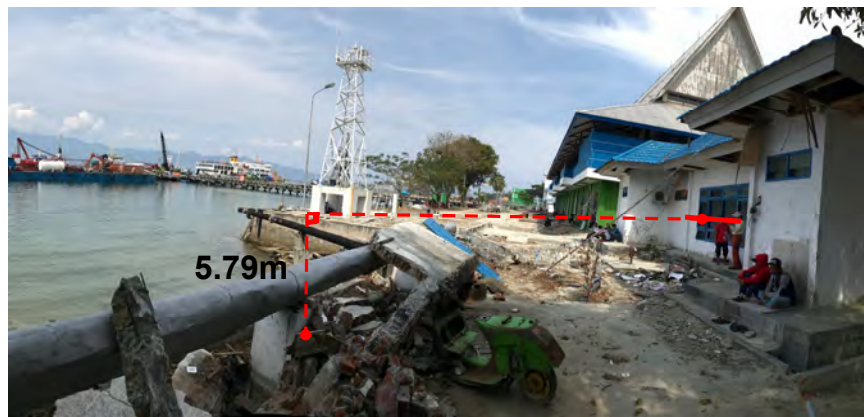
ID15

Tsunami Height at Point E

Splash

Unbroken window glass

Broken window glass

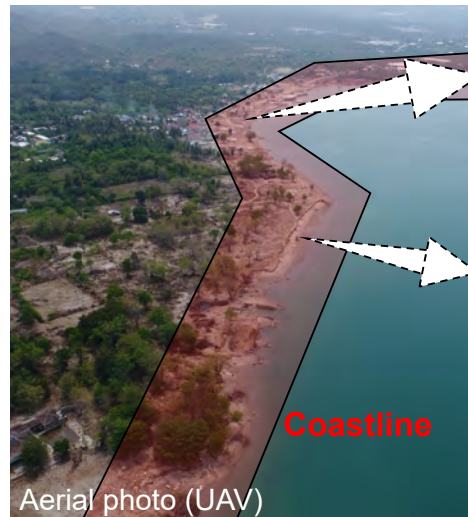
Point F

The area around here seems to have subsided entirely. A comparison by Google Earth is also shown in the subsequent slides. On the other hand, the possibility that there was a step on the sand beach before the earthquake occurred can not be denied

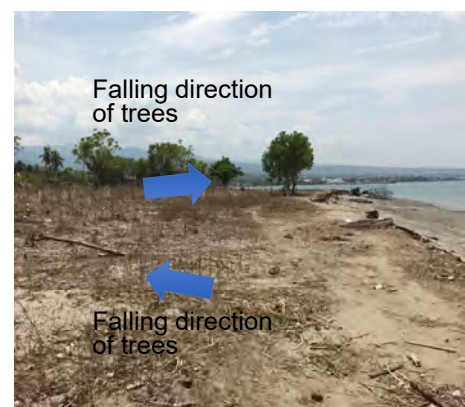
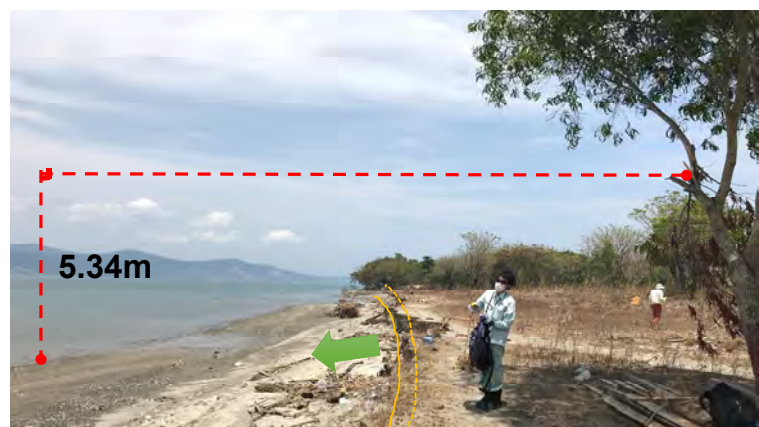
ID16

Tsunami Height and Behavior at Point F

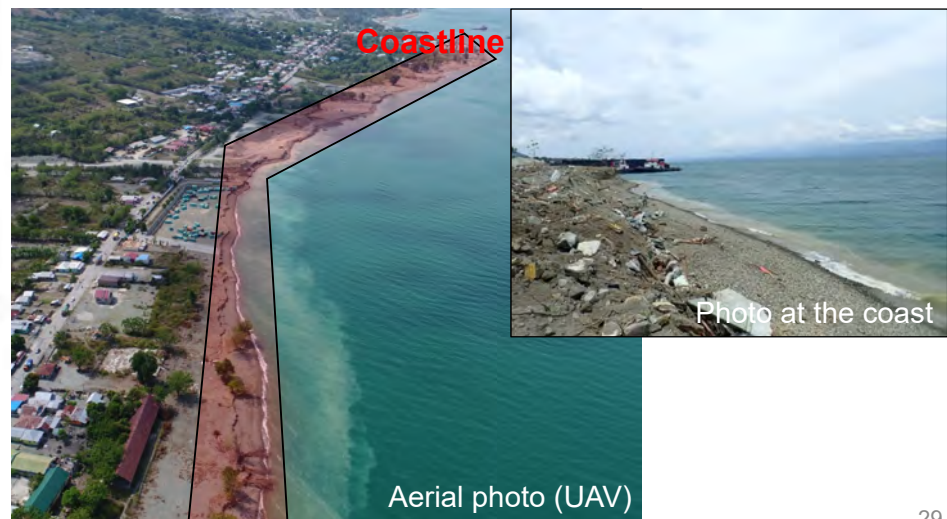
Point G

The steep slope seen at the coast can be considered to be the subsidence.
Additionally, change in the color at the sea surface near the coastline can be seen.
These phenomena indicates the possibility of the tsunami source resulted from the land slide under the sea.

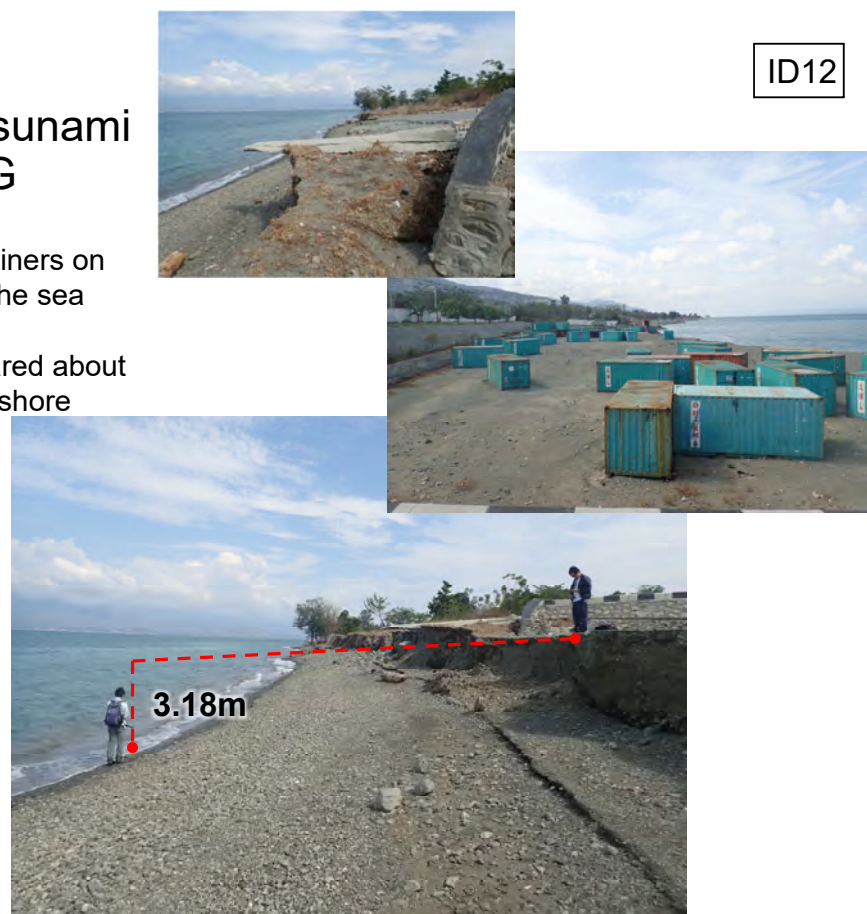
ID12

Subsidence and Tsunami behavior at Point G

- There were drifted containers on the ground 3.18m from the sea level.
- Container yard disappeared about 100 meters in the cross-shore direction

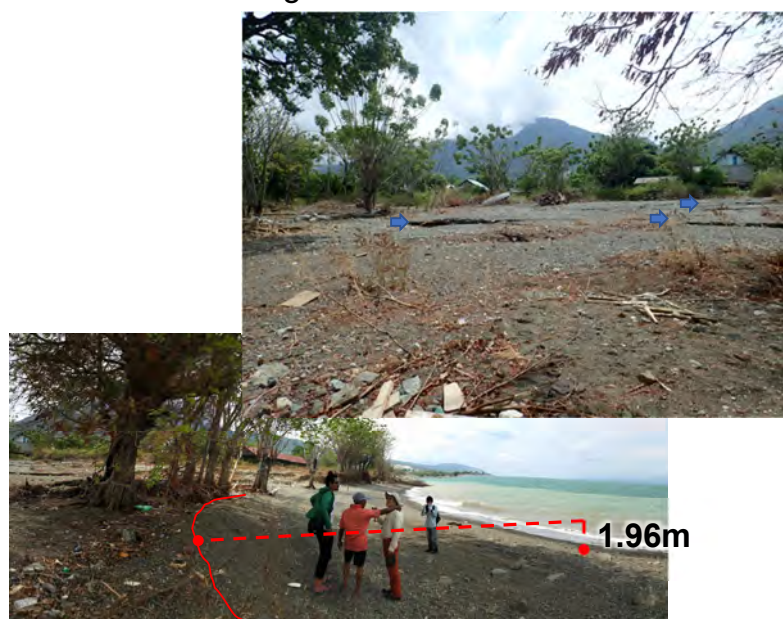
ID11

Tsunami height around point G

- Cracks were found at this place
- The tsunami height was seems to be small

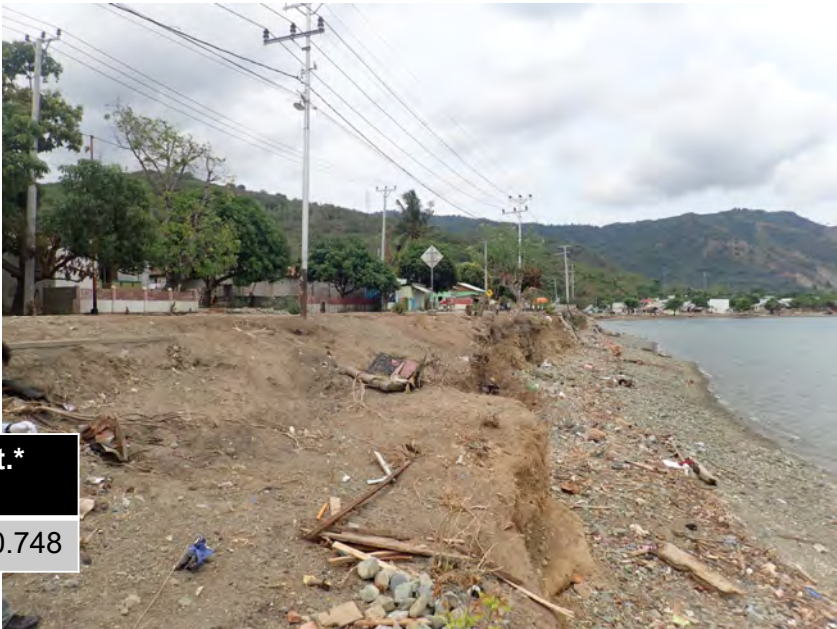
The small cliff was seen at the coast of north part of Point G. It resulted from the subsidence by **1968 earthquake** based on the testimony by the inhabitant. It indicates that the earthquakes repeatedly occur in this region.

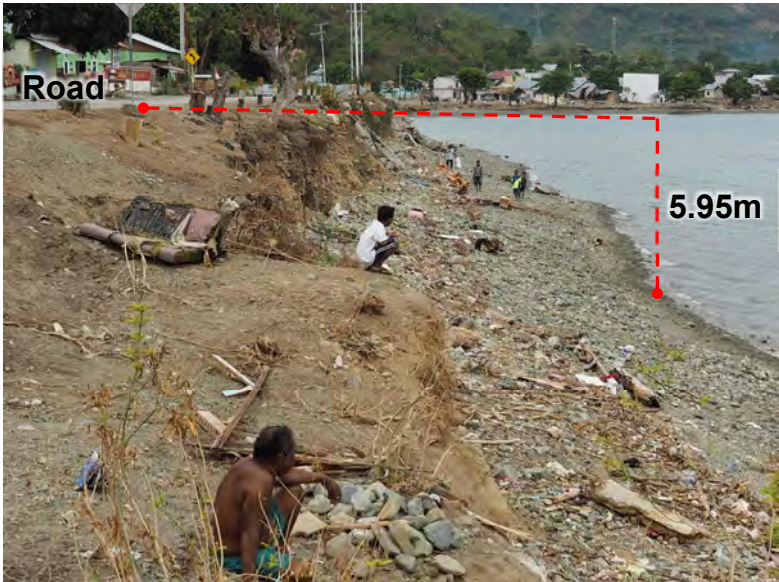
ID8

Tsunami height

A tsunami overflowed the road.

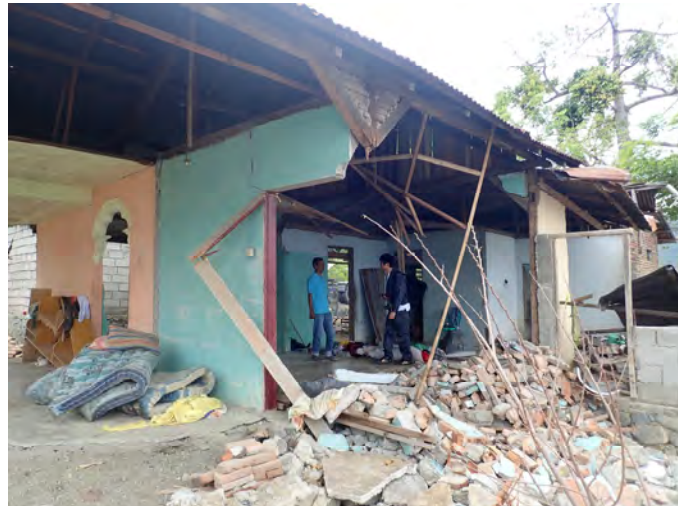
Tsunami height

Splash mark on the ceiling.
The height of the mark above the sea level is 8.51m.

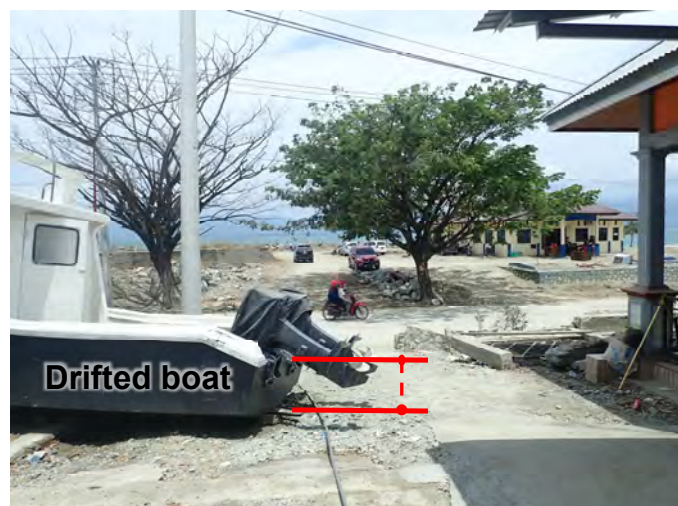
Tsunami height

- Flow depth was a knee level at the place of the drifted boat.
- Inundation height was 5.25m
