Wilson, K.J. Power, W.L., Nishimura, Y., 'Atelea Kautoke, R., Vaiomo'unga, R., Mori, H., Pongi, 'A., Fifita, M., Vaoahi, M., Teukava, S. 2009. Post-tsunami survey of Niuatoputapu Island, Tonga, following the 30<sup>th</sup> September 2009, South Pacific tsunami, *GNS Science Report 2009/71*. 28 p.

## **ABSTRACT**

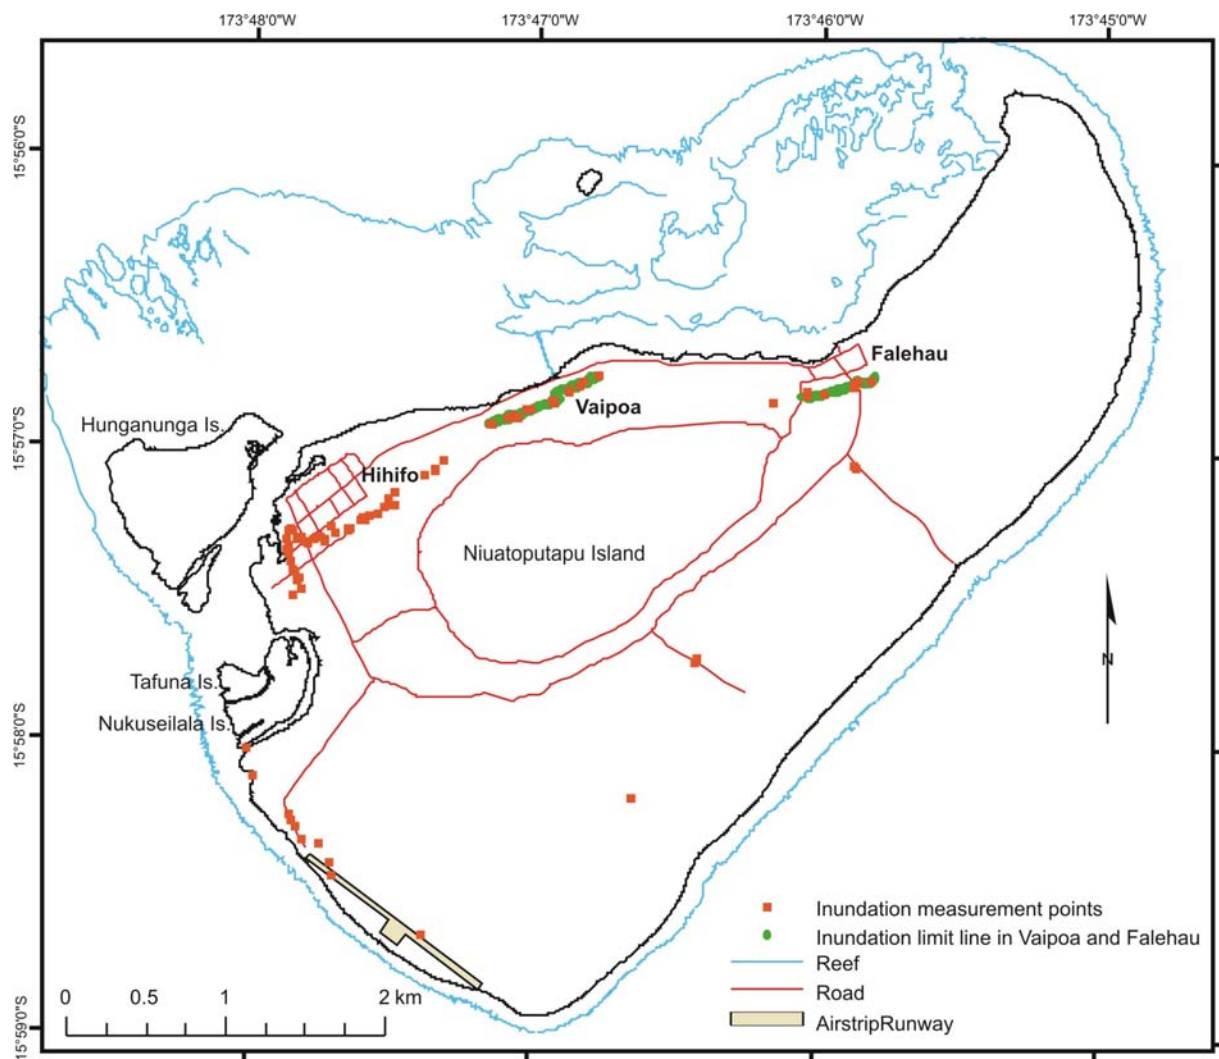
The limit of tsunami inundation was measured in the field at 105 locations by the three survey teams in Niuatoputapu (Fig. 6). Point density is greatest around the three villages where the inundation limit could be walked along completely, but there are fewer points along the eastern coast due to dense forest and limited accessibility. The maximum inundation distance measured in the field was 910 m near along the northeastern part of Niuatoputapu. The minimum amount of inundation was seen along the western side of Niuatoputapu where no tsunami inundation was seen along the southern side of Nukuseilala Island (Tafuna Island was not accessed). In the village of Hihifo the inundation varied between approximately 200 – 570 m, a topographic ridge near the southwestern side of the island affected the inundation pattern. In Vaipoa the inundation distance varied from 120 – 180 m, and in Falehau inundation was between 190 – 310 m. In Vaipoa, the maximum inundation distances were significantly shorter in the eastern part of the village than in the western part. It suggests that the beach forest in the eastern part of the village has worked to reduce the tsunami energy.

Figure 6. Inundation limit points measured in the field using handheld or RTK GPS.

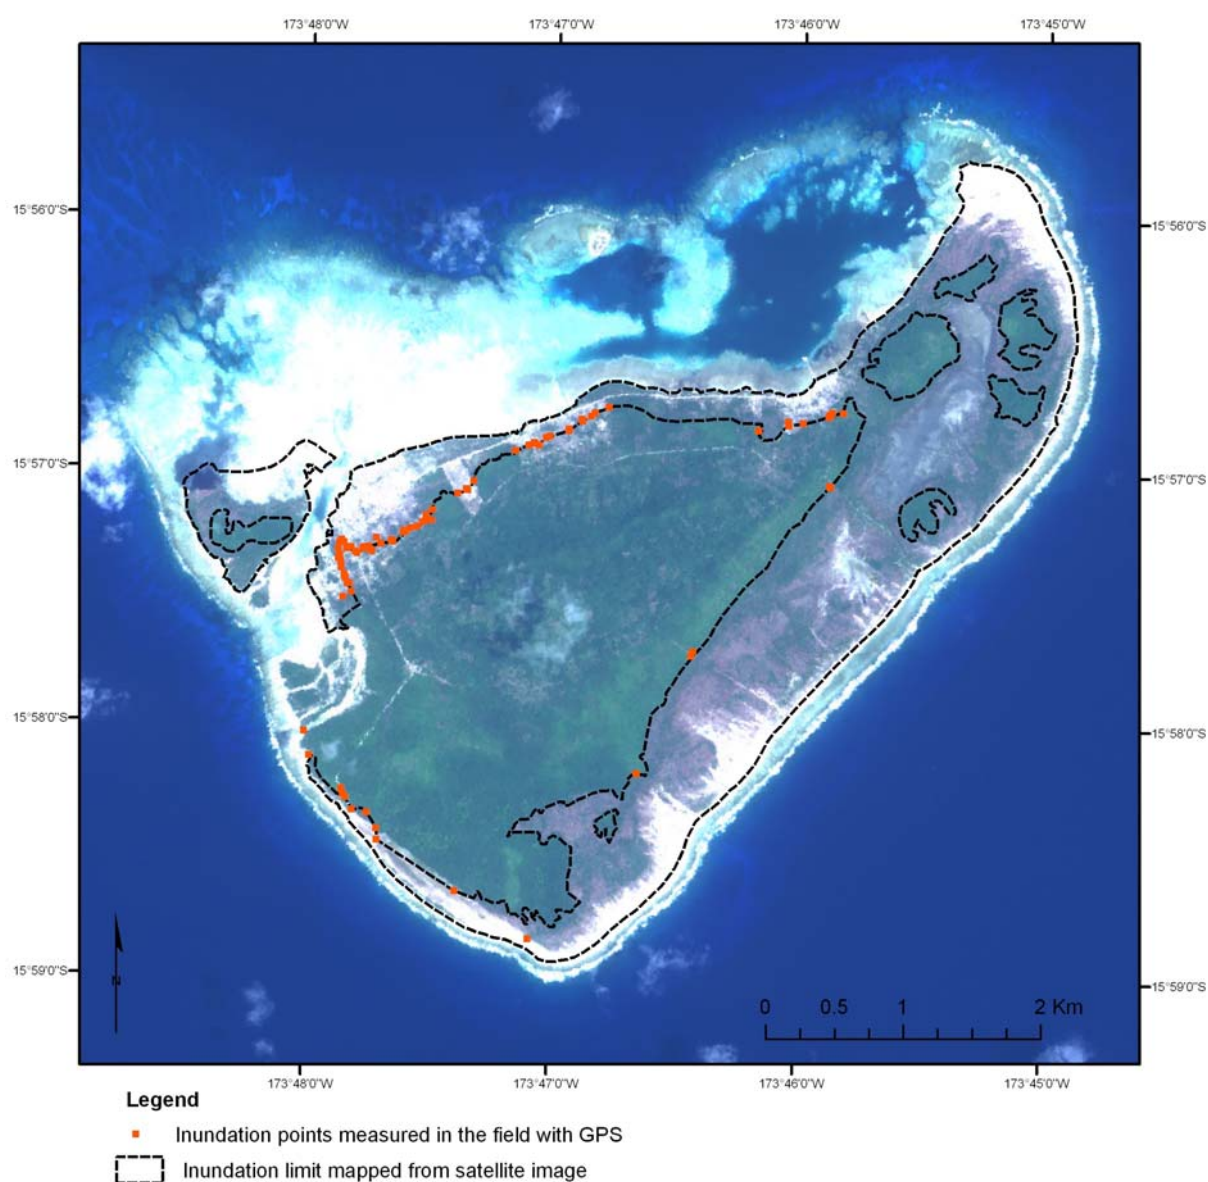
Calculations of inundation distance from the dataset including the satellite interpretation indicates that the maximum inundation distance was 1100 m near the southwest corner of Niuatoputapu (Fig. 7). The inundation distance may have been greater slightly to the north of Falehau village where the tsunami inundation zone bridges the whole island (a width of 1.5 km) but the wave inundated from both sides and we cannot determine at what point in the

middle the tsunami met. Using the GIS map of tsunami inundation we calculate that 46% of the land area of Niuatoputapu was inundated by the tsunami (Fig. 7).

Figure 7. Inundation line mapped on the island of Niuatoputapu from a combination of Formosa 2 satellite images and GPS points collected in the field. Along the east coast there is a precise match between the GPS points and the zone of dead vegetation on the satellite image.

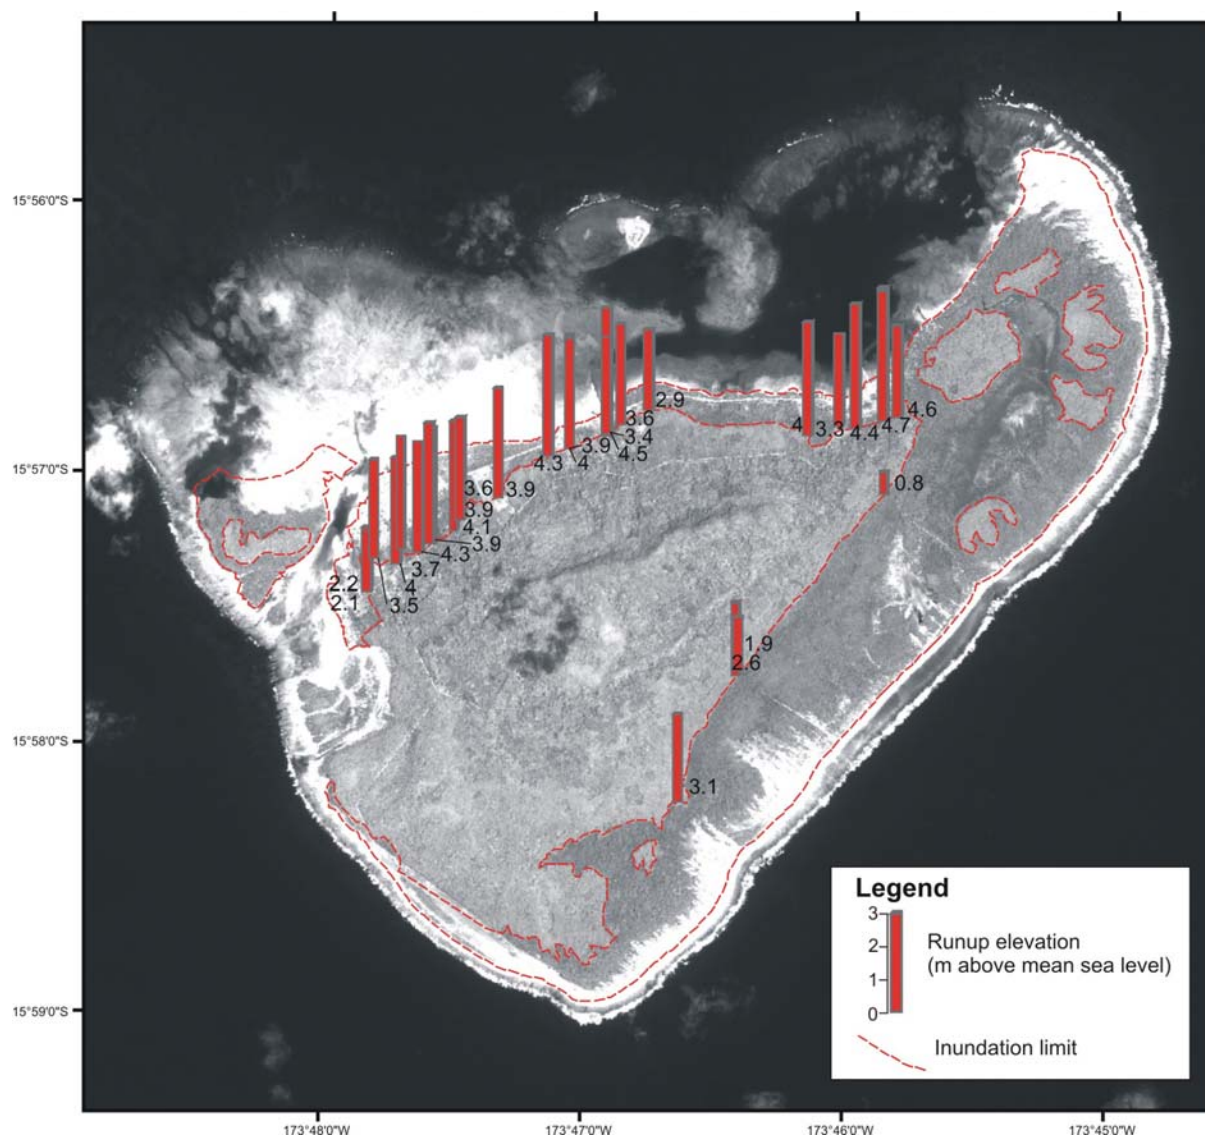
Tsunami runup elevation (i.e. the ground elevation at the maximum inland extent of inundation) was measured at 29 locations (Fig. 9). A maximum runup elevation of 4.7 m above mean sea level (AMSL) was measured at Falehau village. Vaipoa village had tsunami runup up to 4.5 m AMSL and the maximum runup at Hihifo was 4.3 m AMSL. The highest runup elevations were all recorded along the western side of Niuatoputapu. However, it is likely that higher runup elevations were attained at the southern tip of Niuatoputapu because topographic profiles collected there (to be discussed in Section 3.5) showed tsunami inundation up to elevations of 5.8 m AMSL. The topographic profiles could not reach the inundation limit due to dense forest and debris piles but runup was probably at least 5.8 m AMSL in this area. Along the western coast of Niuatoputapu, where the greatest inundation distances were, runup elevations were relatively moderate at 0.8 – 3.1 m AMSL.

Figure 9. Tsunami runup measurement locations on the island of Niuatoputapu. Background image is the panchromatic Formosa 2 satellite image with the inundation limit marked in red dashed lines.

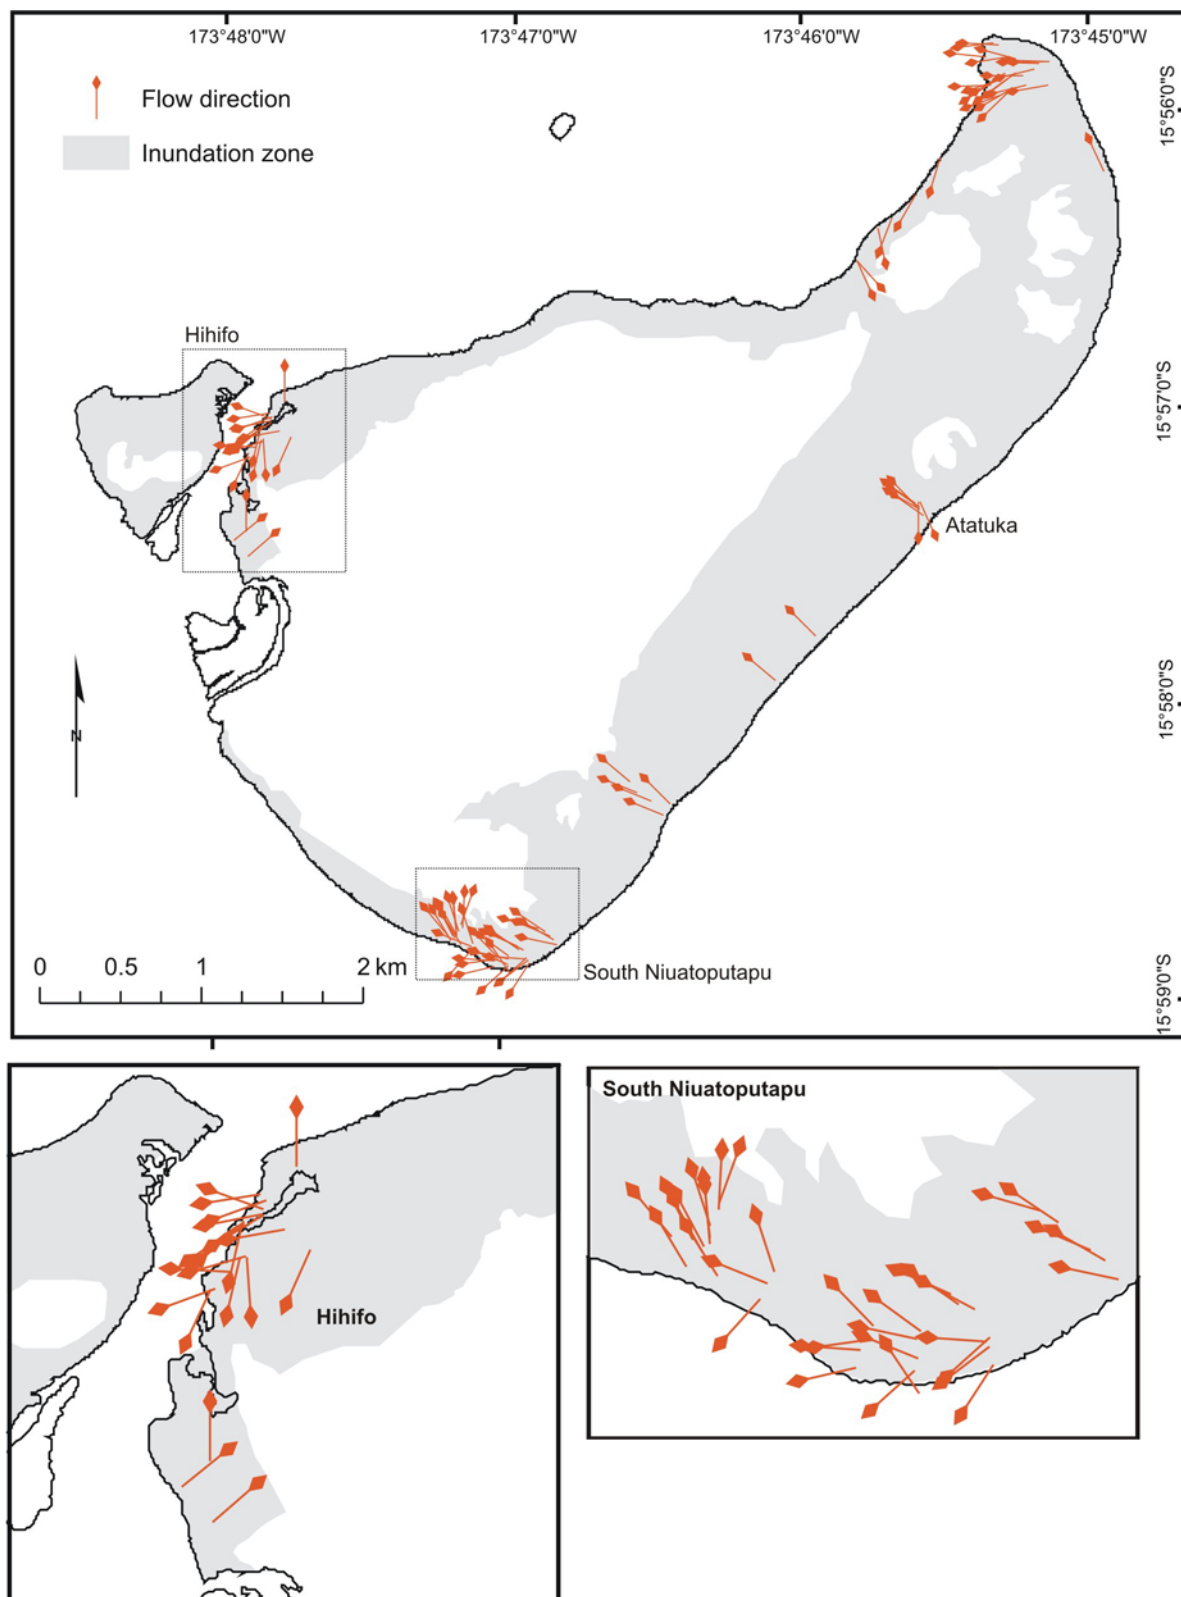
Tsunami flow direction measurements were taken at 98 locations on Niuatoputapu Island (Fig. 10). Flow directions are variable but the general pattern is of the tsunami coming from the northeast direction and “wrapping” around the northern and southern tips of the island. At the northern tip of Niuatoputapu the flow direction indicators were typically  $250^{\circ}$  -  $270^{\circ}$  indicating that the waves came from the northeast. Most flow direction indicators in this region were swathes of large snapped or uprooted trees all aligned in the same direction, undoubtedly representing the direction of the strongest wave. Further around the northern tip the flow directions trended parallel to the coast and then bent landward ( $140^{\circ}$ ) near the village of Falehau. A similar pattern was seen at the southern tip of Niuatoputapu where the flow directions were directly from the east along the east coast, bent approximately parallel with the coast at the very southern promontory and then turned inland (flow directions from the south-southeast) once the flow had turned the corner.

The few flow direction measurements obtained along the eastern coast of Niuatoputapu that indicate the dominant flow direction was directly onshore (flow from the east-southeast). At Atatuka, on the east coast, flow directions were dominantly c.  $300^{\circ}$  but two measurements were almost the opposite of this at  $156^{\circ}$  and  $180^{\circ}$ . It is likely that the latter two measurements represent return (offshore) flow of the tsunami waves.

At Hihifo village the flow directions were generally complex and variable, but it is likely that the tsunami waves came from two directions. The northern part of village appears to have been inundated by waves from north and northeast directions, and the southern part by waves from the southwest. Flow directions at Hihifo may also have been influenced by the small scale topography. A small tidal channel indenting the coastline at the north of the Hihifo and a ridge along the southern part of the village probably caused some of the flow variability.

Figure 10. Flow direction measurements around Niuatoputapu Island.

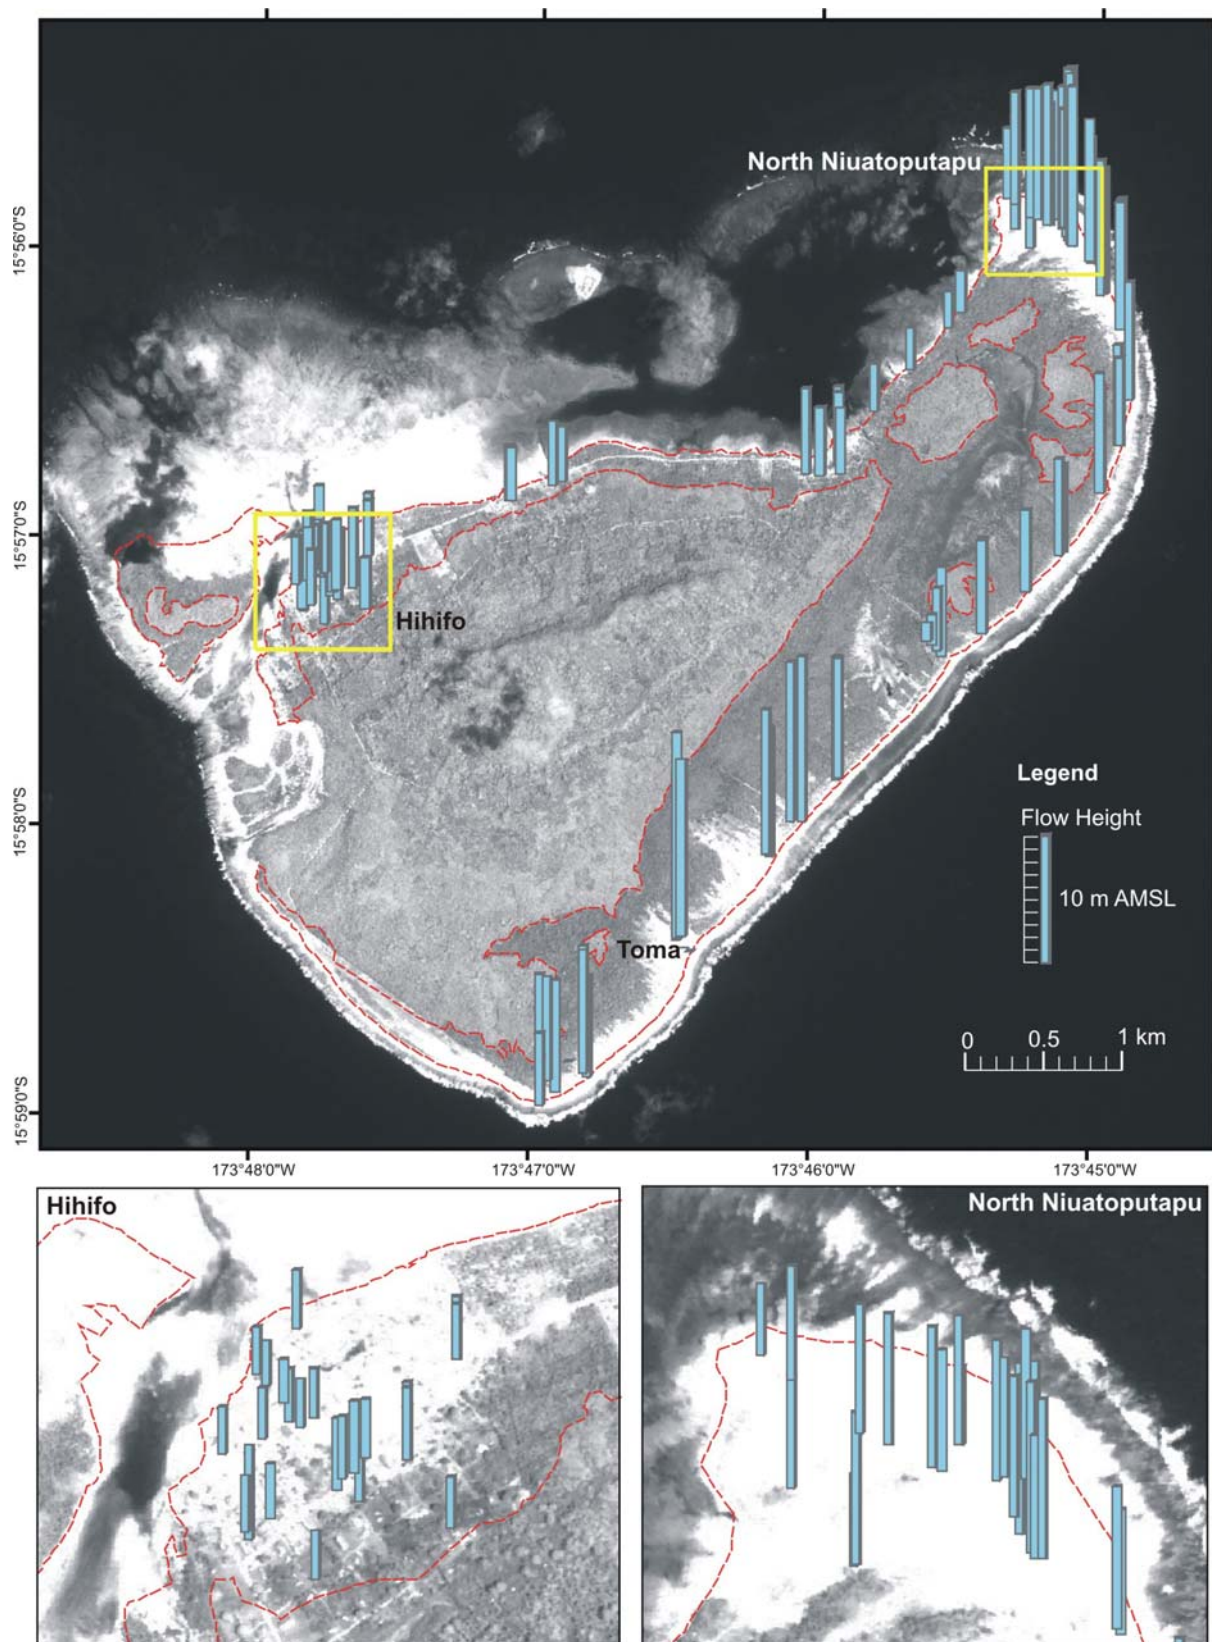
The flow heights of the tsunami were highest at the along the western coast and northern tip of Niuaotoputapu (Fig. 11). The maximum flow height was 16.9 m AMSL at the coastline at Toma, in the southeast of Niuaotoputapu (Fig. 11). Generally the flow heights around southeast of the island were between 8.5 – 15 m AMSL. At the northern tip of Niuaotoputapu flow heights varied between 6 - 10.8 m AMSL. Flow heights decreased by approximately half along the western side of the island.

Figure 11. Tsunami flow heights at Niuatoputapu, measured in metres above mean sea level.

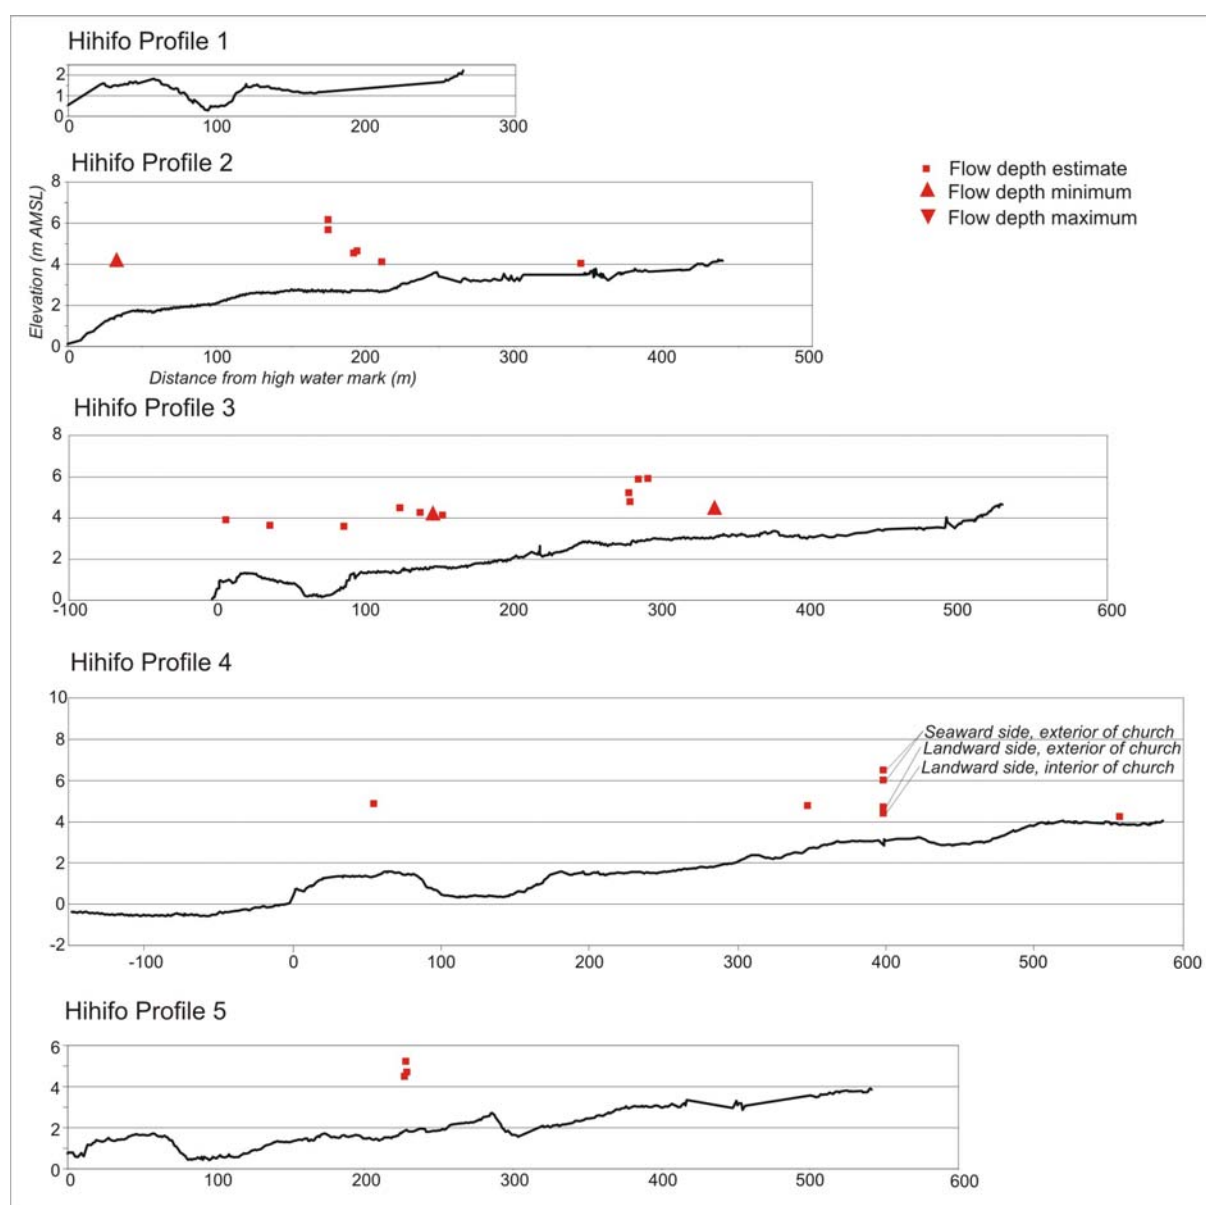
In the village of Hihifo five profiles were obtained, along with approximately 30 flow depths, along or near the profiles (Figures 12 and 13). Plots of topography and flow depths show, as expected, a general decrease in flow depth with increasing distance inland but there is some variability. Hihifo Profile 2 shows a rapid decrease in flow depth at approximately 190 m inland while Hihifo Profile 3 shows flow depths consistently c. 2 m above the ground surface up to 300 m inland. At 400 m inland on Hihifo Profile 4 flow depths on the seaward and landward side of a church were obtained. The landward flow depths were 1.6 m lower than those on the seaward side of the church; this data may be used in future to calculate a flow velocity.

Figure 13. Topographic profiles and flow depth measurements from Hihifo village, Niuatoputapu.

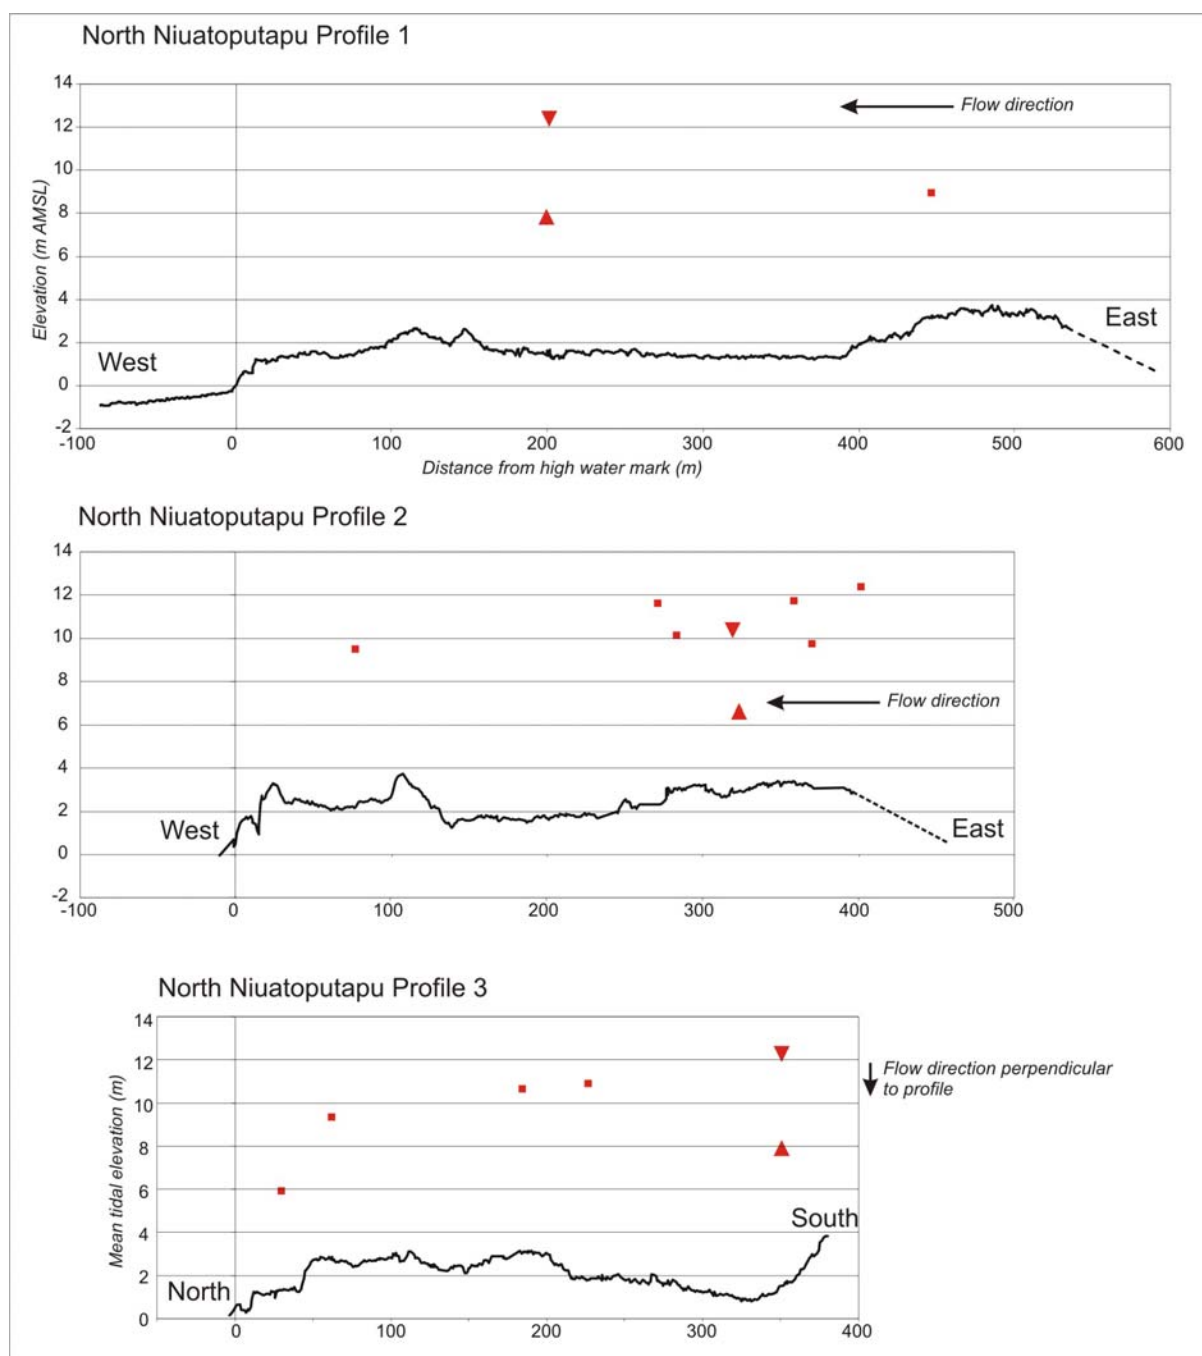
10). Profiles 1 and 2 indicate that the tsunami flow depth decreased very little as it crossed the peninsula, despite encountering dense forest which was completely destroyed and uprooted by the force of the tsunami.

Figure 14. Topographic profiles and flow depth measurements from the northern point of Niuatoputapu Island.

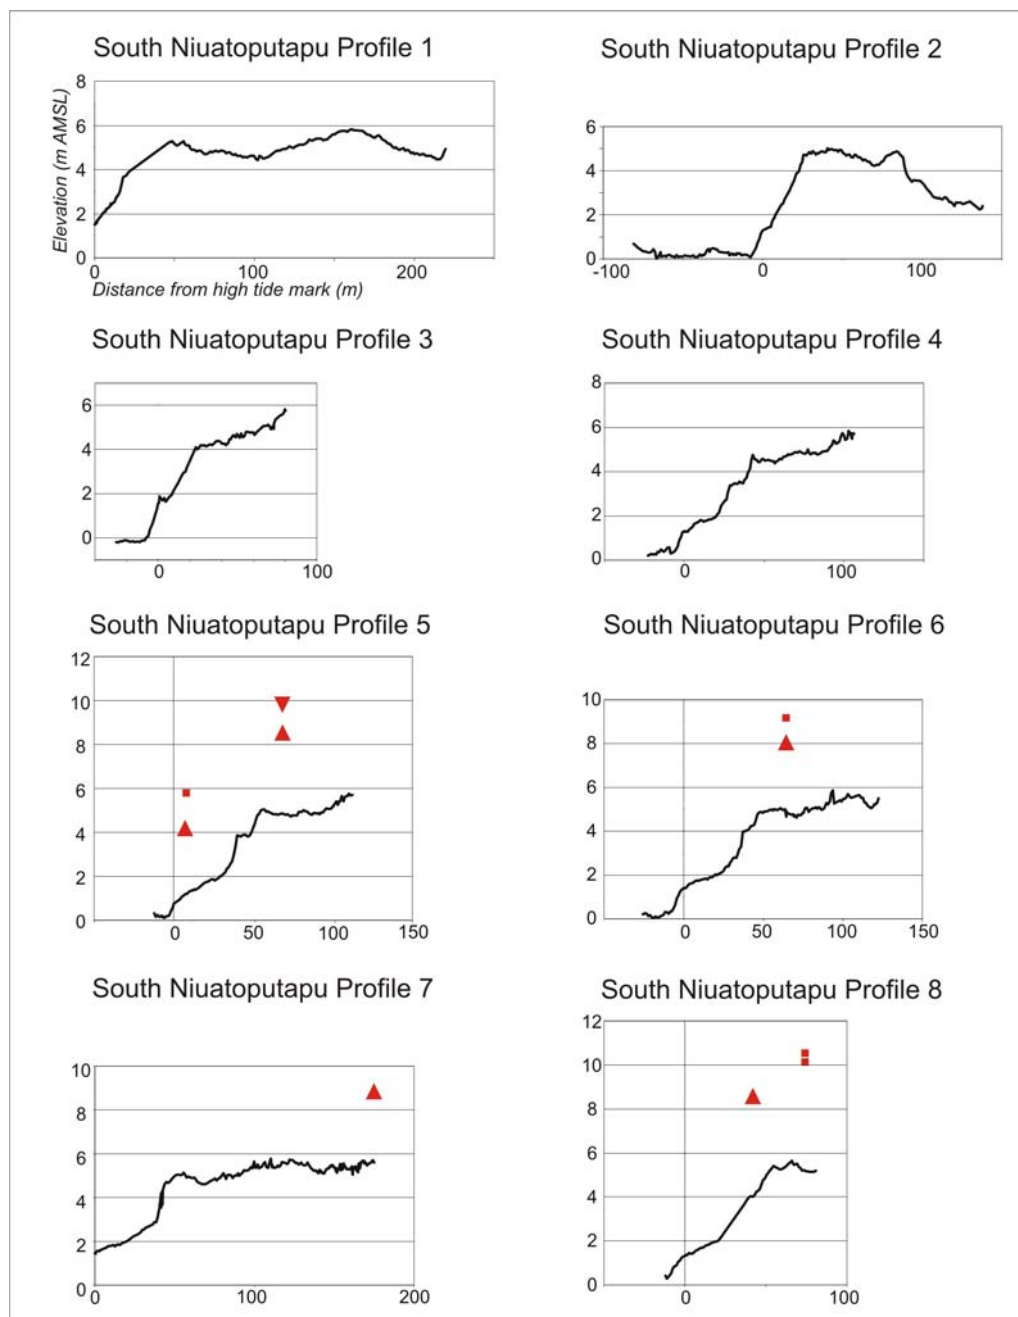
Eight topographic profiles were obtained from the southern point of Niuatoputapu, however due to dense forest and debris piles only one of these profiles (South Niuatoputapu Profile 1) reached the inundation limit (Fig. 15). The South Niuatoputapu profiles all display the steep shoreface characteristic of this area and flow depths are typically 3 – 4 m above ground level.

Figure 15. Topographic profiles and flow depth measurements from the southern tip of Niuatoputapu Island.
