THE 28TH SEPTEMBER 2018 PALU EARTHQUAKE AND TSUNAMI

ITST, 07-11 November 2018

POST TSUNAMI FIELD SURVEY REPORT (SHORT)

November 23, 2018

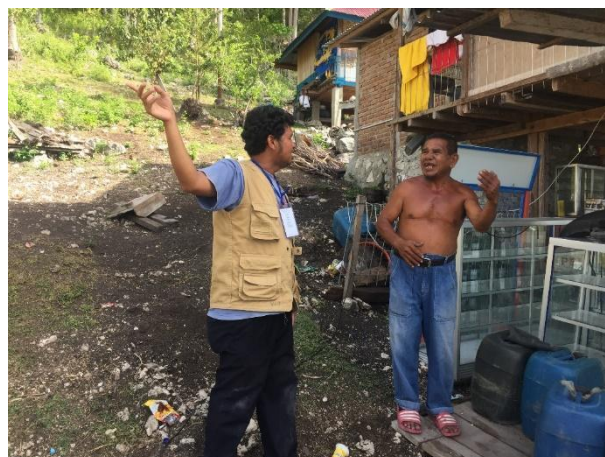
Point: W-01.1 Western tip of Tanjung Karang

At the western side (tip) of the Tanjung Karang cape of Palu Bay (0.64596S 119,72738E). According to eyewitnesses (people living a sea-side house, Figs 3.2) no tsunami was observed in this location. This was confirmed by an in-situ survey conducted by the team that found no tsunami traces along the shore.

Figure 3.2. The eyewitnesses telling his observations during the event at W-01.1 survey point

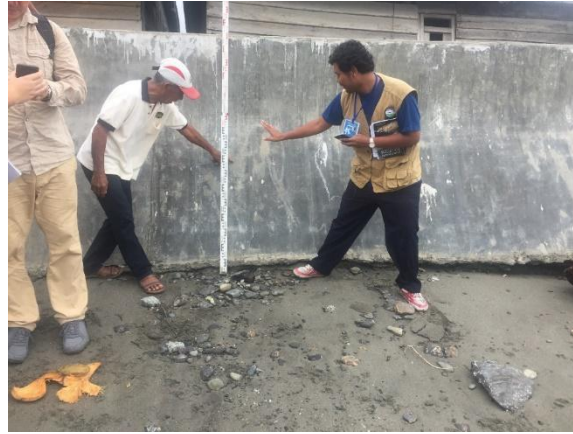
Point: E-01 Alindau

The eyewitnesses at this survey location in Alindau (0.35395S 119.76194E) reported no tsunami observation. They stated that the water first receded (in less than 1 min after the quake) but regained to its normal position. In Figure 3.14 the eyewitness shows the water level which fits with the tide level at the time of tsunami.

Figure 3.14. The eyewitness showing the water level at the time of tsunami

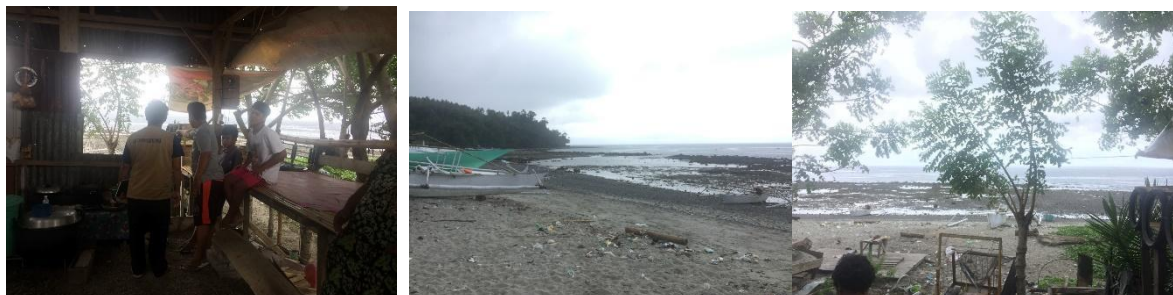
Point: E-02 Bulu Salugoo

According to the eyewitnesses, there was very small wave motion (the water receded and came back) at this survey location (0.41283S 119.7613E), runup was 0.5m.

Figure 3.15. Eyewitness telling and showing his observations at Bulu Salugoo (E-02)

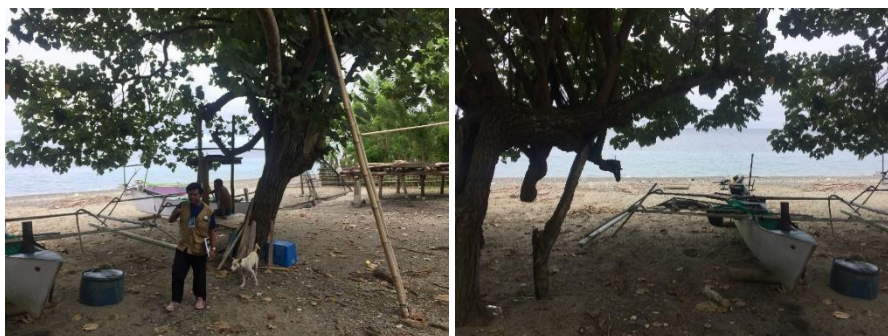
Point: E-03 Kaliburu

The eyewitnesses reported no tsunami observation at this survey location (0.50688S 119.7665E).

Figure 3.16. Eyewitness telling no tsunami observation at the coast at Kaliburu region (E-03)

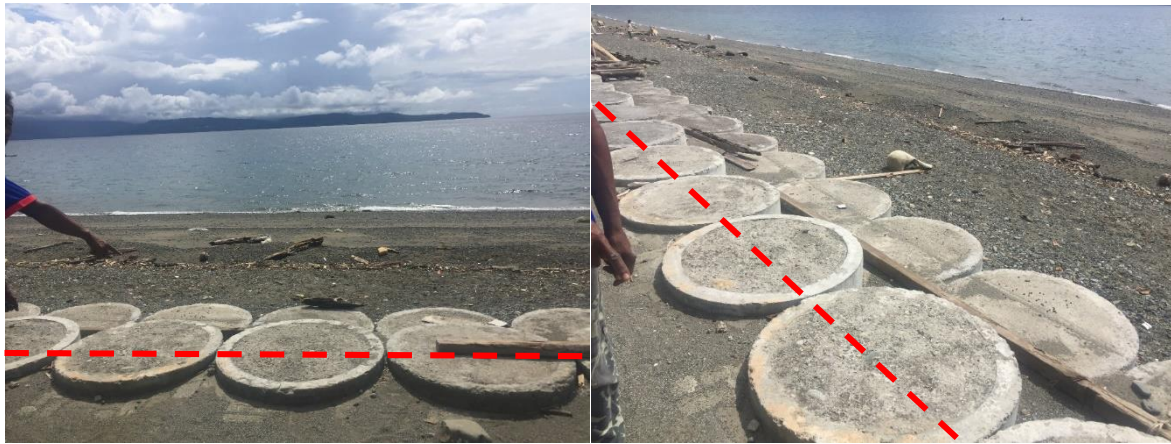
Point: E-06 Bulu Kadia

The eyewitness in this location (0.6221S 119.8044E) was in his boat at the time of the earthquake and he experienced that first the sea receded and then 3 times up and down motion of the sea. He showed the inundation point of the waves as given in Figure 3.18.

Figure 3.18. The eyewitnesses showing the inundation point at Bulu Kadia region (E-06)

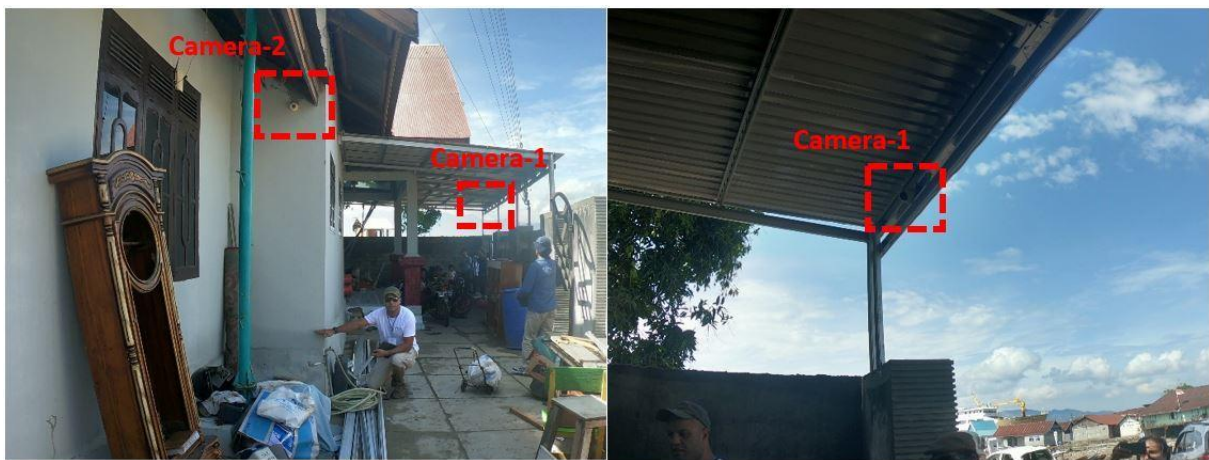
Point: E-09 Wani

This survey point is the location that CCTV video records <https://www.youtube.com/watch?v=oBvx32WgxnY&t=1s> <https://www.youtube.com/watch?v=m3QOX3GxxVQ> during the earthquake and tsunami wave arrivals are available from two camera points on the house (0.6939S 119.8421E). The team analyzed the video images before surveying this location. According to the video images, the earthquake shaking started at 18:02:54 (time at camera record) and ended at 18:03:40. The advancing flow started at 18:06:29 and stopped at 18:06:51 according to the time at camera record. In the second part of the video (from another Camera) the wave arrives at 18:06:32 and, advancing flow stops at 18:06:59. Figure 3.21 shows the locations of these two cameras in the house.

Figure 3.21. Camera locations in the house

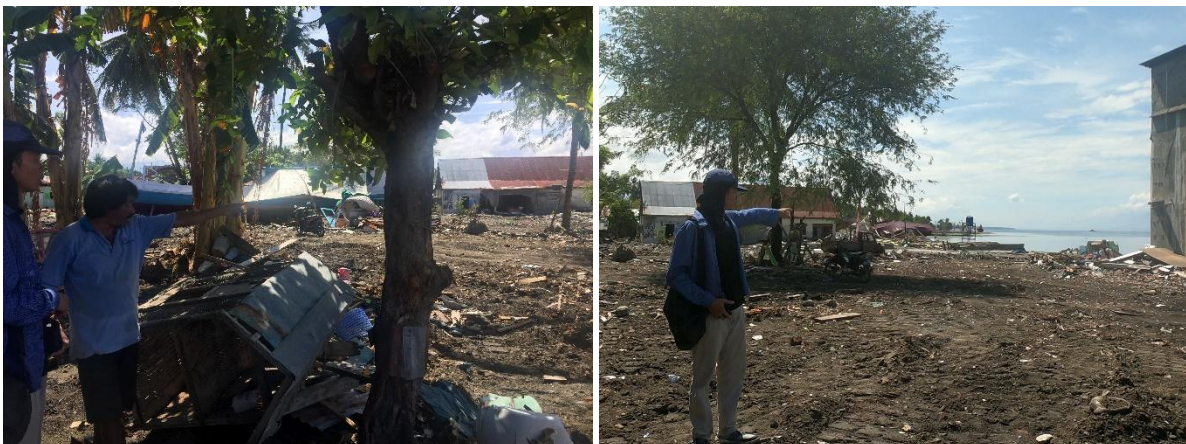
The team also conducted several eyewitness interviews to understand what happened at the time of the event with the owner of the house of video recordings at Wani and also with a fisherman who was in his boat at the event time and another householder in this location. The fisherman stated that first the sea receded around 3m since he was in his boat around this depth and just hit the ground. The other two people also confirmed the first motion of the wave was negative which indicates a leading depression wave. The eyewitnesses reported three positive waves, first a small wave and the second wave was the largest. The eyewitnesses reported that the waves were coming from two different directions (from South and West directions) (Figure 3.23).

Figure 3.23. Eyewitness and local helper showing the wave directions observed at Wani (Point E-09)

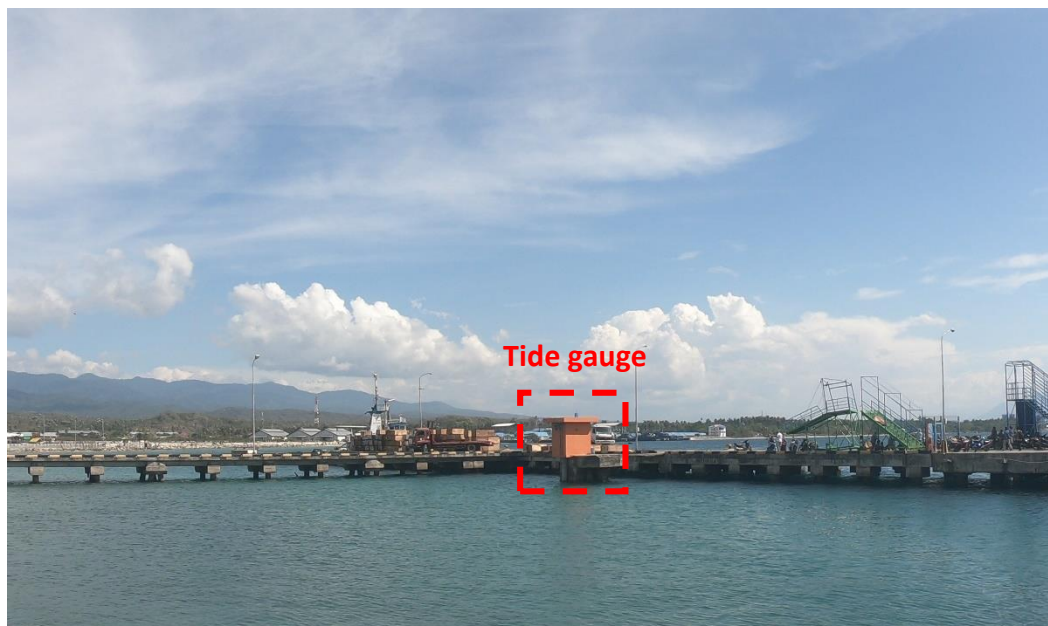
Point: E-12 Pantoloan

This survey point (E12, 0.7108S 119.8585E) is the Port of Pantoloan where stands the tide gauge that measured the tsunami. The location of the tide gauge in the port is shown in Figure 3.27.

Figure 3.27. The location of the tide gauge in the Pantoloan port

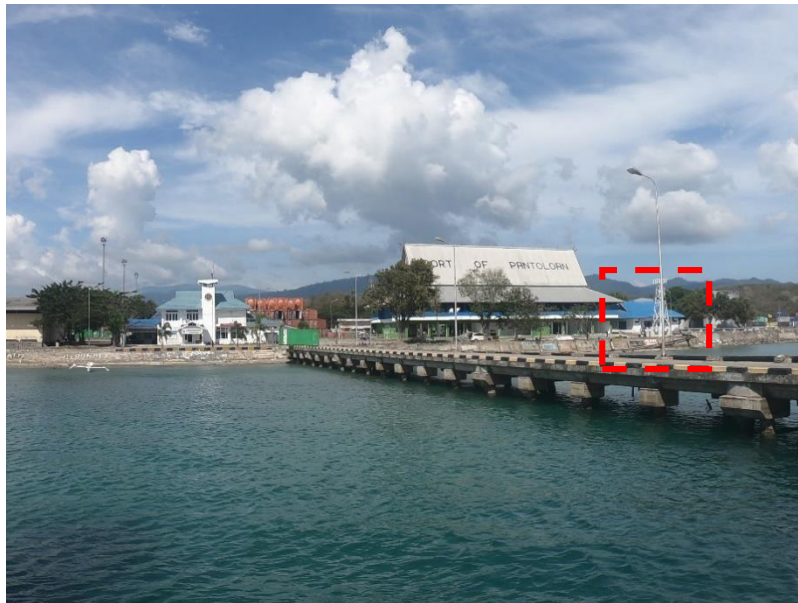
The wave direction was reported as from northwest at this location. The runup height is measured as 2.7m after detiding according to both observations and eyewitnesses. The inundation distance is measured as 73m.

Figure 3.28. The location of the house/building eyewitnesses reported flow depth and splash

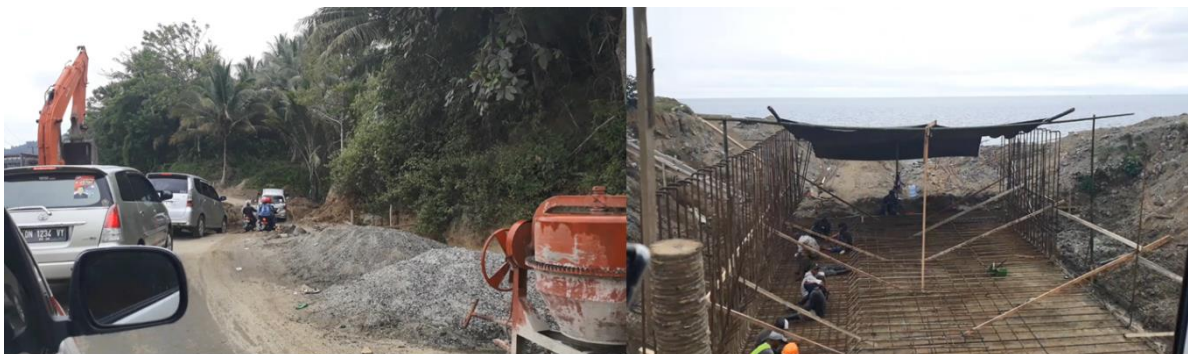
The earthquake triggered several landslides that affected the regional road. After one month, many construction works were ongoing. It lasted more than 3 hours to reach the target area from Palu.

Figure 3.33 Difficulties to reach the area
