BIBLIOGRAPHIC REFERENCE

Cousins, W. J.; Power, W. L.; Palmer, N. G.; Reese, S.; Tejakusuma, I.; Nugrahadhi, S. 2006. South Java Tsunami of 17th July 2006, Reconnaissance Report, *GNS Science Report* 2006/33 p42.

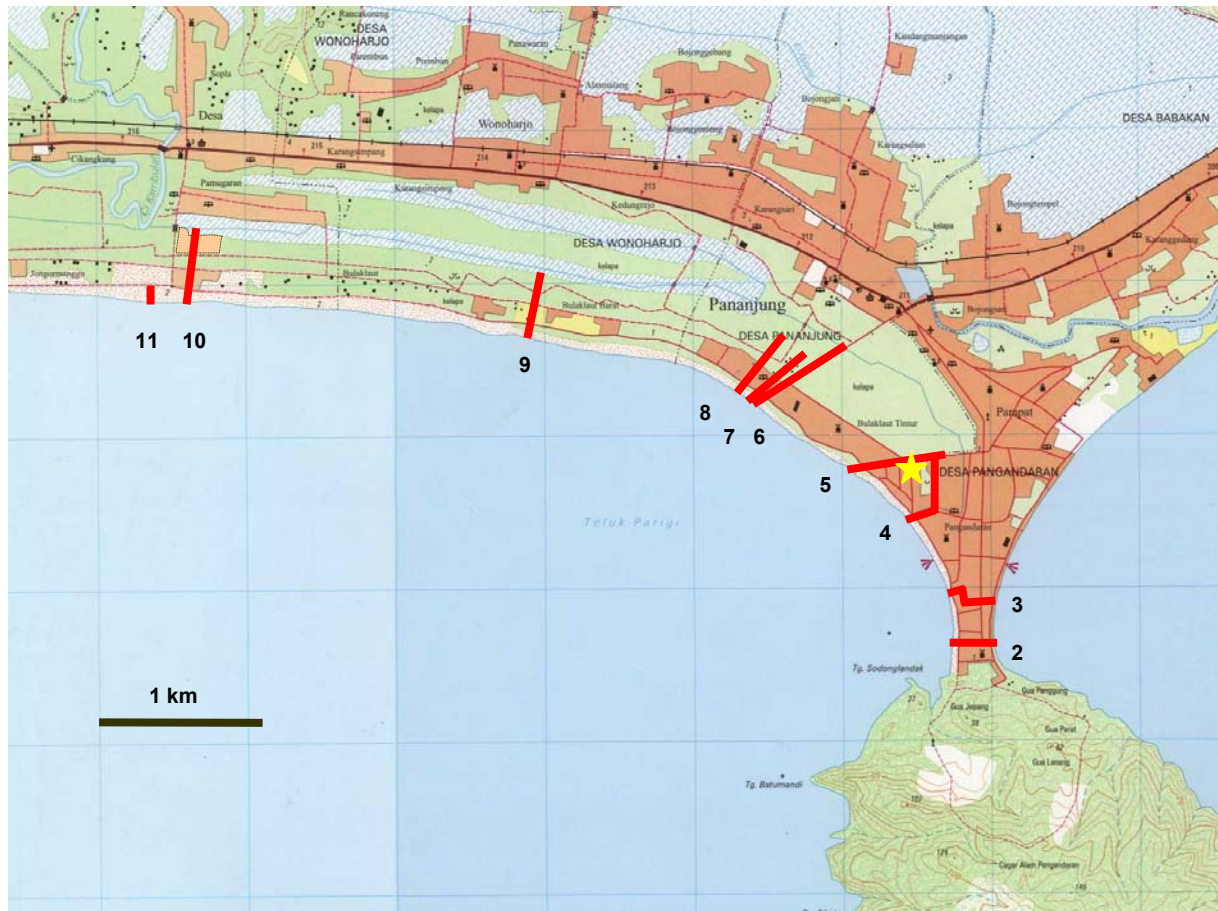
Figure 2.4.1 Pangandaran and vicinity. North is up, orange denotes built-up areas, green is tree covered areas (coconut plantations in the upper part of the map, forest on the hilly land in the lower part), and stippled blue is paddy-field. Red lines show the locations of ground profile measurements (numbered from east to west). The yellow star marks the location of the GPS base-station.

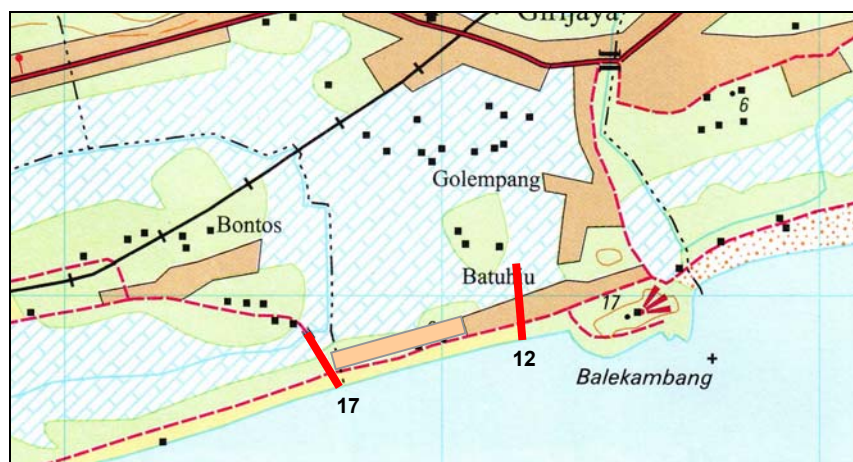
Ciliang Village was about 13km west of Pangandaran. The damaged area, Batuhui, was located on a narrow sand dune between the beach and low-lying paddy fields (Figure 2.6.1). The sand dune was about 100 m wide and had a central crest that was 4 – 5 m above mean sea level. The houses were typically 1 – 2 m below the crest on the slope away from beach, hence were somewhat protected from the sea by the crest. Not all of the houses had been destroyed. Approximately 30% were still standing, and about half of those had suffered relatively little damage. Thus the additional 1 – 2 m near-shore elevation, compared with near-shore elevations near Pangandaran, may have significantly reduced the damage levels.

Figure 2.6.1 Map of Batuhui area of Ciliang Village. Batuhui occupied the inland side of a relatively narrow (about 100 m wide) sand dune between the sea and low-lying paddy fields. The road bordering Batuhui ran along the crest of the sand dune. Ground profiles 12 to 17 were taken here, approximately equally spaced. See also Appendix Figure A2.3.

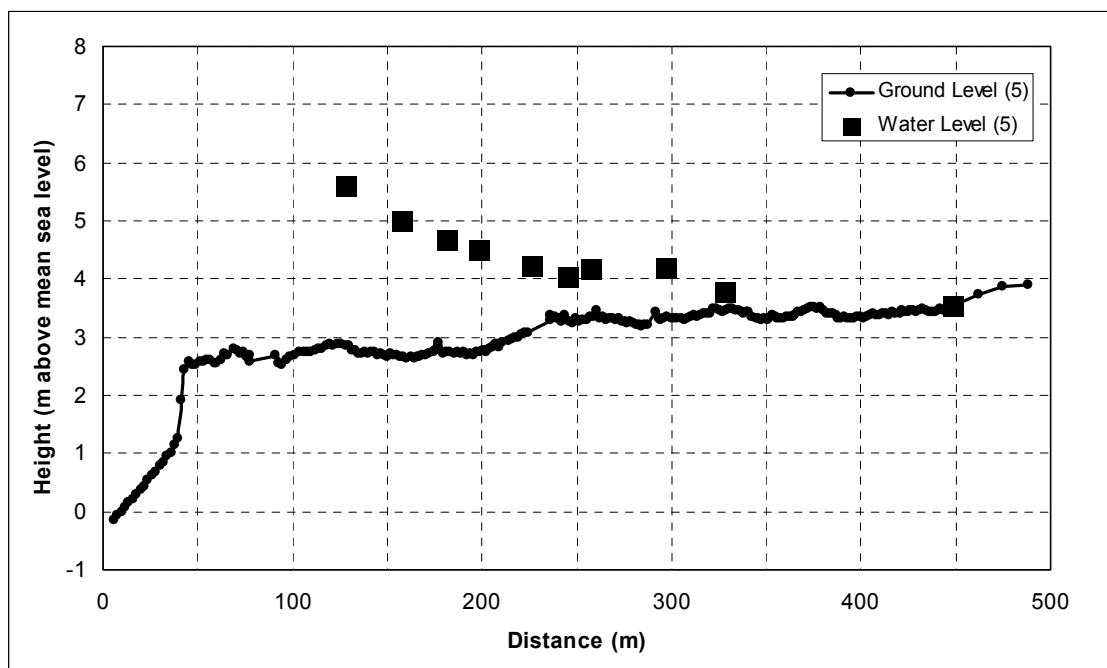
Figure 2.7.7 Ground profile 5 and water levels in Pangandaran Village.
