StEER: Structural Engineering Extreme Event
Reconnaissance Network
PALU EARTHQUAKE AND TSUNAMI, SUWALESI, INDONESIA
PRELIMINARY VIRTUAL ASSESSMENT TEAM (PVAT) REPORT

Released: October 2, 2018

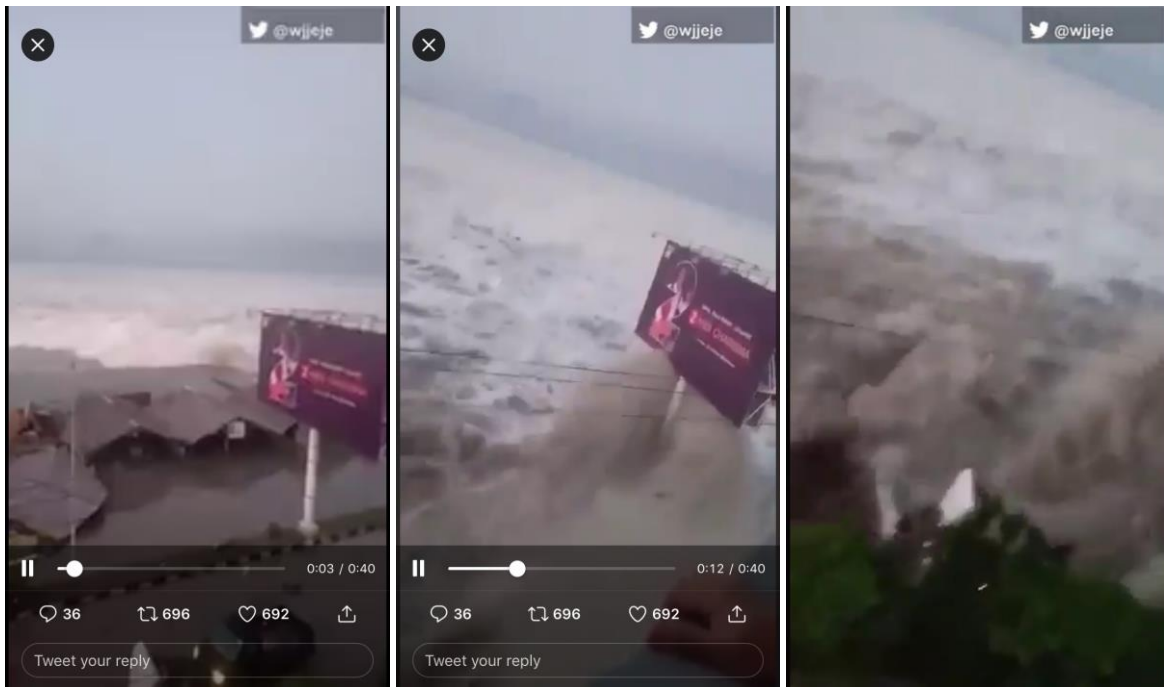
A number of survivor videos are available online. Figure 8 shows three images extracted from a survivor video of a tsunami wave approaching the Palu shoreline as a broken bore. The nearshore area is already wet, indicating that this was not the first wave in the tsunami sequence. The full video is available at: <https://twitter.com/i/status/1045682372623052802>

This video was taken from the top level of a circular ramp leading to the roof of a parking structure close to the shoreline (Figure 9).

Figure 8: Images from survivor video taken from parking structure spiral ramp as tsunami bore approached the Palu shoreline (Source: cbsn.ws/2OSf94xp[pic.twitter.com/mW4qhK9n3X](https://twitter.com/mW4qhK9n3X)).

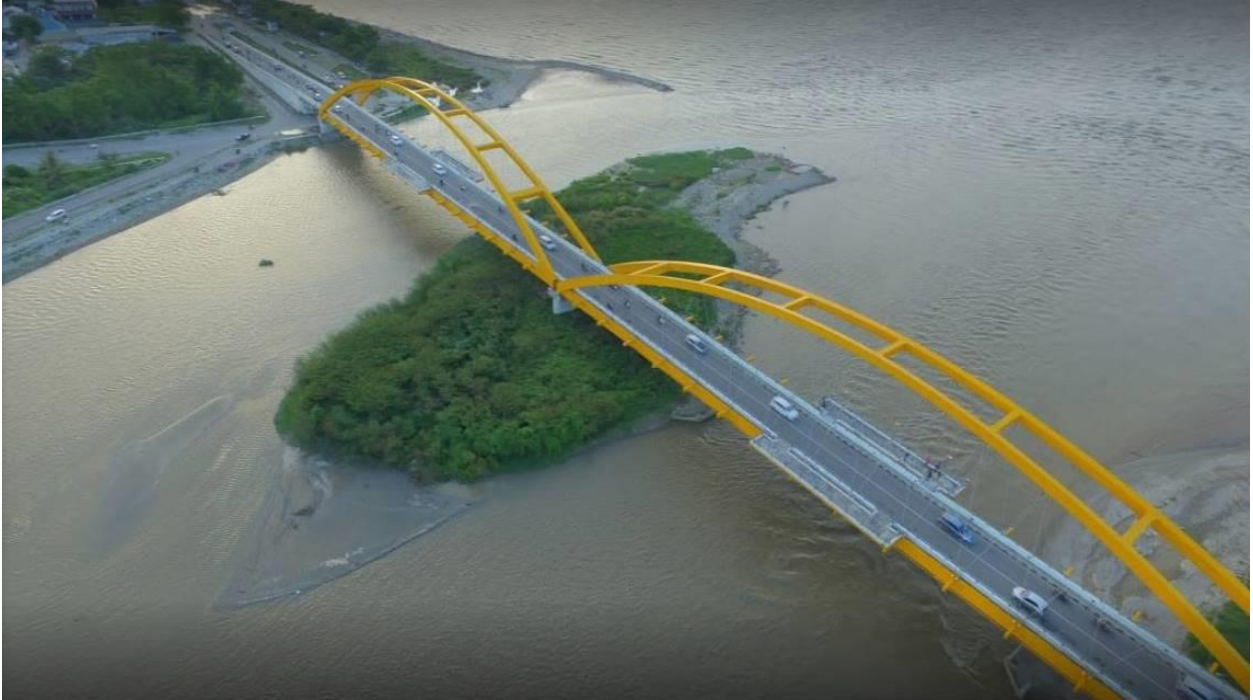
Figure 23: Palu Bridge IV prior to earthquake (Tofan Rozianto) (0.885423 S, 119.85883 E)

The iconic twin steel arch cable-suspended Palu Bridge IV over the mouth of the Palu River (Figure 23 and Figure 24) collapsed, presumably during the earthquake (though this needs to be confirmed) (Figure 25 and Figure 26). The bridge had a total span of 250 meters and the steel box arches were 20 meters tall. A number of other bridges are reportedly damaged, hampering road traffic in and around the city.
