Historical Tsunami Effects near the Tonga Trench (1837-2021)

Introduction

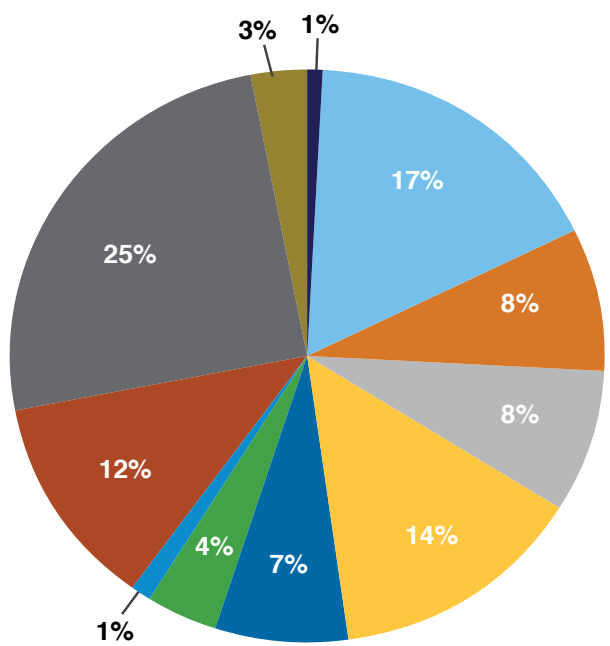
American Samoa (2022)

The majority of tsunamis observed in American Samoa, Samoa and Tonga are distant tsunamis (source >1000km). Distant tsunamis (event validity ≥ 3) make up 86% of tsunamis in American Samoa and 63% in Tonga (through 2022), and 80% in Samoa (through 2015). Local and regional tsunamis (source ≤ 1000 km) account for 14% of tsunamis in American Samoa and 37% in Tonga (through 2022), and 20% in Samoa (through 2015). Although only two damaging eruptions generated a confirmed tsunami in the region, local and regional volcanic sources should not be overlooked given the number of volcanoes along the Tonga Trench.

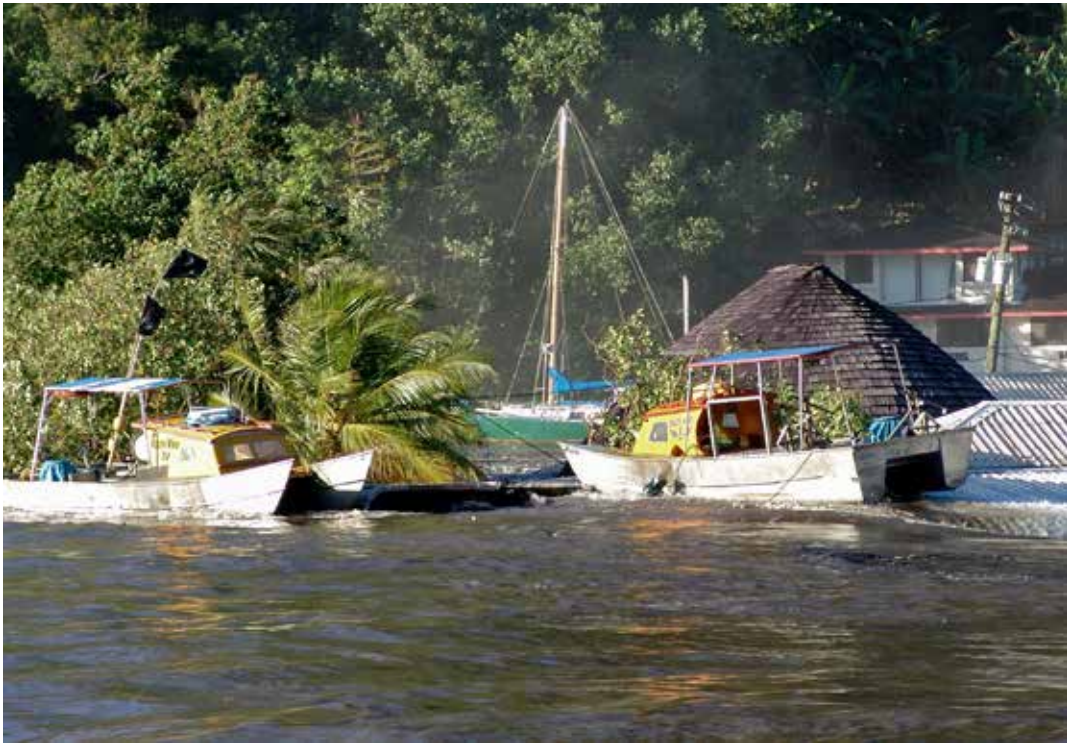
2009 tsunami flooding Pago Pago Bay, American Samoa, lifting boats onto submerged structures and into the tops of coconut trees. credit: R. Madsen, aboard sailboat Barbarella

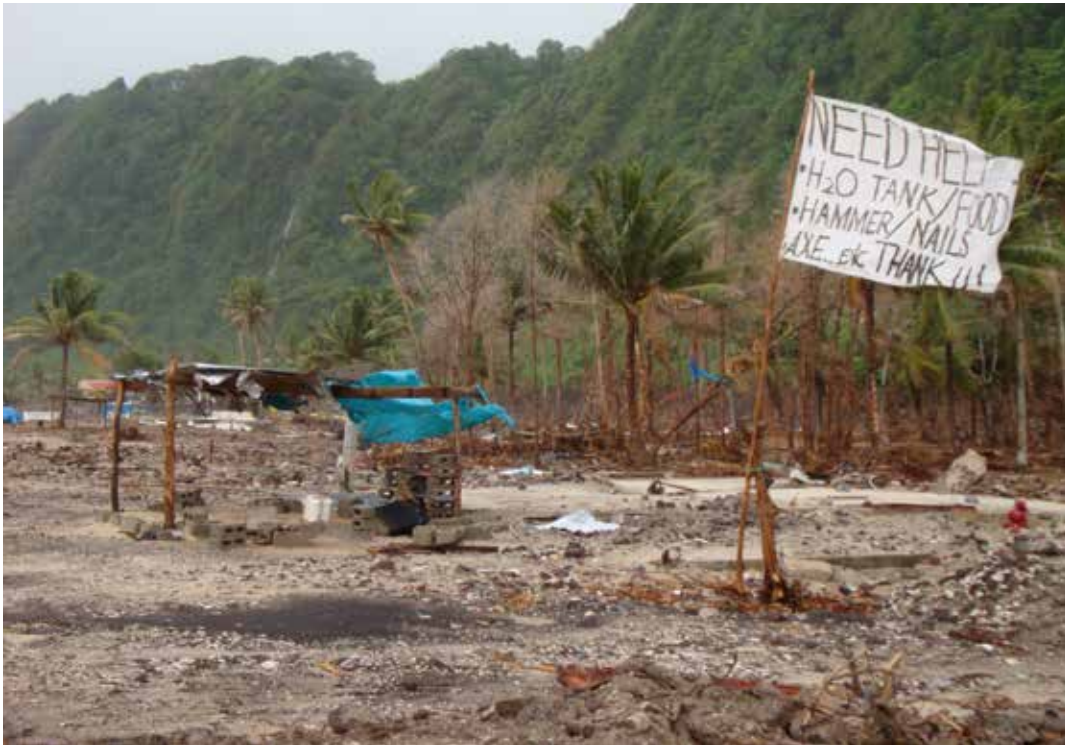
Many coastal villages along the south and east coasts of Upolu, Samoa were destroyed in the 2009 tsunami - only foundations of homes remained afterward. credit: ITST Samoa Social Science team

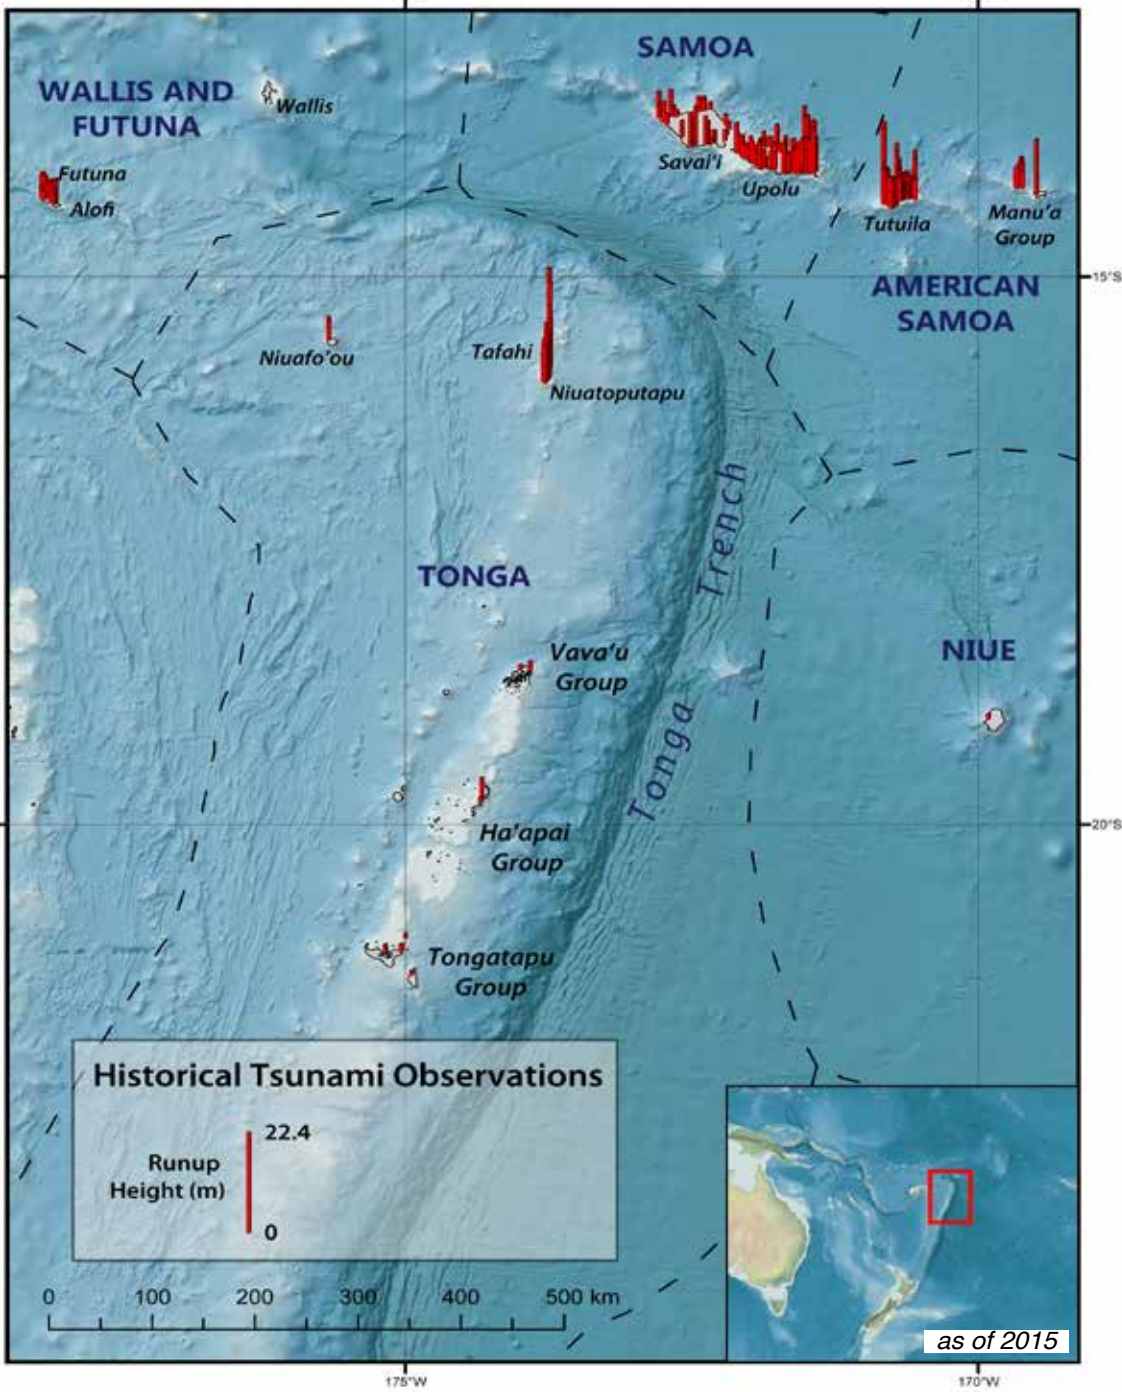
Historical tsunami observations near the Tonga Trench

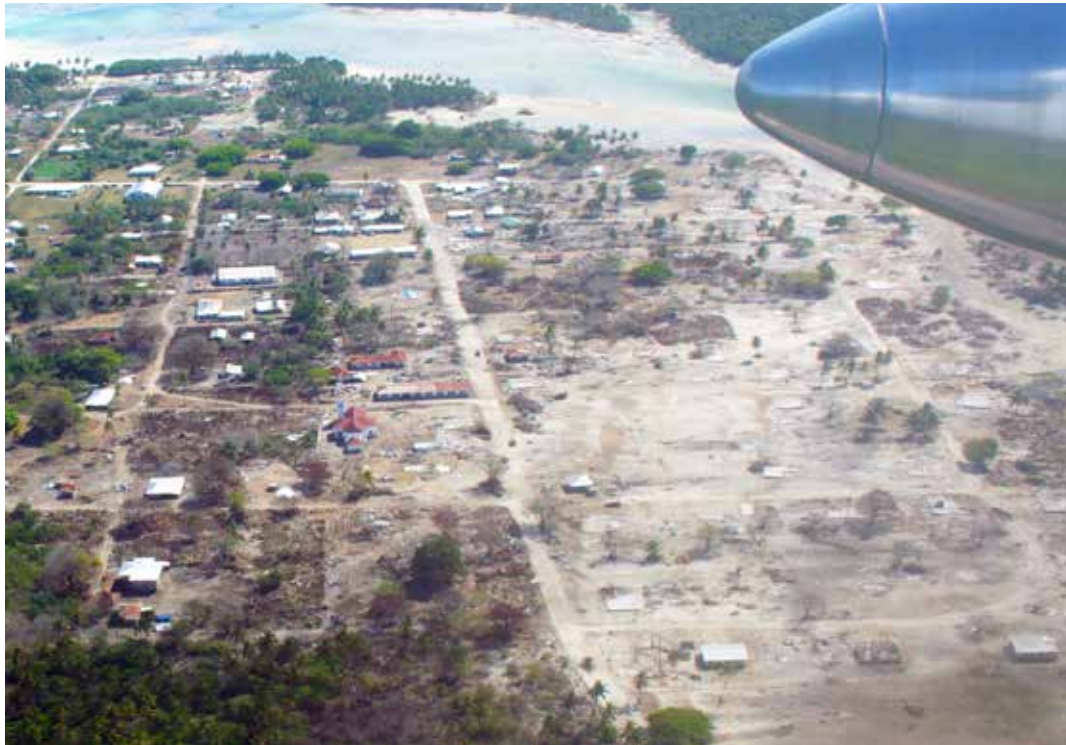
Aerial photo of tsunami-damaged Hihifo, the main town in Niuaotupapu, Tonga. Overall, the highest runups (> 22 m) for the 2009 tsunami were measured here on the island's eastern coast. credit: Tonga Met. Svc.
